NATIONAL REGISTER OF HISTORIC PLACES
REGISTRATION FORM

historic name: Smith, William H., House

city/town: Atlanta

county: Columbia

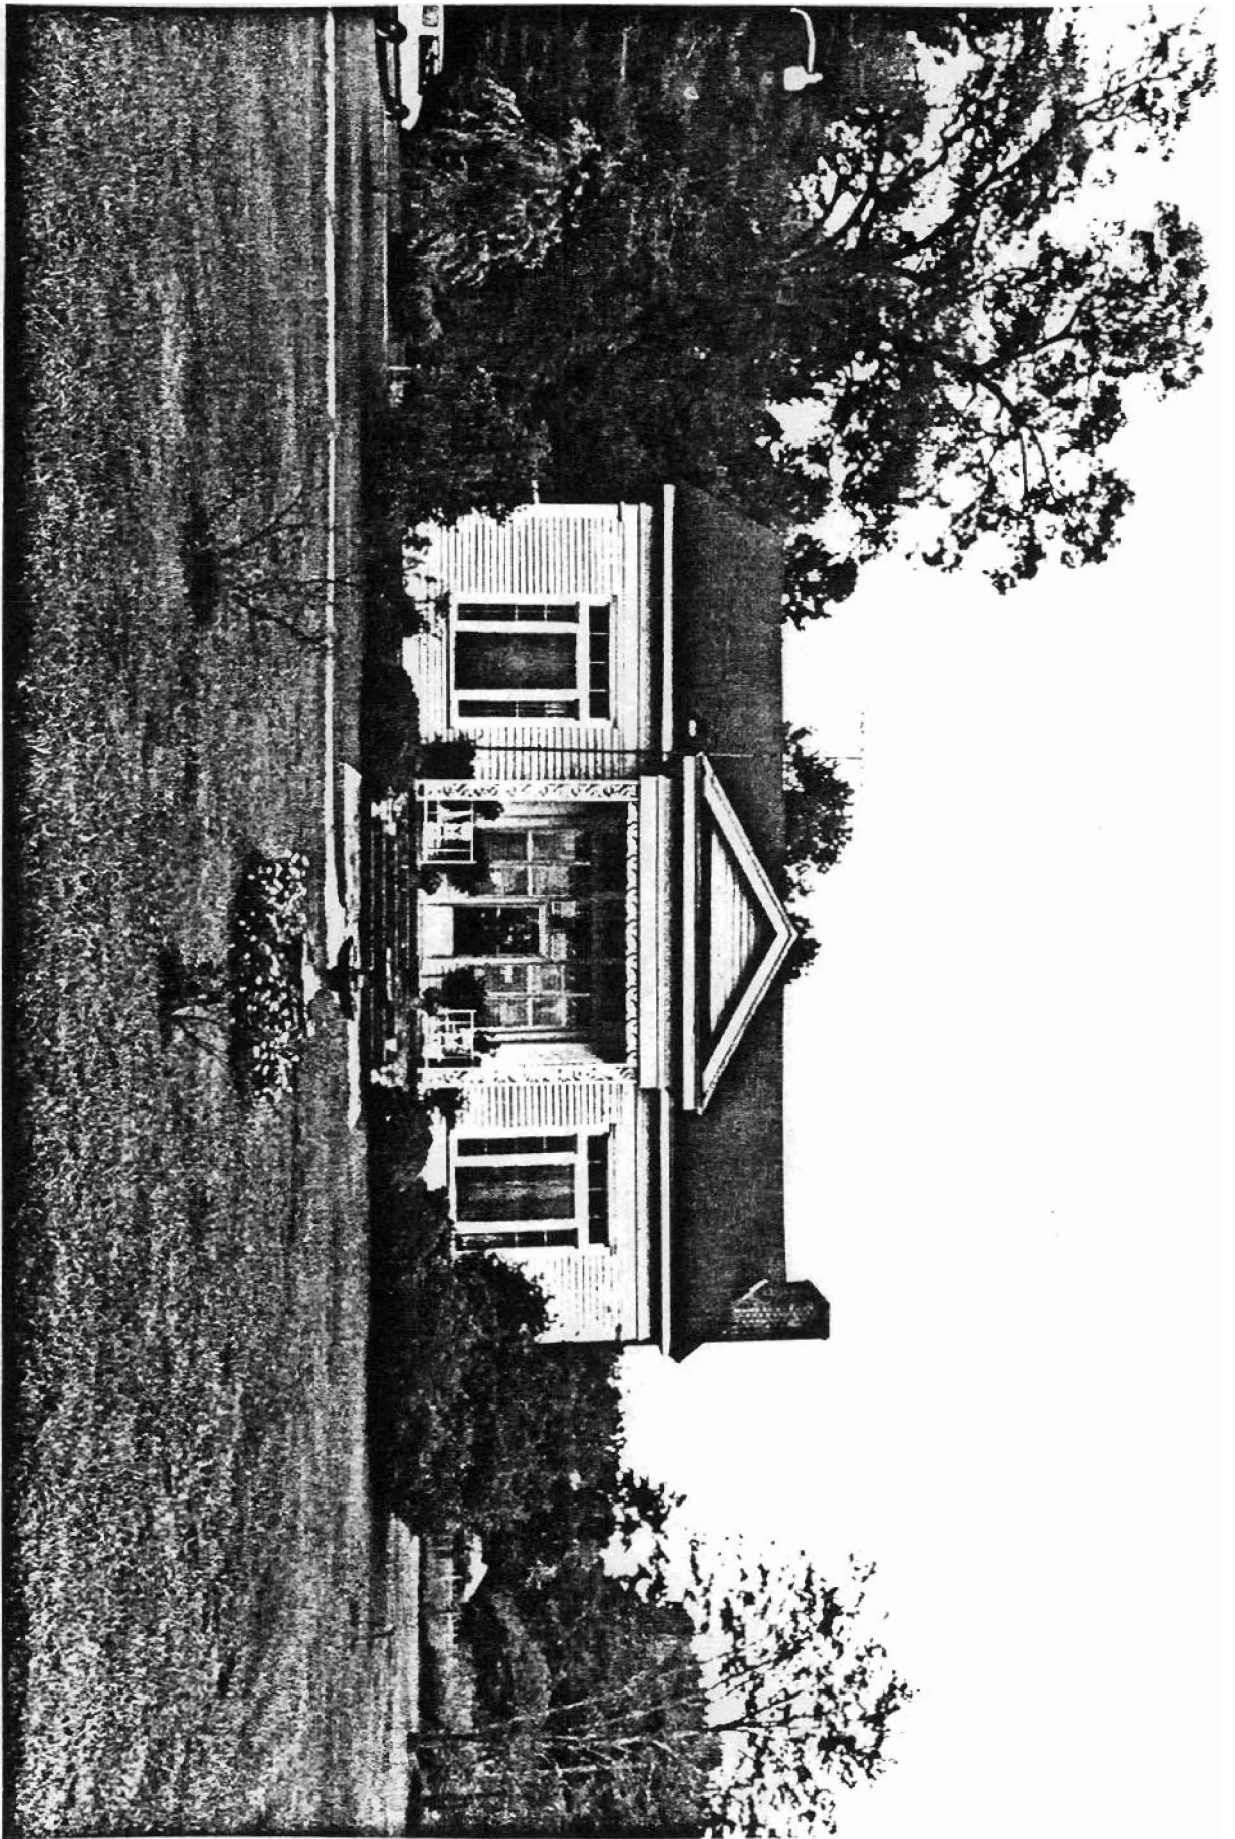
William H. Hare
Columbia Co., Arkansas
Photographed by Patrick Zolner
August 1992
Negative on file at AHPP
View from the south

A central, gable-roof porch dominates the front, or southern, elevation. The porch roof was originally supported by wood columns; however, in the 1950's they were replaced with two wrought-iron columns. Also at this time, a new brick porch and steps were installed. The pediment, which rests upon a full classical entablature that circumscribes the entire house, is outlined by a projecting boxed eave with a shallow, composition-shingled pent roof at the base. Ordinary weatherboard is used to fill the interior of the pediment. Although the porch originally sheltered a dogtrot, the open hallway was enclosed during the 1950's remodeling. A single-leaf door is now located in the center and is surrounded by aluminum-frame, jalousie-style glass windows above a short, weatherboard bulkhead. Three wood-frame, six-pane window sashes are juxtaposed in the manner of a transom above the jalousie-style windows and provide a more classical appearance to the otherwise modern enclosure. Two original wood pilasters flank the enclosed dogtrot. The square pilasters rest upon a simple base and taper upward to a correspondingly simple capital. The owner plans to reconstruct the original porch columns based upon these pilasters.

The remainder of the elevation is fenestrated by two symmetrically placed, six-over-six, double-hung windows that are unusual in that they are each surrounded by a four-pane transom and four-pane sidelights. Apparently, the original windows have been replaced with wood-frame windows of identical sash configuration. The transoms

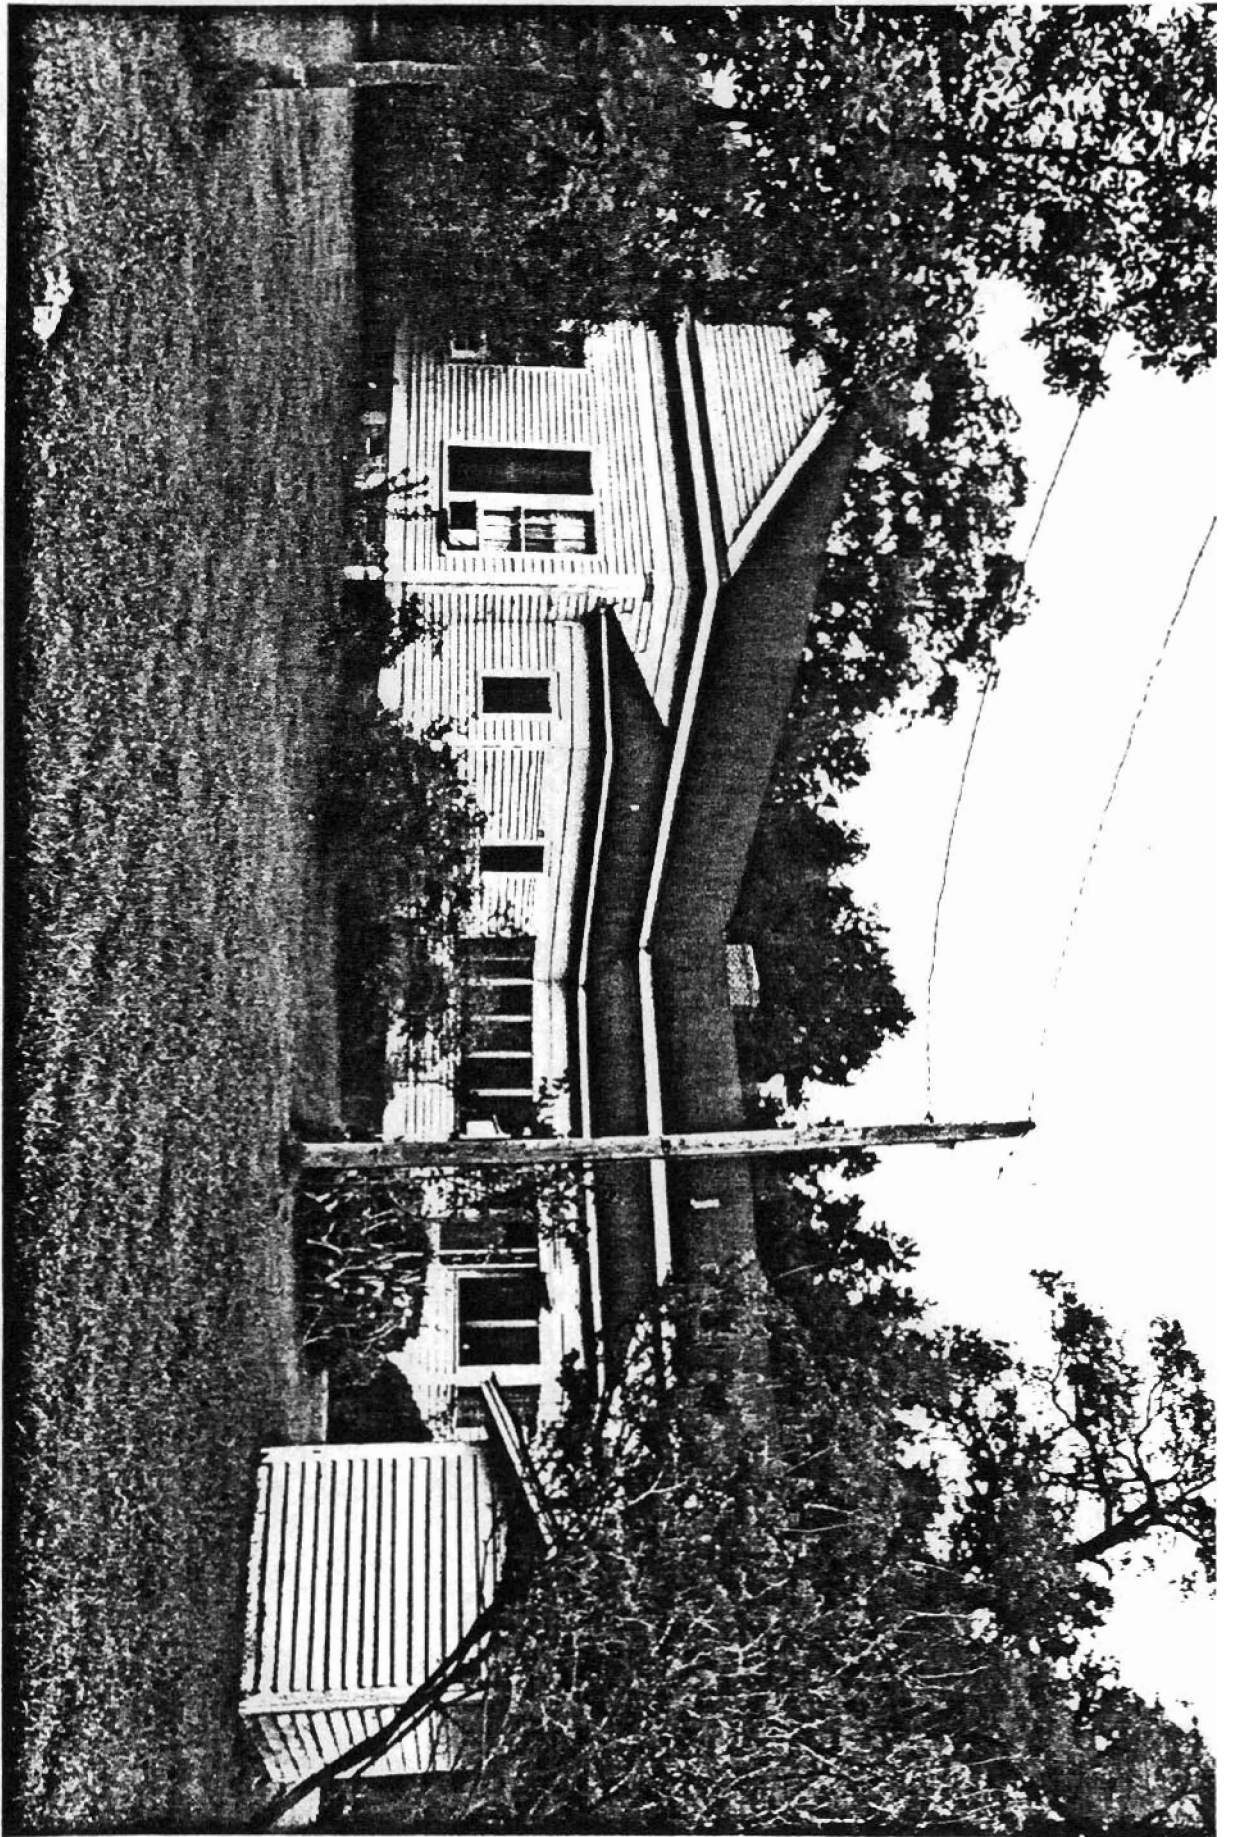
Smith, William H., House
Columbia Co., Arkansas
Photographed by Patrick Zollner
August 1992
Negative on file at AHPP
View from the northeast

An L-shaped, hipped-roof porch is attached to the rear of eastern section of the dogtrot and the eastern side of the ell section. The portion at the rear of the dogtrot appears to have been enclosed during the 1920's as it contains two, small three-over-one Craftsman windows. The porch attached to the side of the ell was apparently enclosed at the time of the 1950's remodeling. A single-leaf door, covered by a metal canopy roof similar to the one used on the western elevation, provides access into the porch. Jalousie-style windows, identical to the ones of the front entrance, span the entire portion of the porch on this elevation. Both portions of the L-shaped porch are enclosed with matching weatherboard, but contain a much simpler entablature than that found on the main house.

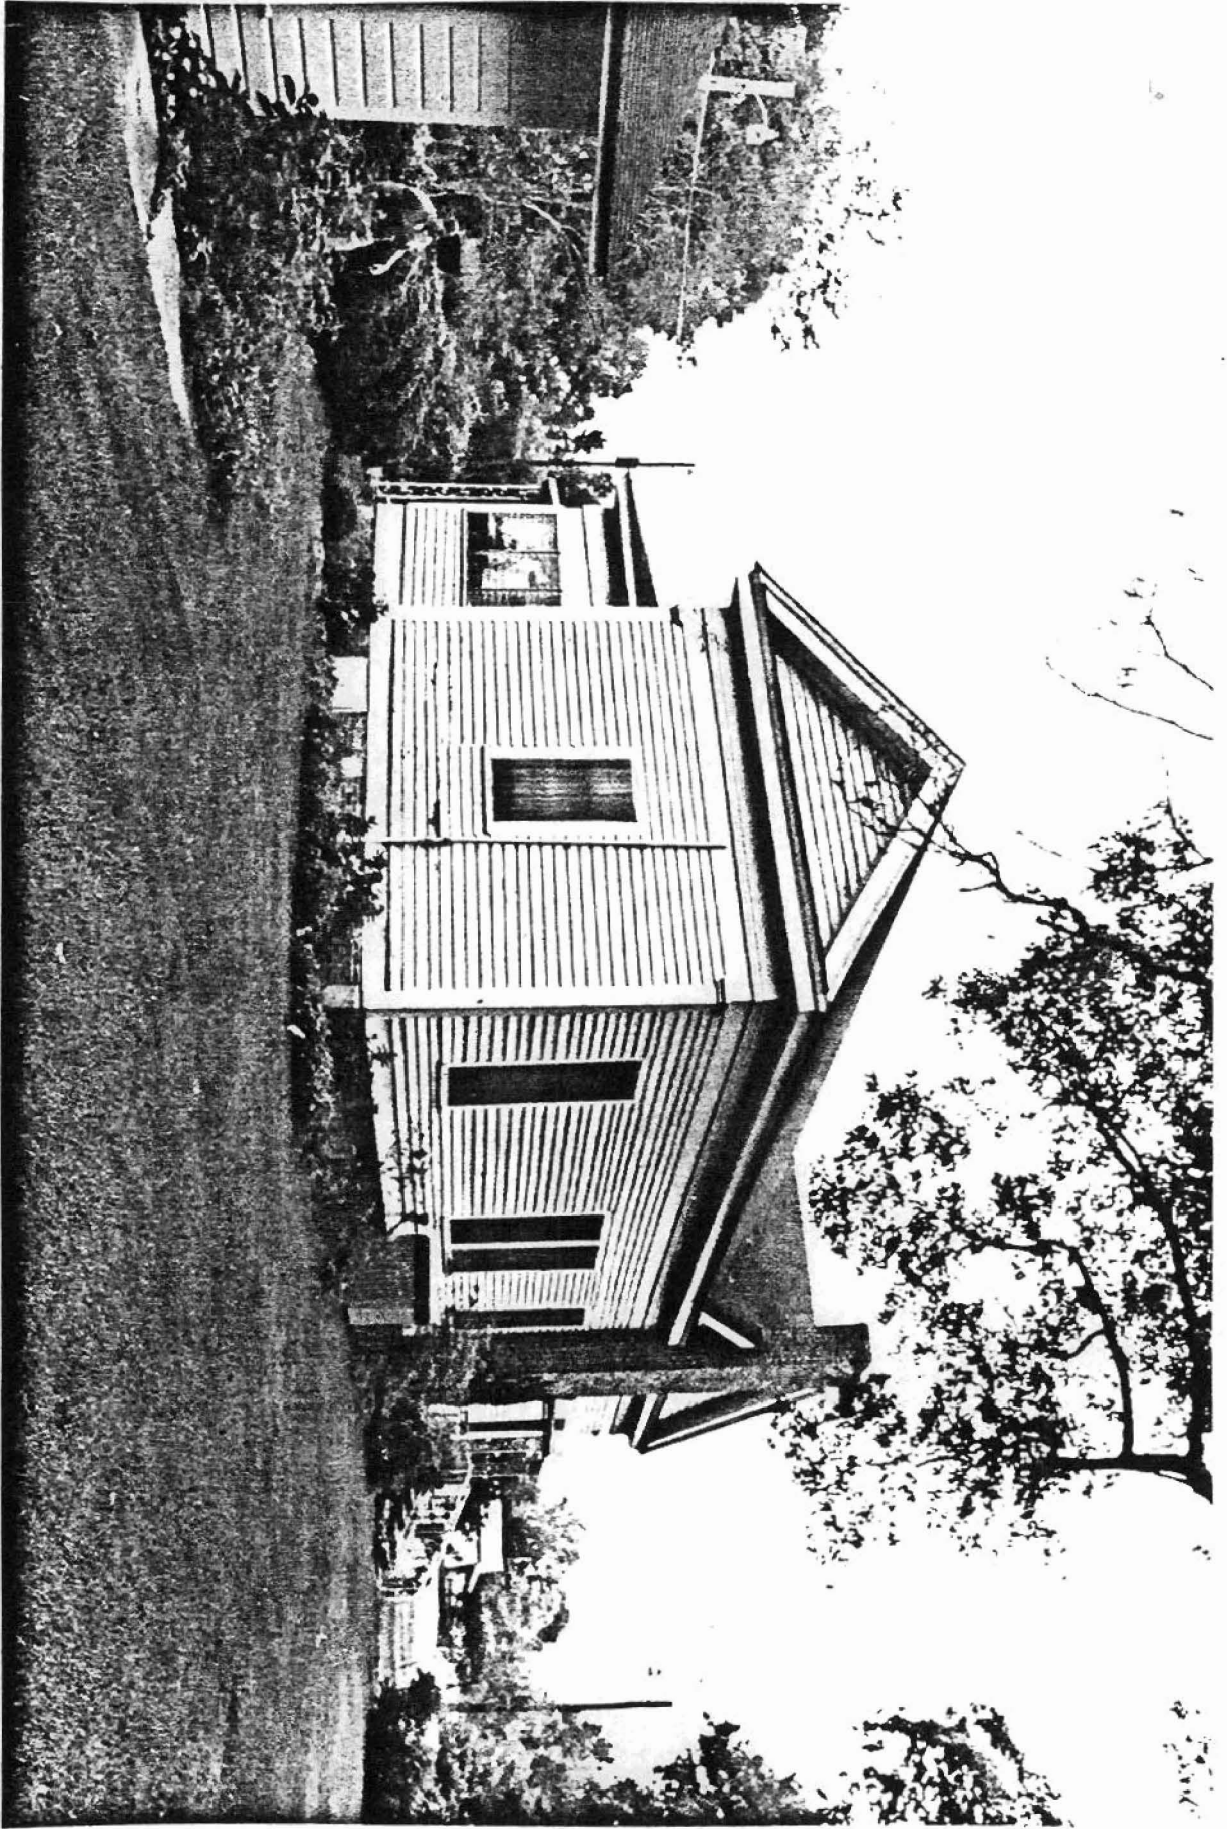
Smith, William H., House
Columbia Co., Arkansas
Photographed by Patrick Zoller
August 1992
Negative on file at AHPP
View from the northwest

The western elevation is also composed of the side elevation of the original ell. It contains a pair of six-over-six, double-hung windows near the juncture with the side-gabled roof and an identical single window near the northern corner. The rear, or northern, elevation of the ell likewise features a pedimented gable end over the entablature. The original window opening in the center of the wall has been shortened and a more recent window installed.

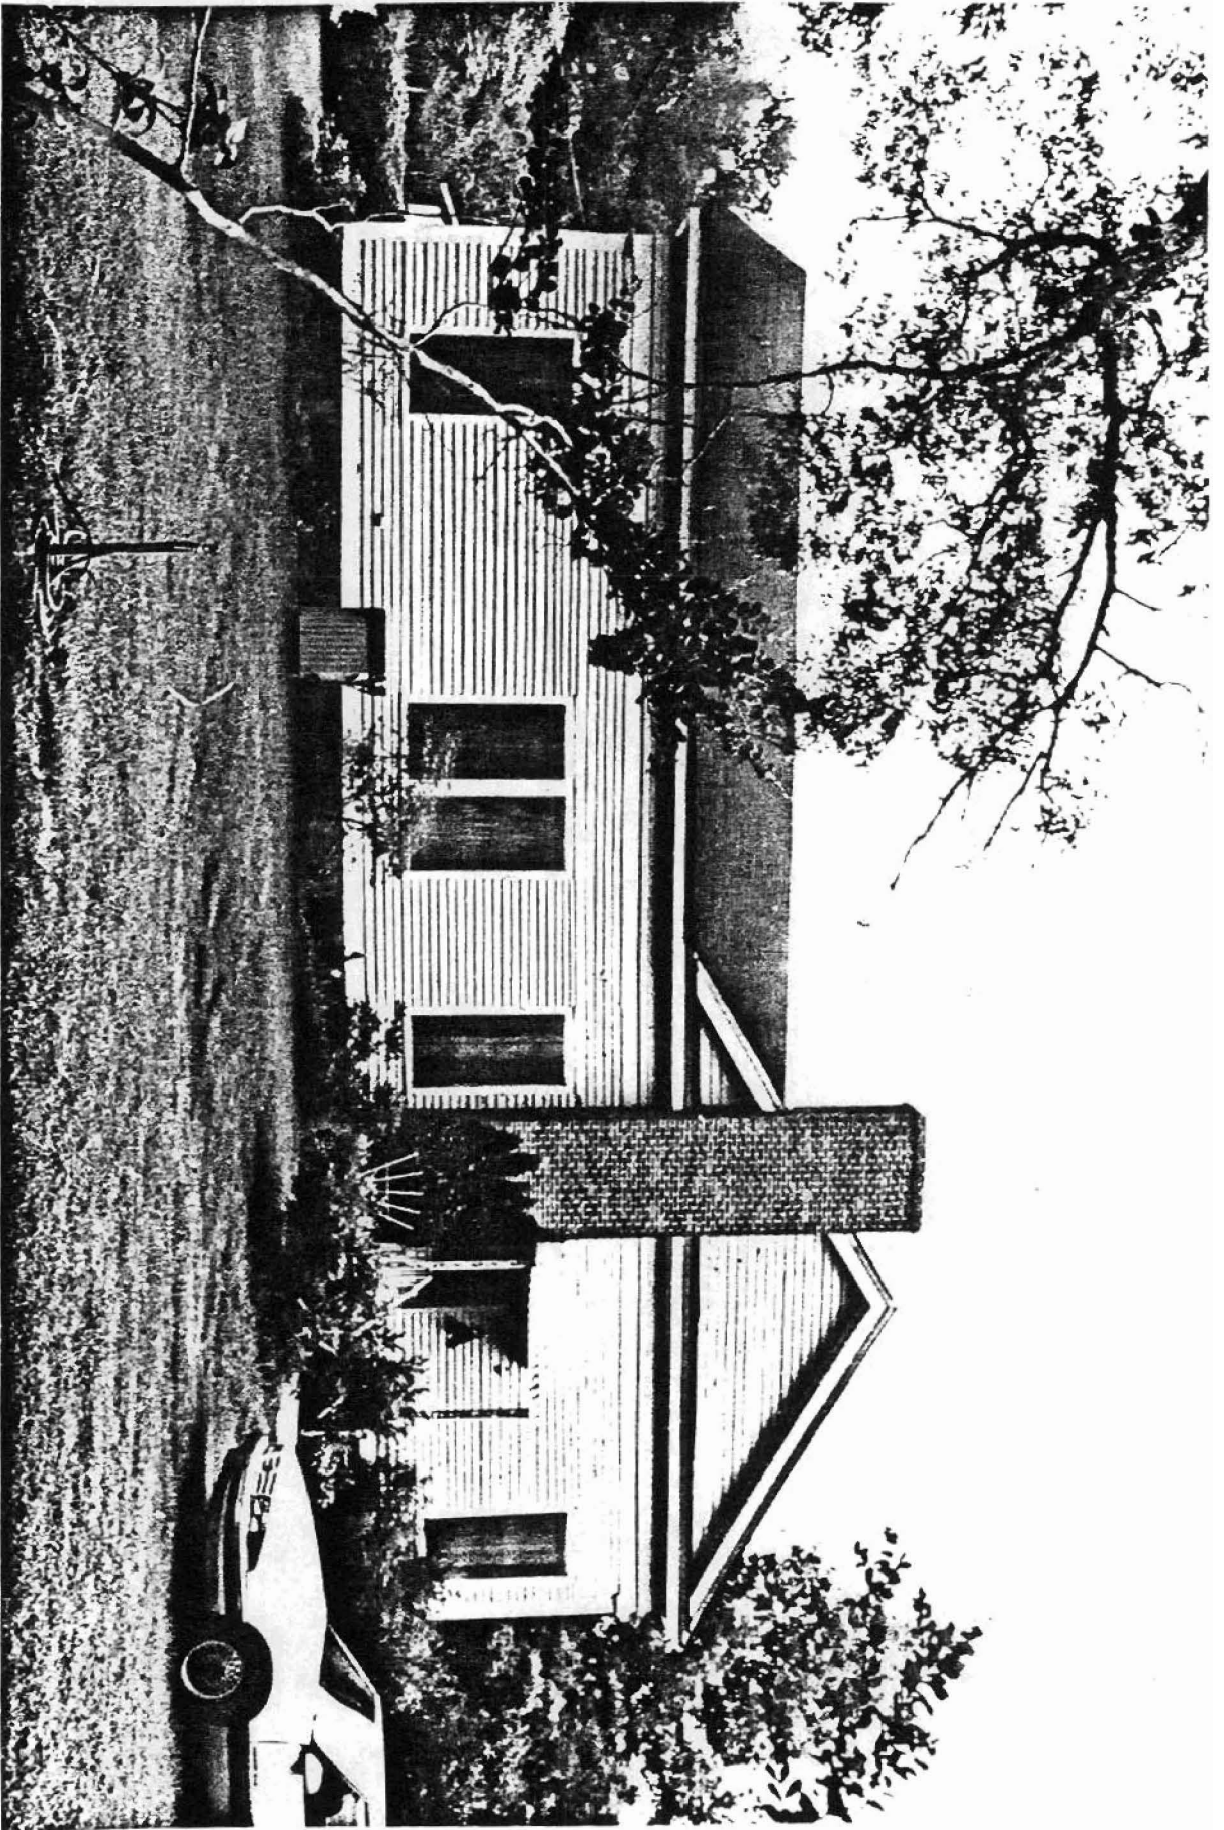
Smith, William H., House
Columbia Co., Arkansas
Photographed by Patrick Zoller
August 1992
Negative on file at AHPP
View from the west

Both side elevations contain pedimented gable ends similar to the smaller porch roof on the front elevation. On the western elevation, the exterior brick chimney pierces the boxed eave on the slope north of the roof peak; however, on the eastern elevation, the position is reversed. The eastern elevation is fenestrated by a six-over-six, double-hung window adjacent to both sides of the chimney and a pair of identical windows at the northern end. On the western elevation, a single six-over-six, double-hung window at the southern corner and another identical window adjacent to the northern side of the chimney provide illumination for the interior. A single-leaf entry is placed adjacent to the southern side of the chimney. This entry is covered by a metal canopy roof supported by wrought-iron columns and accessed by a brick stoop.

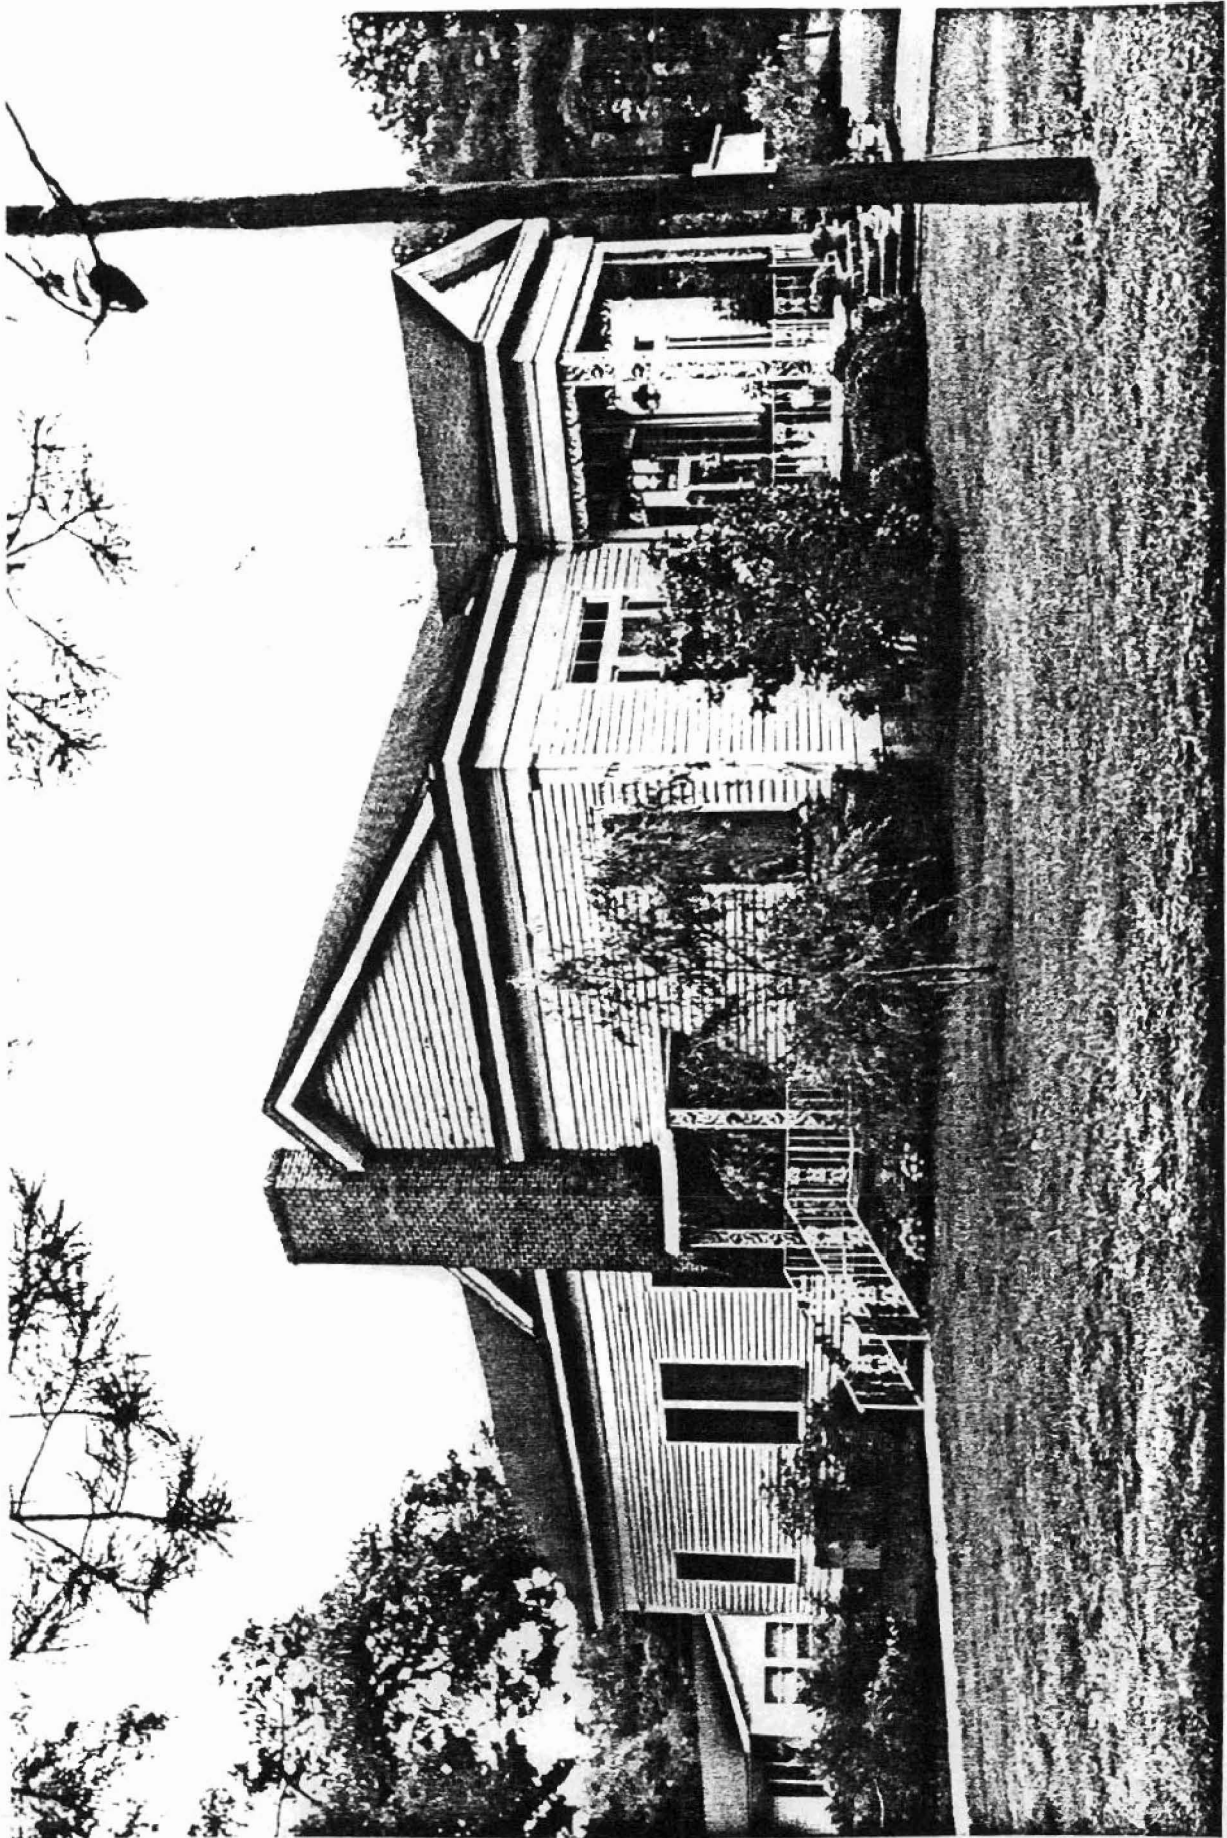
Smith, William H., House
Columbia Co., Arkansas
Photographed by Patrick Zollner
August 1992
Negative on file at AHPP
View from the southwest

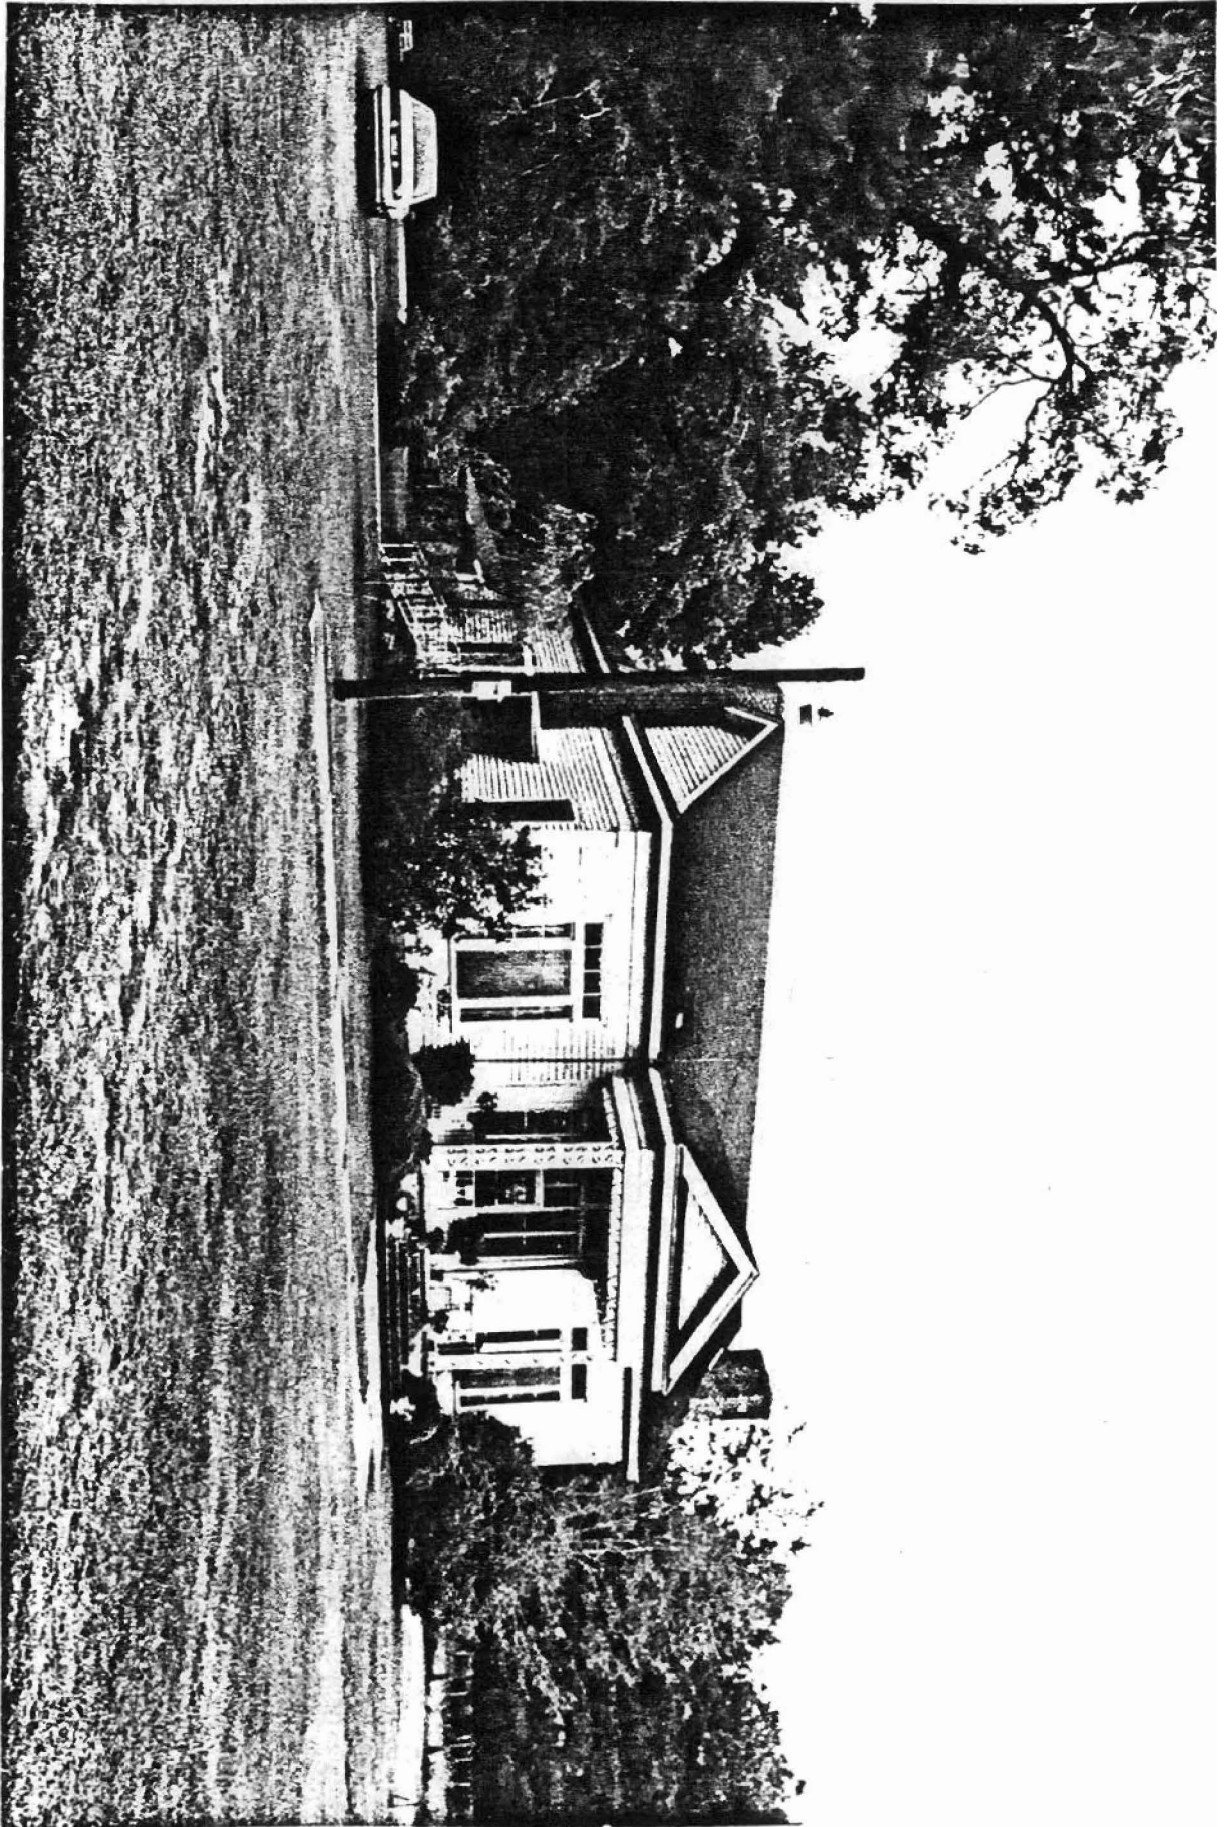
Smith, William H., House
Columbia Co., Arkansas
Photographed by Patrick Zoller
August 1992
Negative on file at AHPP
View from the southwest

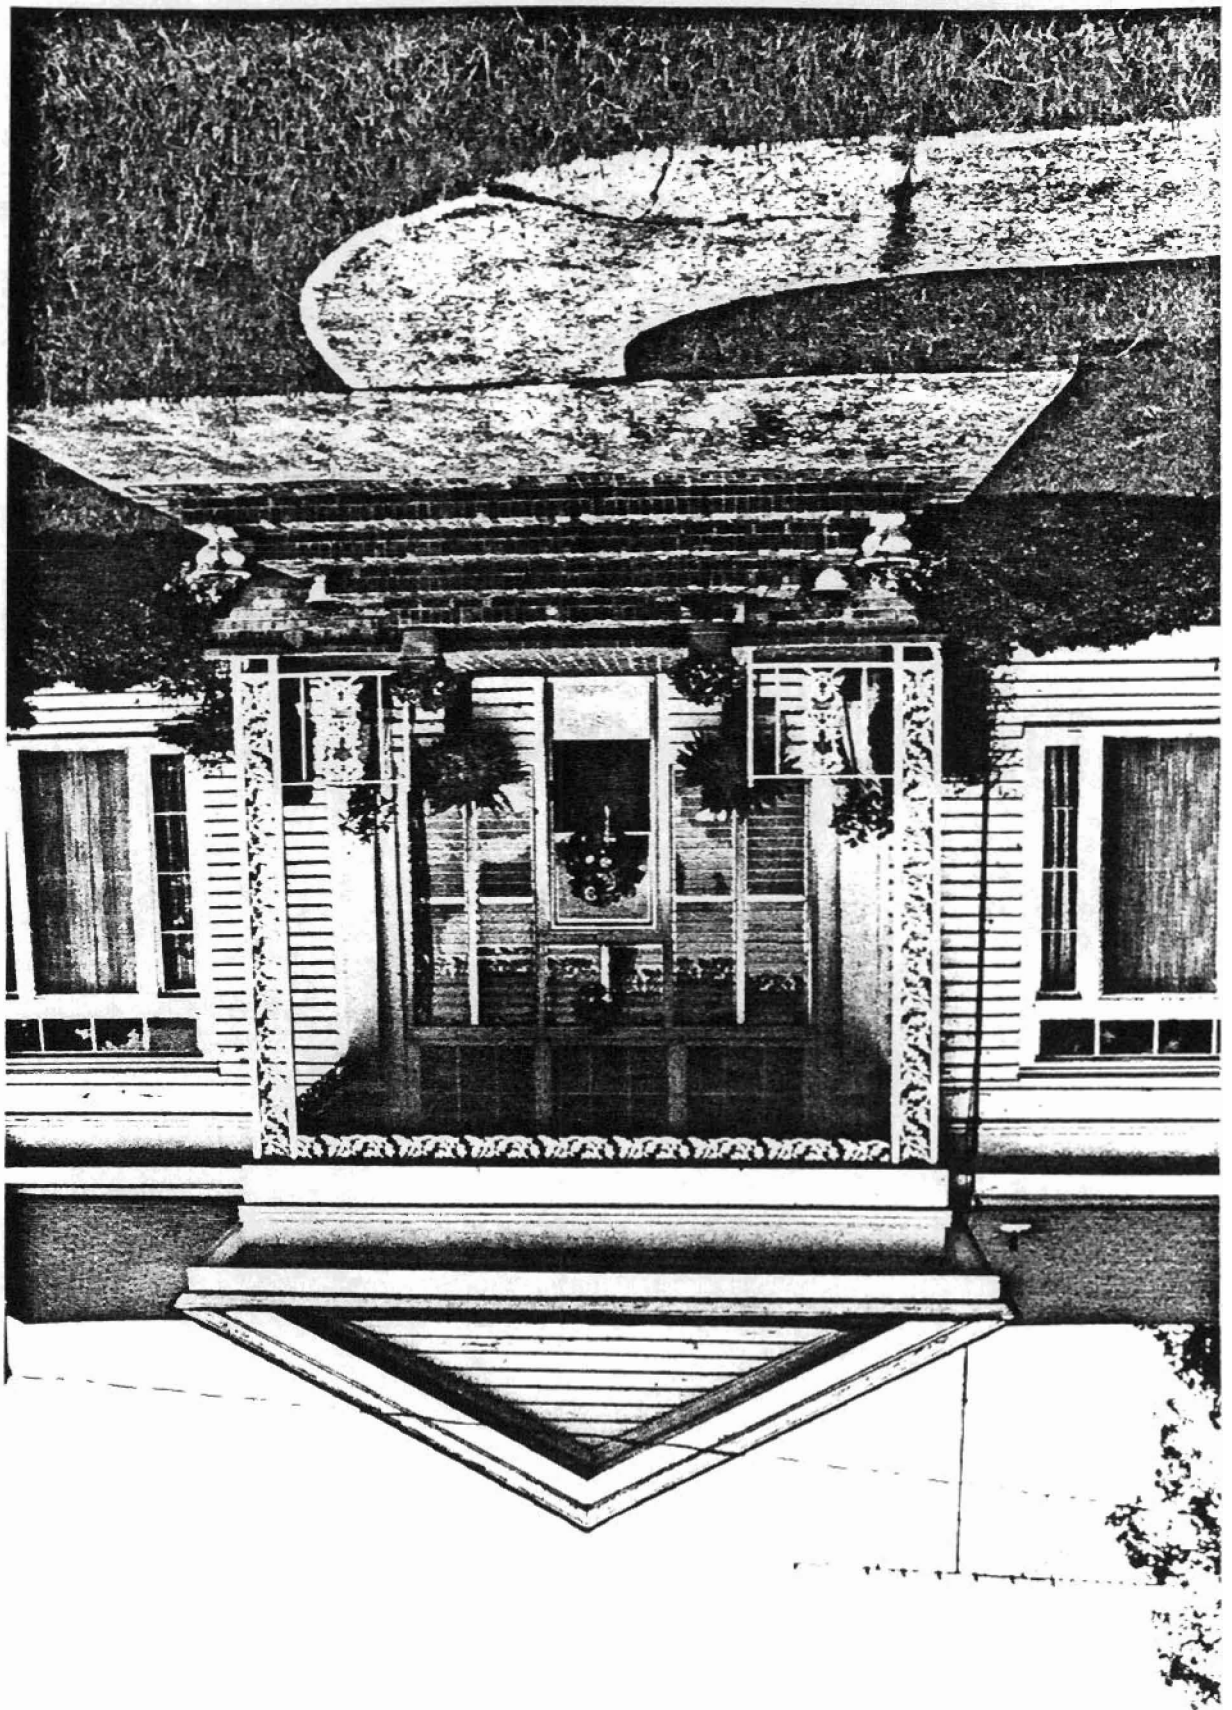
William H. House
Columbia Co., Arkansas
Photographed by Patrick Zolner
August 1992
Negative on file at AHPP
View of front porch from
the south

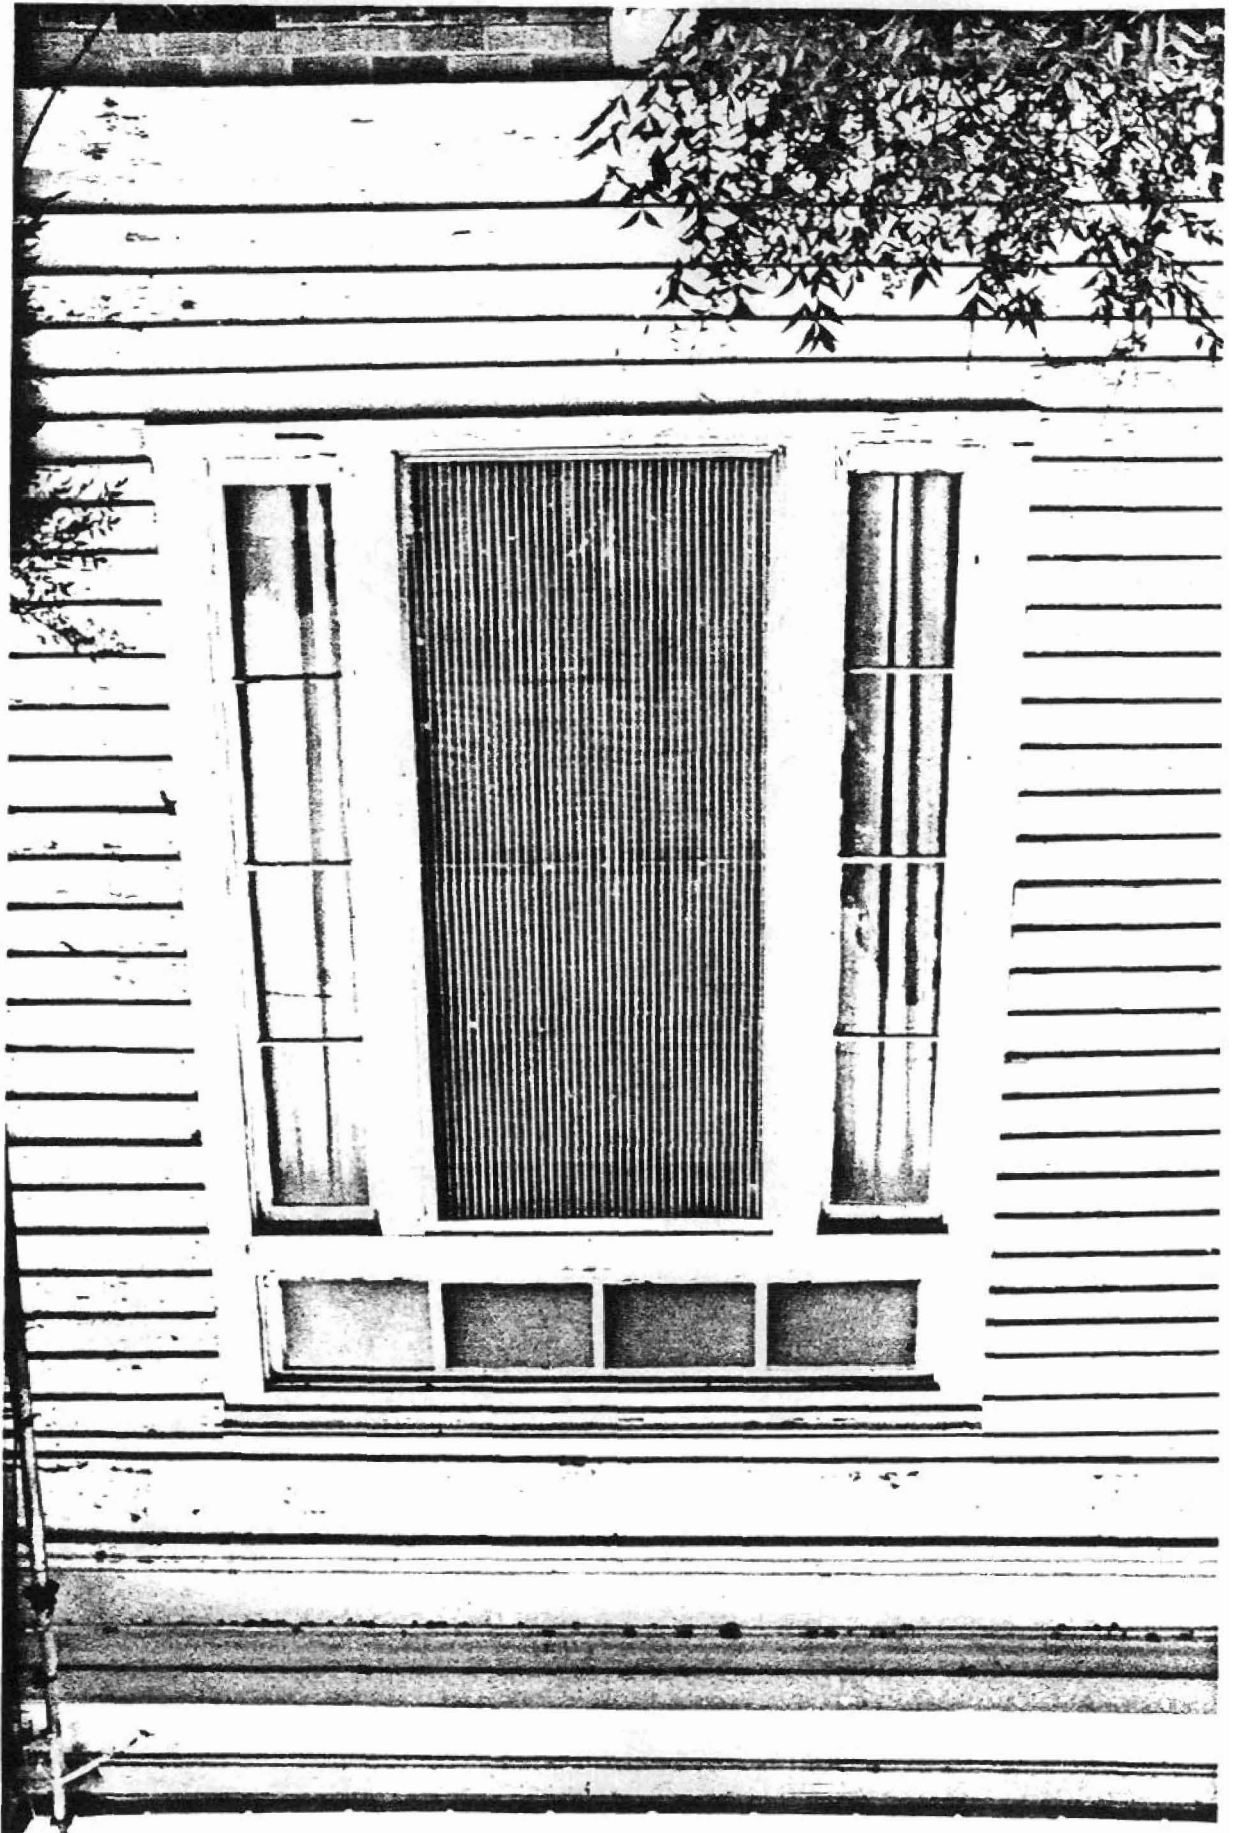
View of western front window from
the south.

and sidelights, however, appear to retain the original framing and several of the original glass panes.

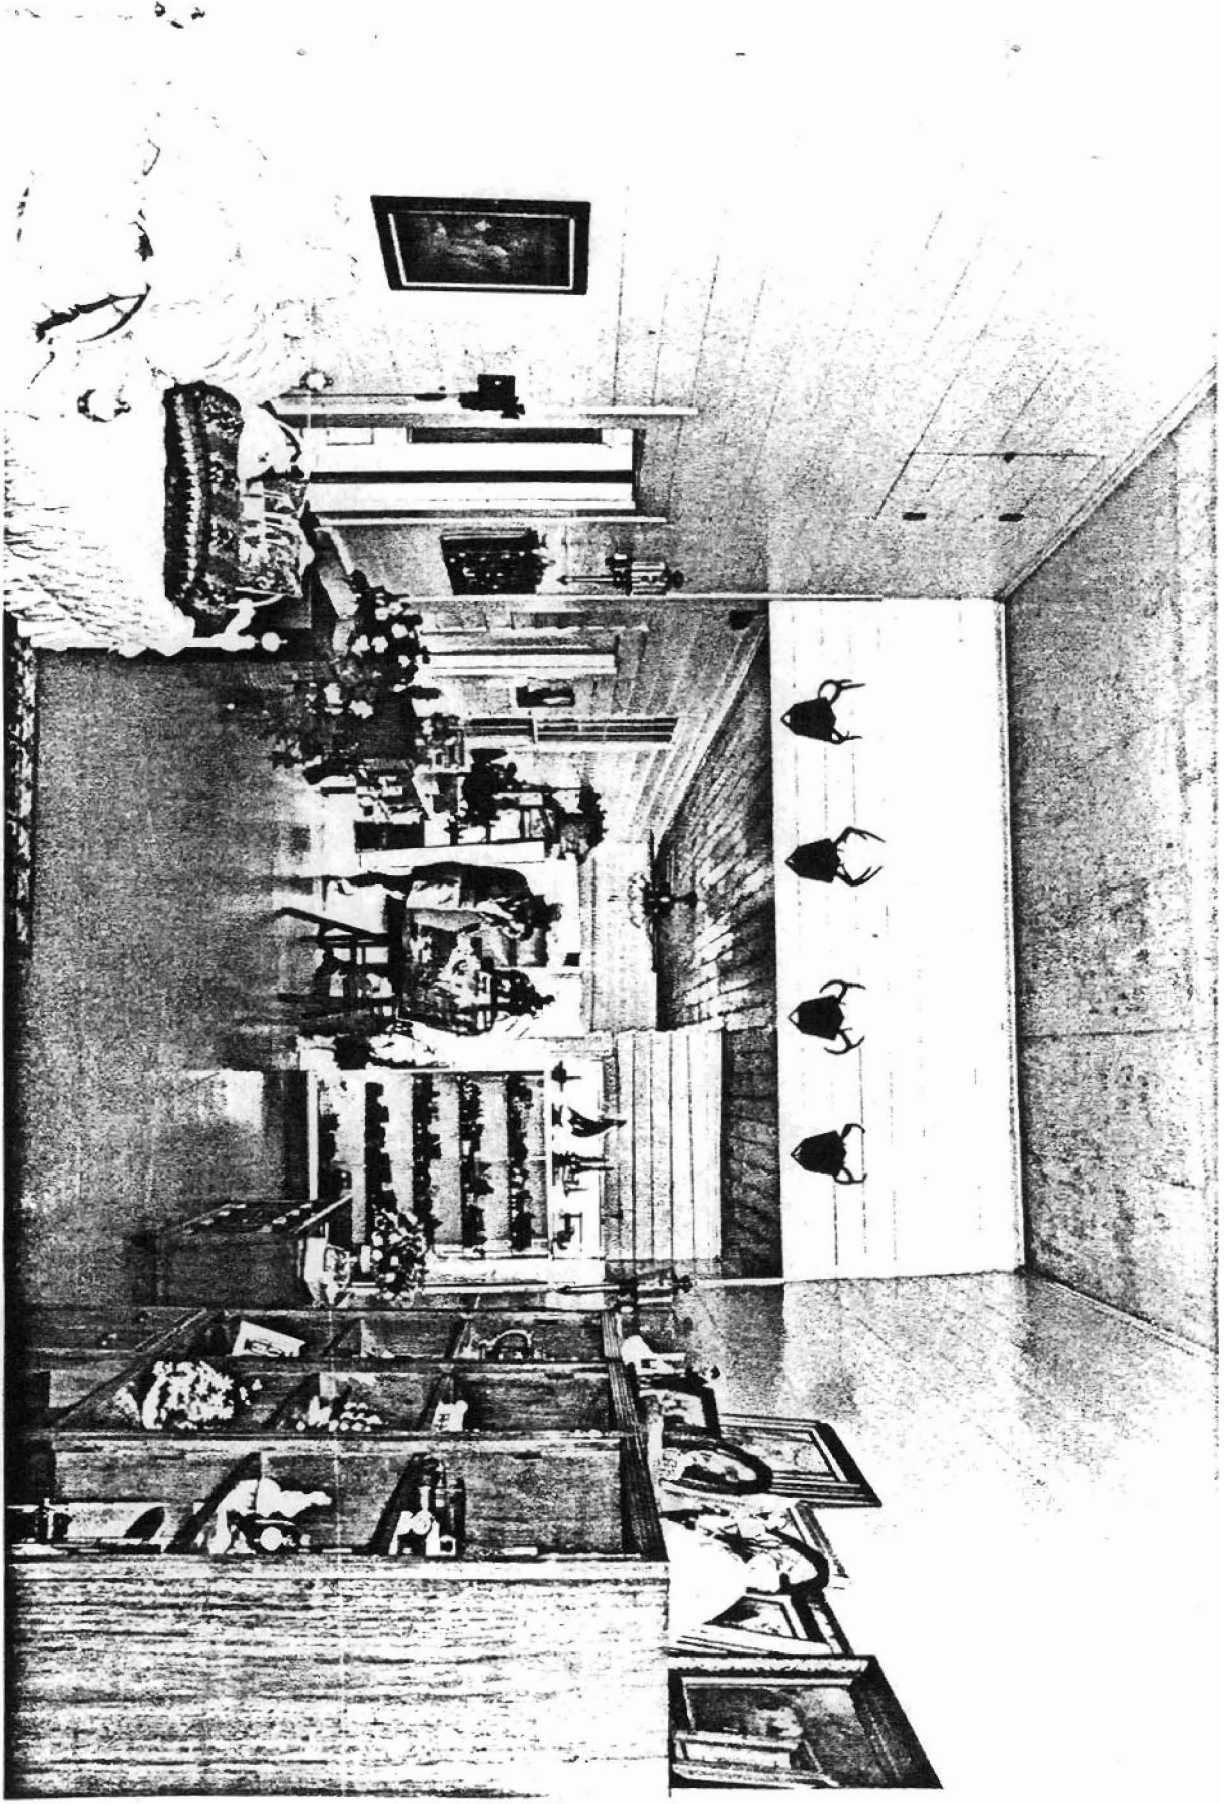
Smith, William H., House
Columbia Co., Arkansas
Photographed by Patrick Zollner
August 1992
Negative on file at AHPP
View of dogtrot from the south
