National Register of Historic Places Inventory—Nomination Form

historic Bank of Malvern

street & number 212 South Main Street

city, town Malvern

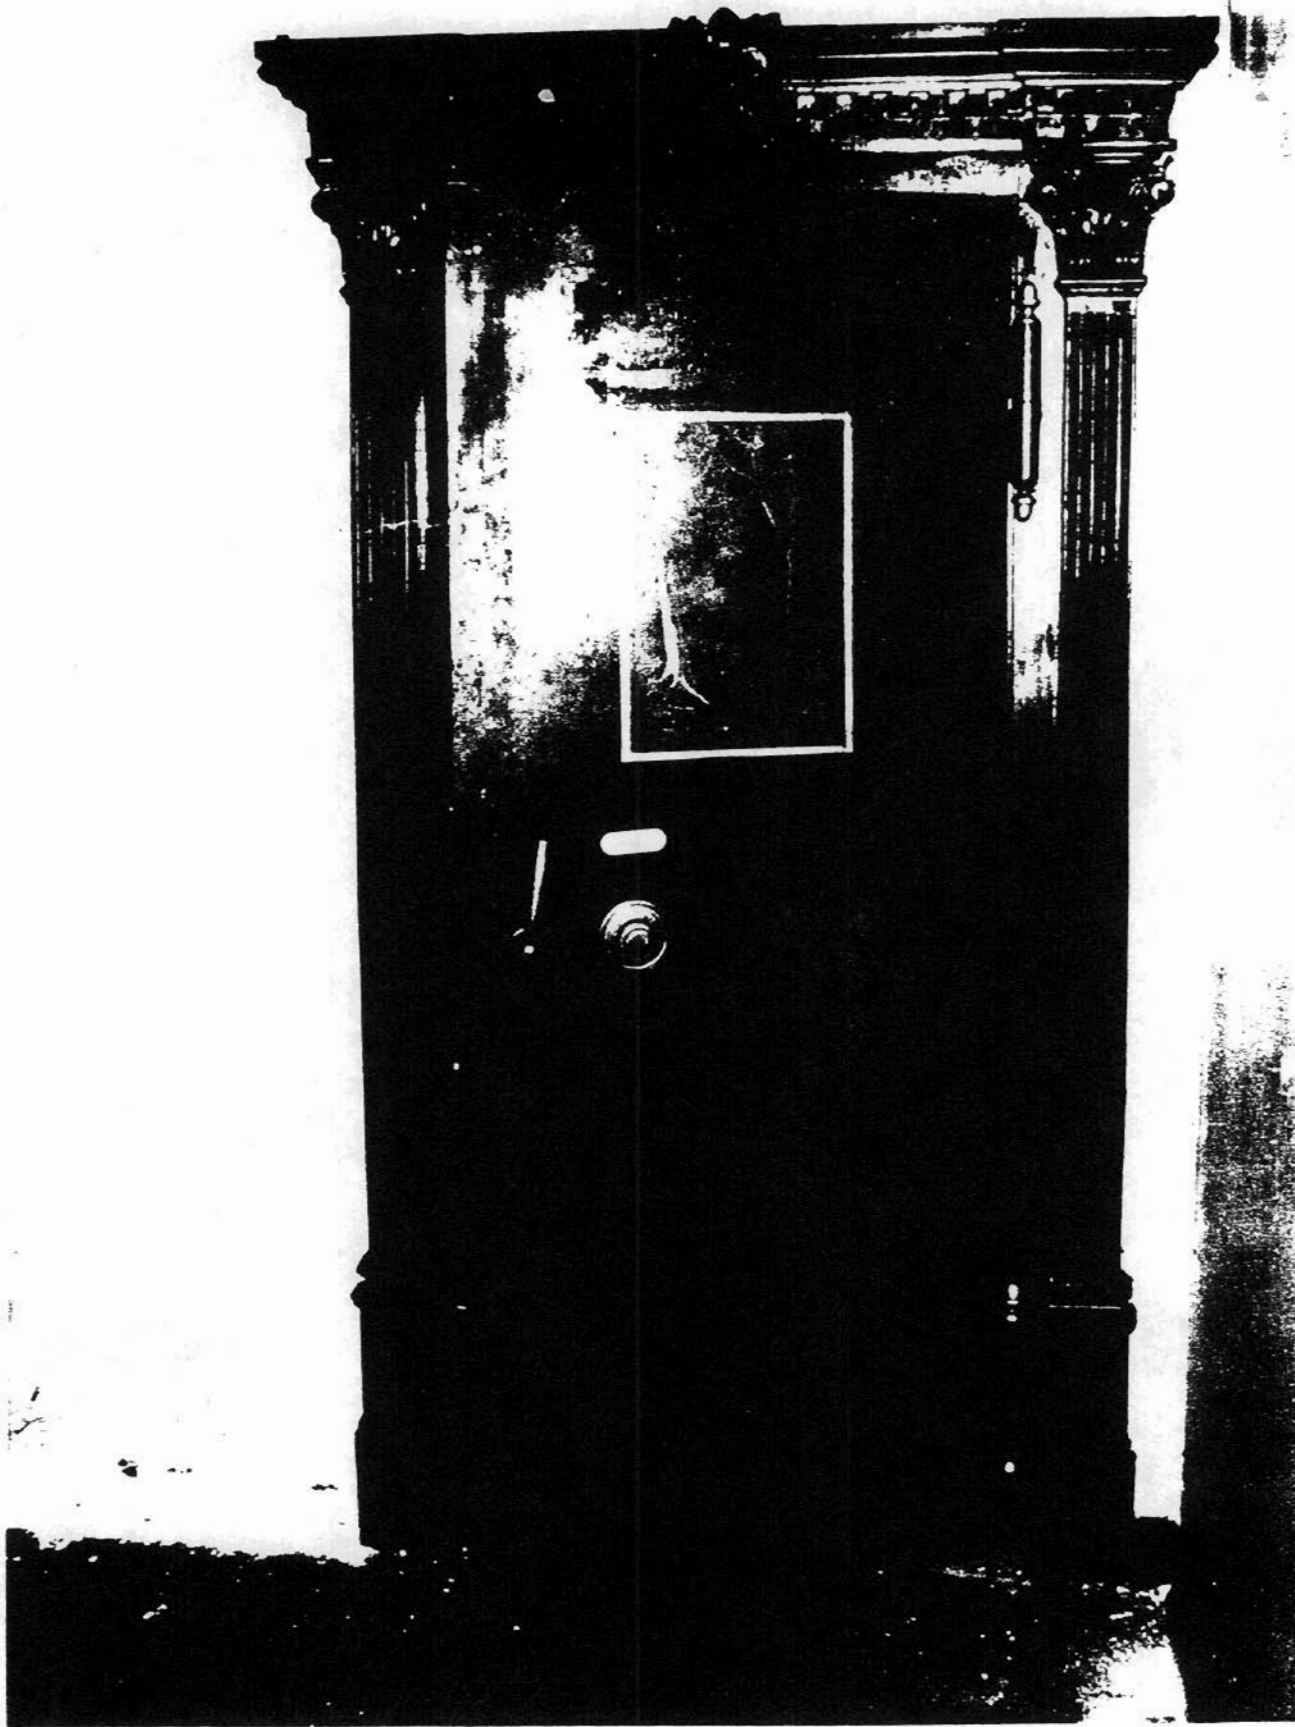
Interior detail

The interior of the structure reveals major alterations from the 1950 renovation; however, many of the original ornamental details remain intact. The entryway is floored with mosaic tiles. Beneath the present wall covering, the painted frieze is still visible and above the suspended ceiling the pressed-tin ceiling can still be found. The ornate door-surround of the vault is in excellent condition. It has fluted, composite pilasters at each side and an architrave and cornice with dentils, as well as a lions head keystone, above.
