NATIONAL REGISTER OF HISTORIC PLACES  
REGISTRATION FORM

historic name: St. John the Baptist Catholic Church

city/town: Brinkley

The St. John the Baptist Catholic Church in Brinkley is single-story, brick-veneer church building designed in the Classical Revival style of architecture. The church was originally constructed in 1875 as a wood frame Gothic Revival-styled church building. The church attained its current appearance in 1928.

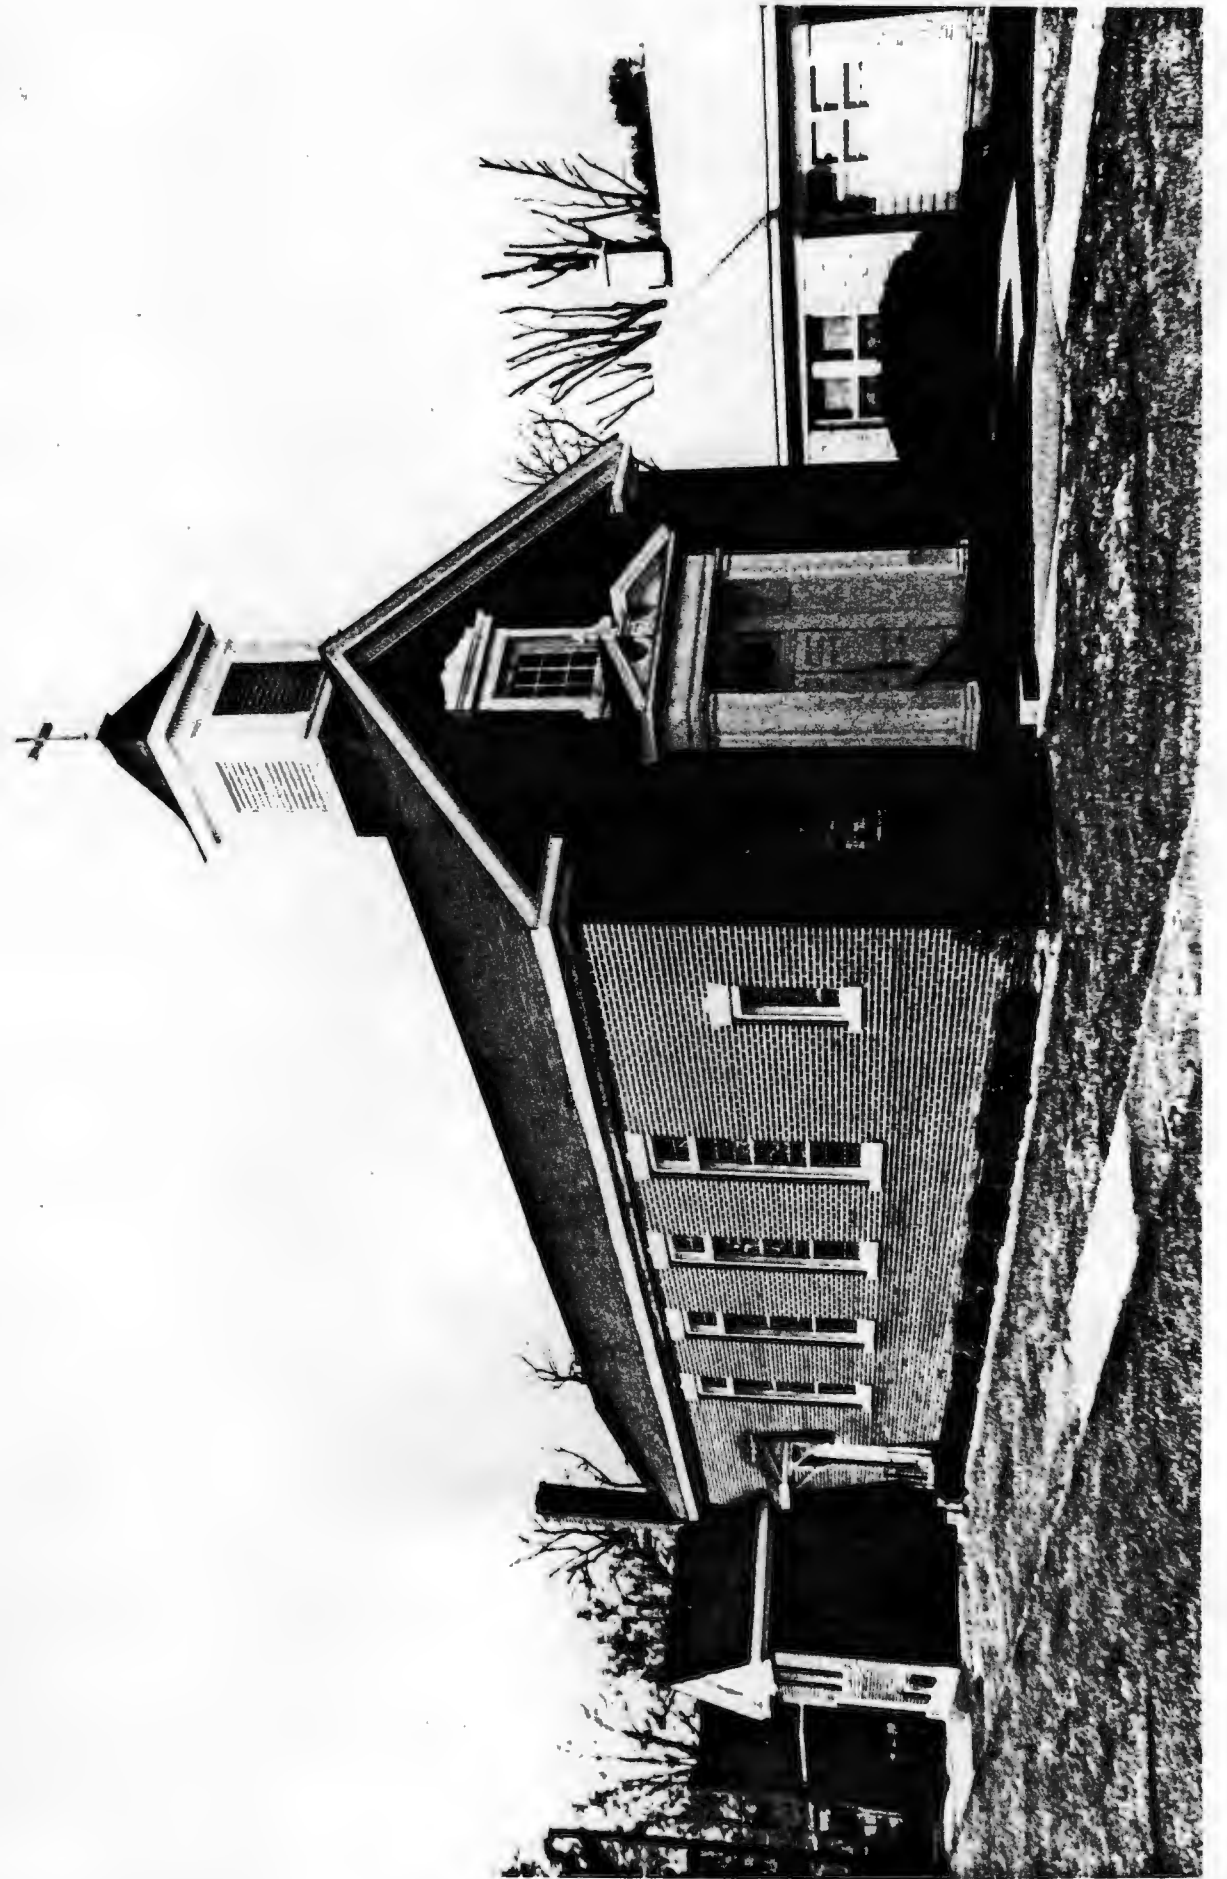
St. John the Baptist Church  
Morris Co., Arkansas  
Photographed by Patrick Zollner  
March 1992  
Negative on file at AHPD  
View from the northeast

The eastern elevation consists of a small stained-glass window to the north, which lights and beautifies the narthex and four large, stained-glass windows that illuminate the nave. The stained-glass windows are composed of multiple panes with a transom and a small, movable lower sash. All stained-glass window feature masonry lintels with keystones. To the south of the row of windows, a single-leaf door, sheltered by a bracketed shed roof, opens into the front of the

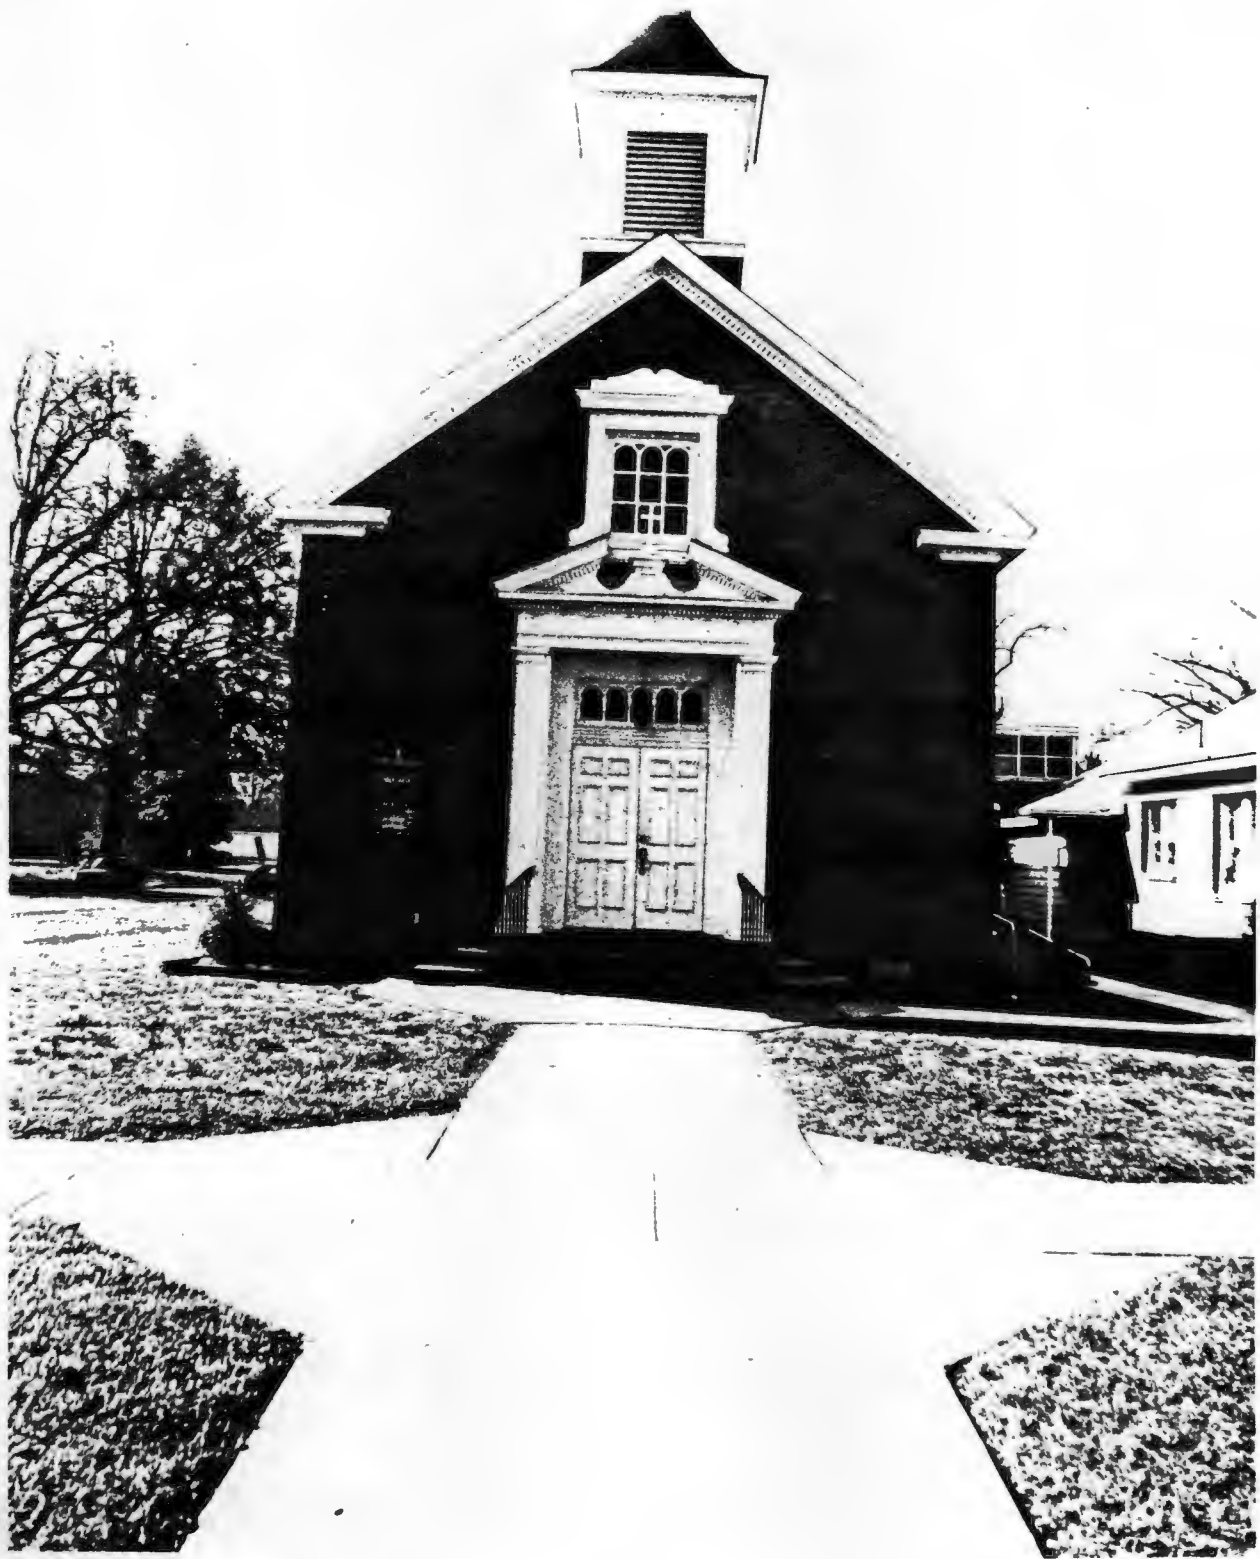
St. John the Baptist Church  
Monroe Co., Arkansas  
Photographed by Patrick Zollner  
March 1992  
Negative on file at AHPP  
View from the north

A massive, broken-pedimented, double-leaf entrance dominates the front or northern elevation. Fluted pilasters support the broken triangular pediment, which is adorned by dentilling underneath the cornice of the entablature and the boxed cornices of the broken pediment. A pedestal-based cross within the broken pediment crowns the affair. Underneath the broken pediment, the recessed, six-panel wood doors enter into the narthex, which is lighted by a five-pane transom with yellow-tinted, semi-circular arched panes. The choir loft above the entrance is illuminated by a stationary six-pane window, also yellow tinted with the top three panes arched. The window is surrounded by a full-length drip mold and is topped by a jig-sawn, broken ogee-shaped pediment over a projecting crown. A raking boxed cornice with returns defines the gable end of the front elevation. The familiar dentil course is present here as well and further adds to the classical appearance of the front elevation.

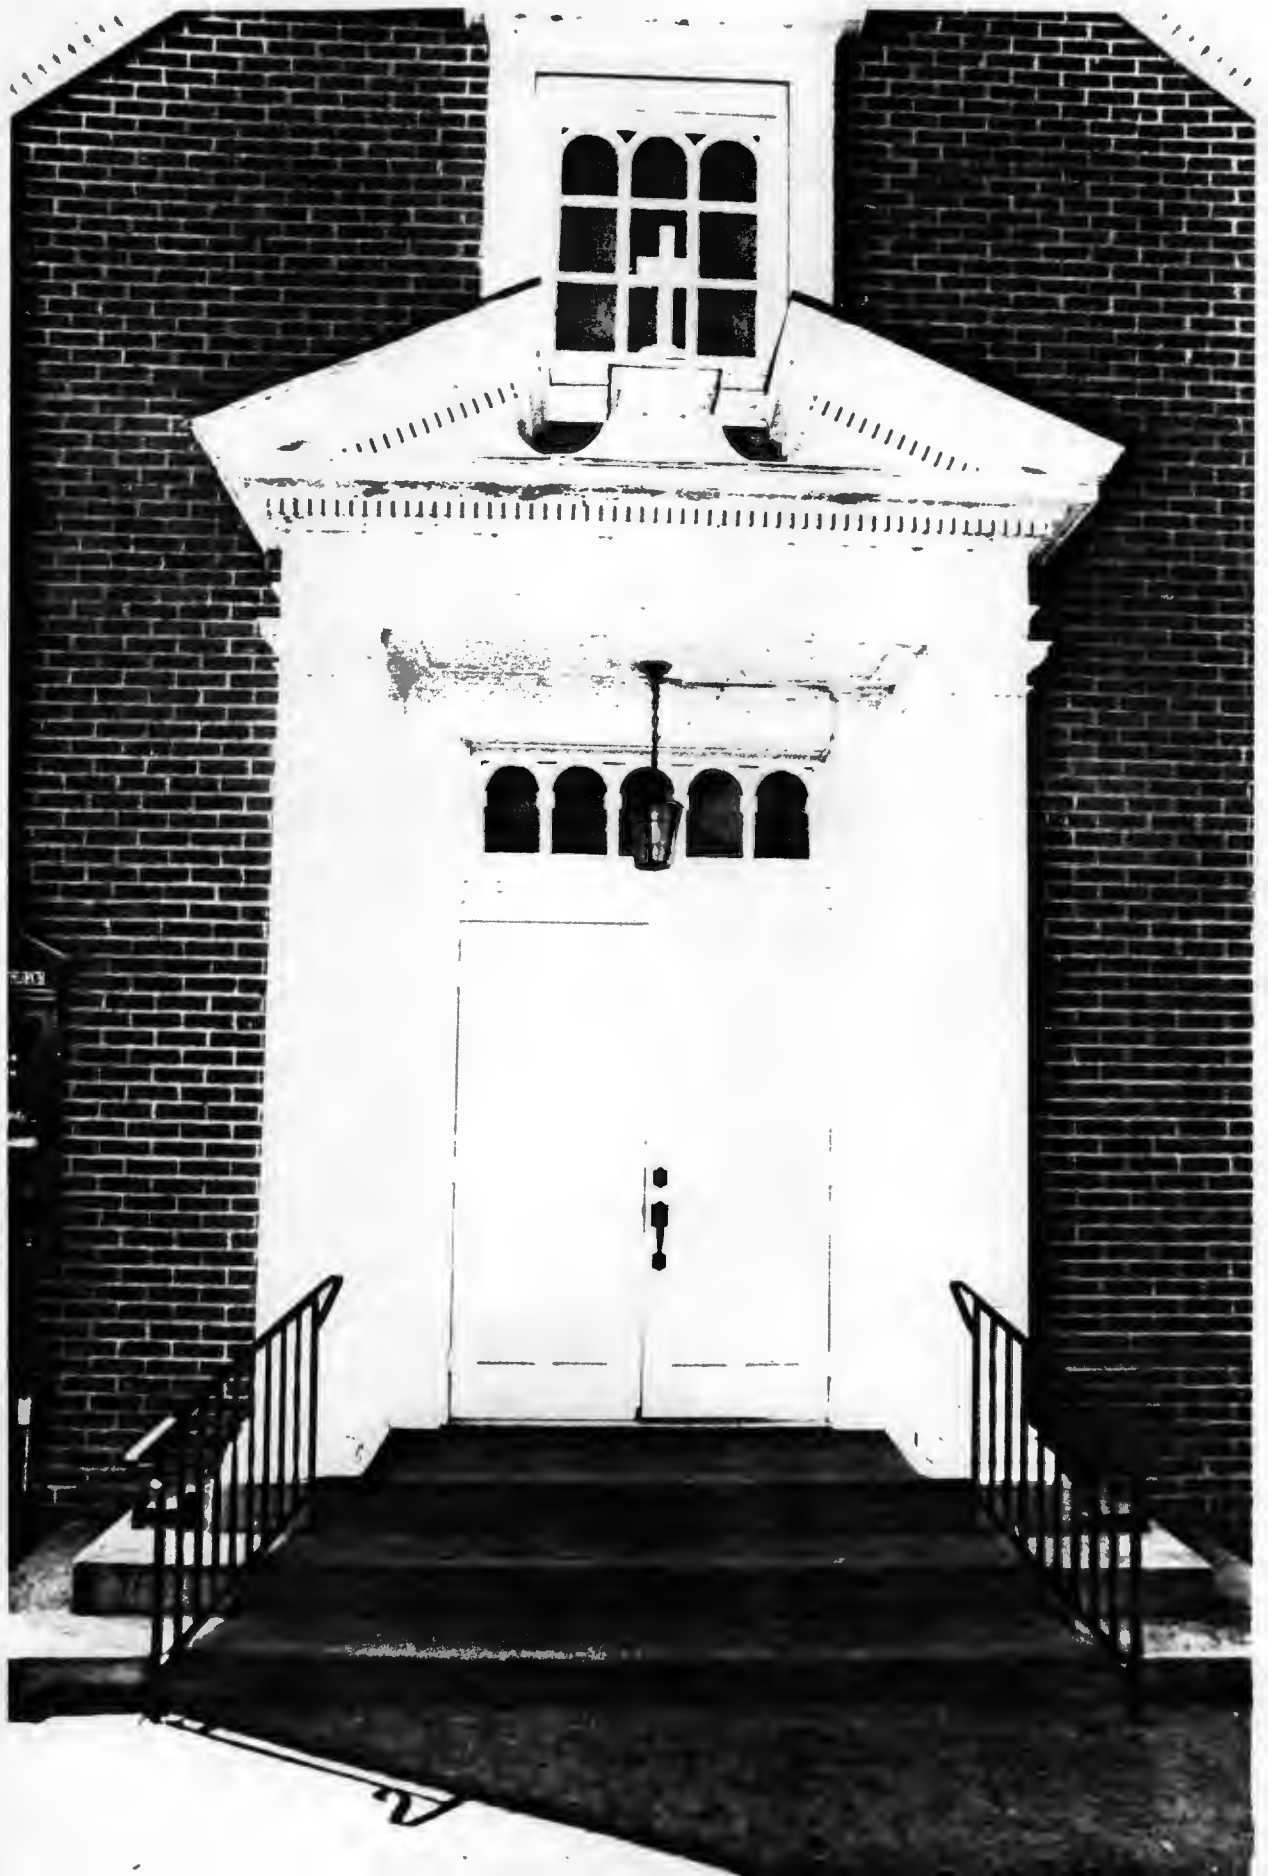
Dr. John H. Baptist Church  
Monroe Co., Arkansas  
Photographed by Patrick Zollner  
March 1992 Negative on file at AHPP  
View of front entrance from the north

Constrained to the existing building form, Kramer maximized the classical potential offered by the front gable orientation. He established a heavy, monumental atmosphere, a required characteristic of proper Classical Revival styling, by focusing attention on the massive broken pediment above the double-leaf front entrance. Boxed cornice returns were added to the gable end to further promote the temple front effect. By utilizing dentil courses wherever possible, Kramer was able to temper the inherent starkness in the style. This added a more delicate Federal flavor to the building's appearance. The result of Kramer's efforts was a well-executed, remarkably integrated design with little hint of the previous Gothic Revival style.
