**National Register of Historic Places
Continuation Sheet**

The McKenzie House, originally constructed between the years 1868-75, is a simple one-story, wood frame, Plain Traditional style residence, yet which also features both Italianate details and an attention to symmetry and balance in its overall composition.

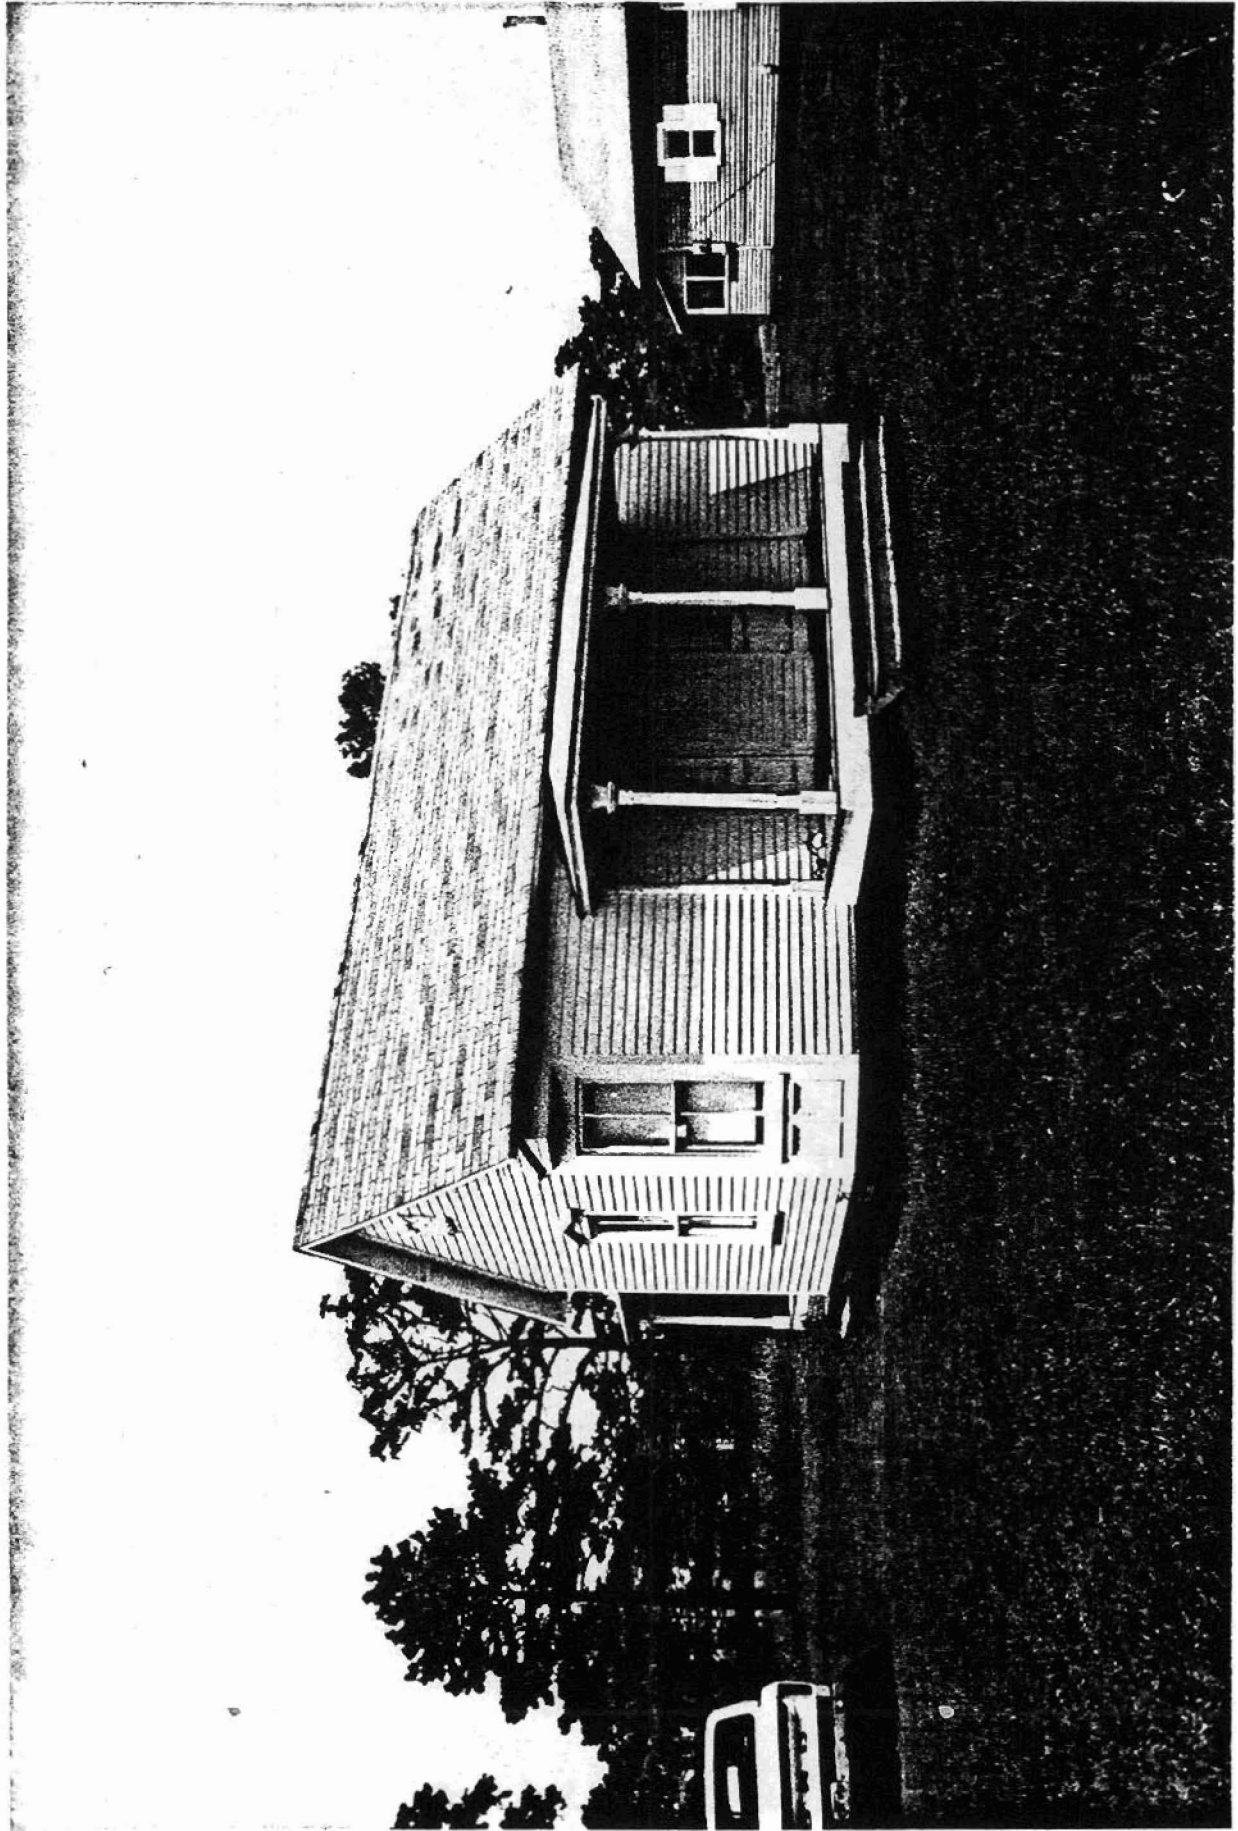
VIEW FROM THE EAST

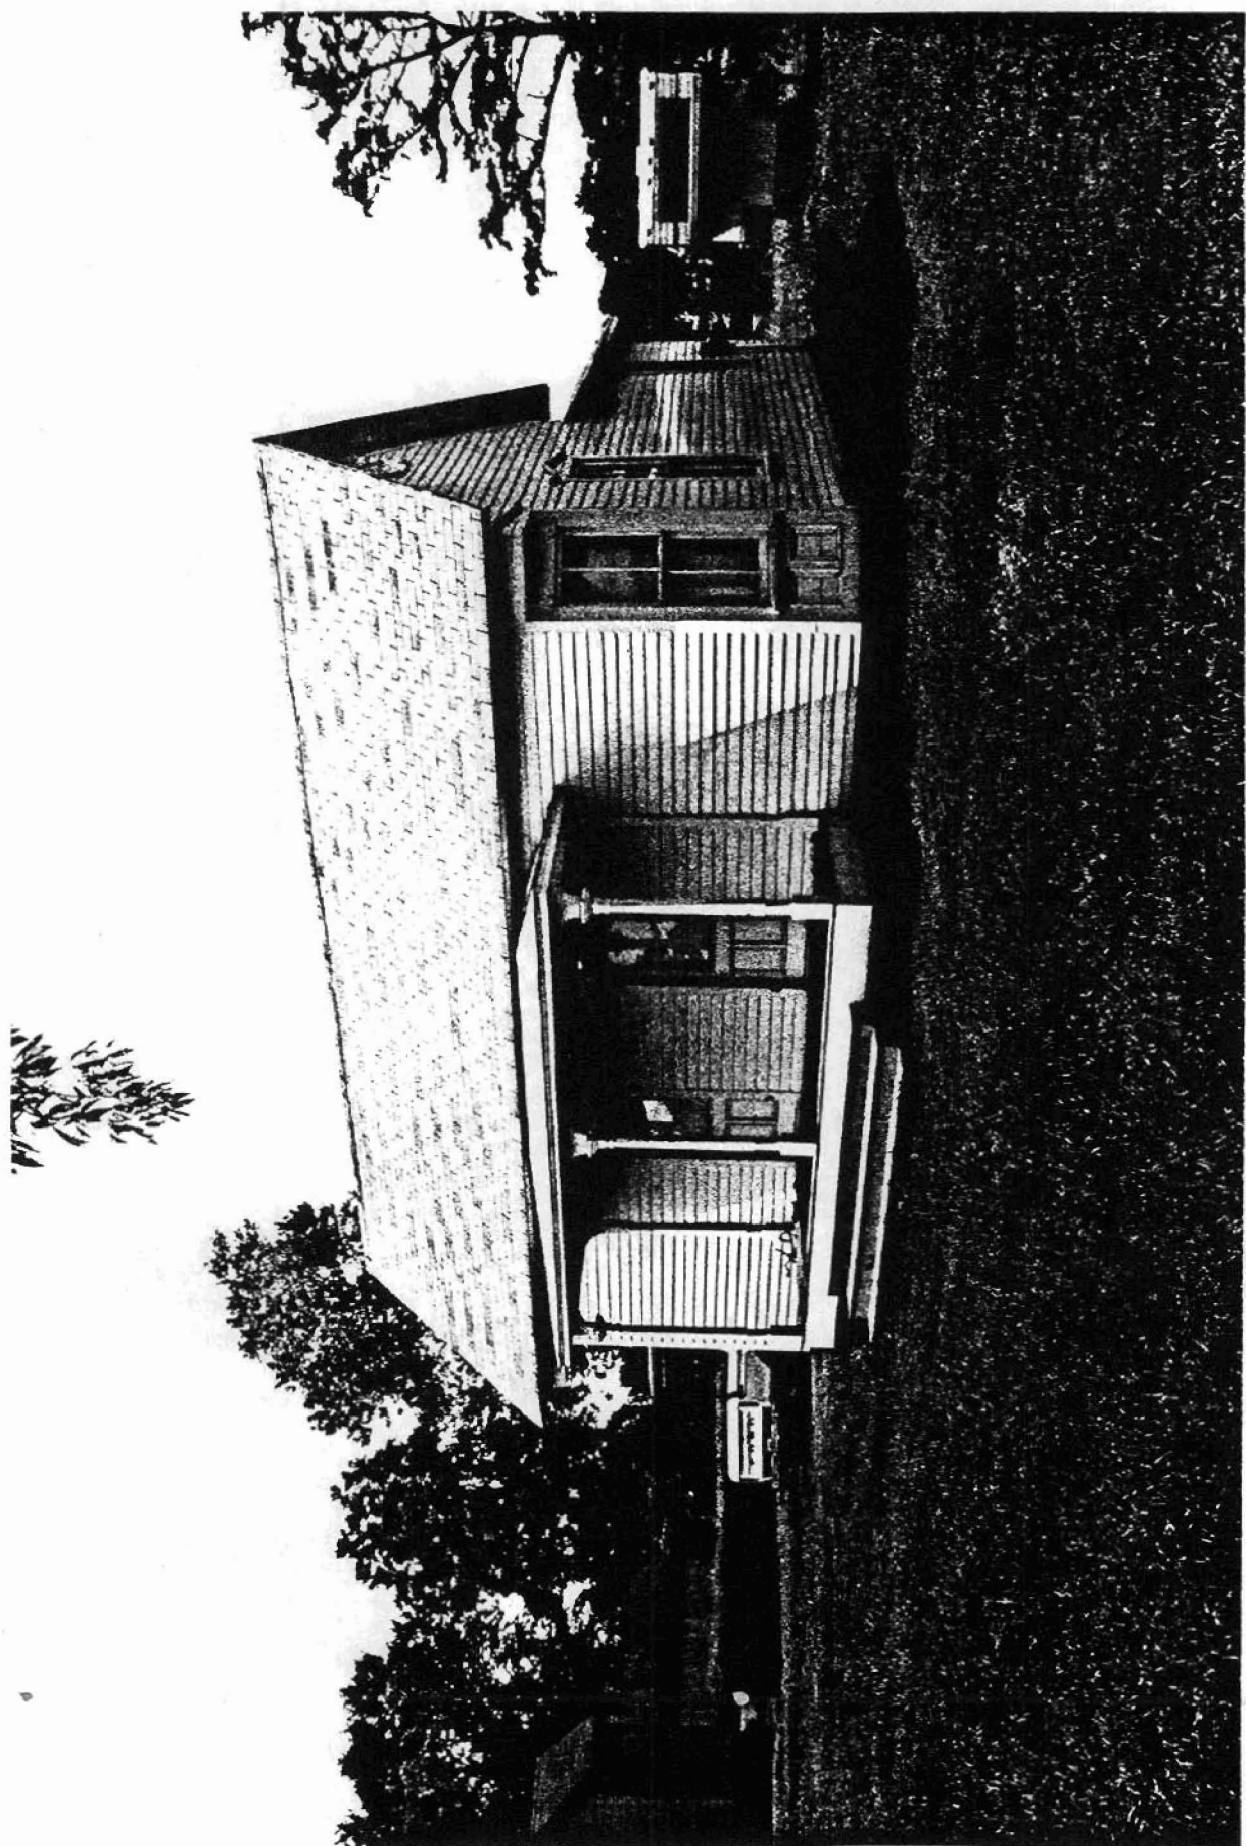
VIEW FROM THE EAST

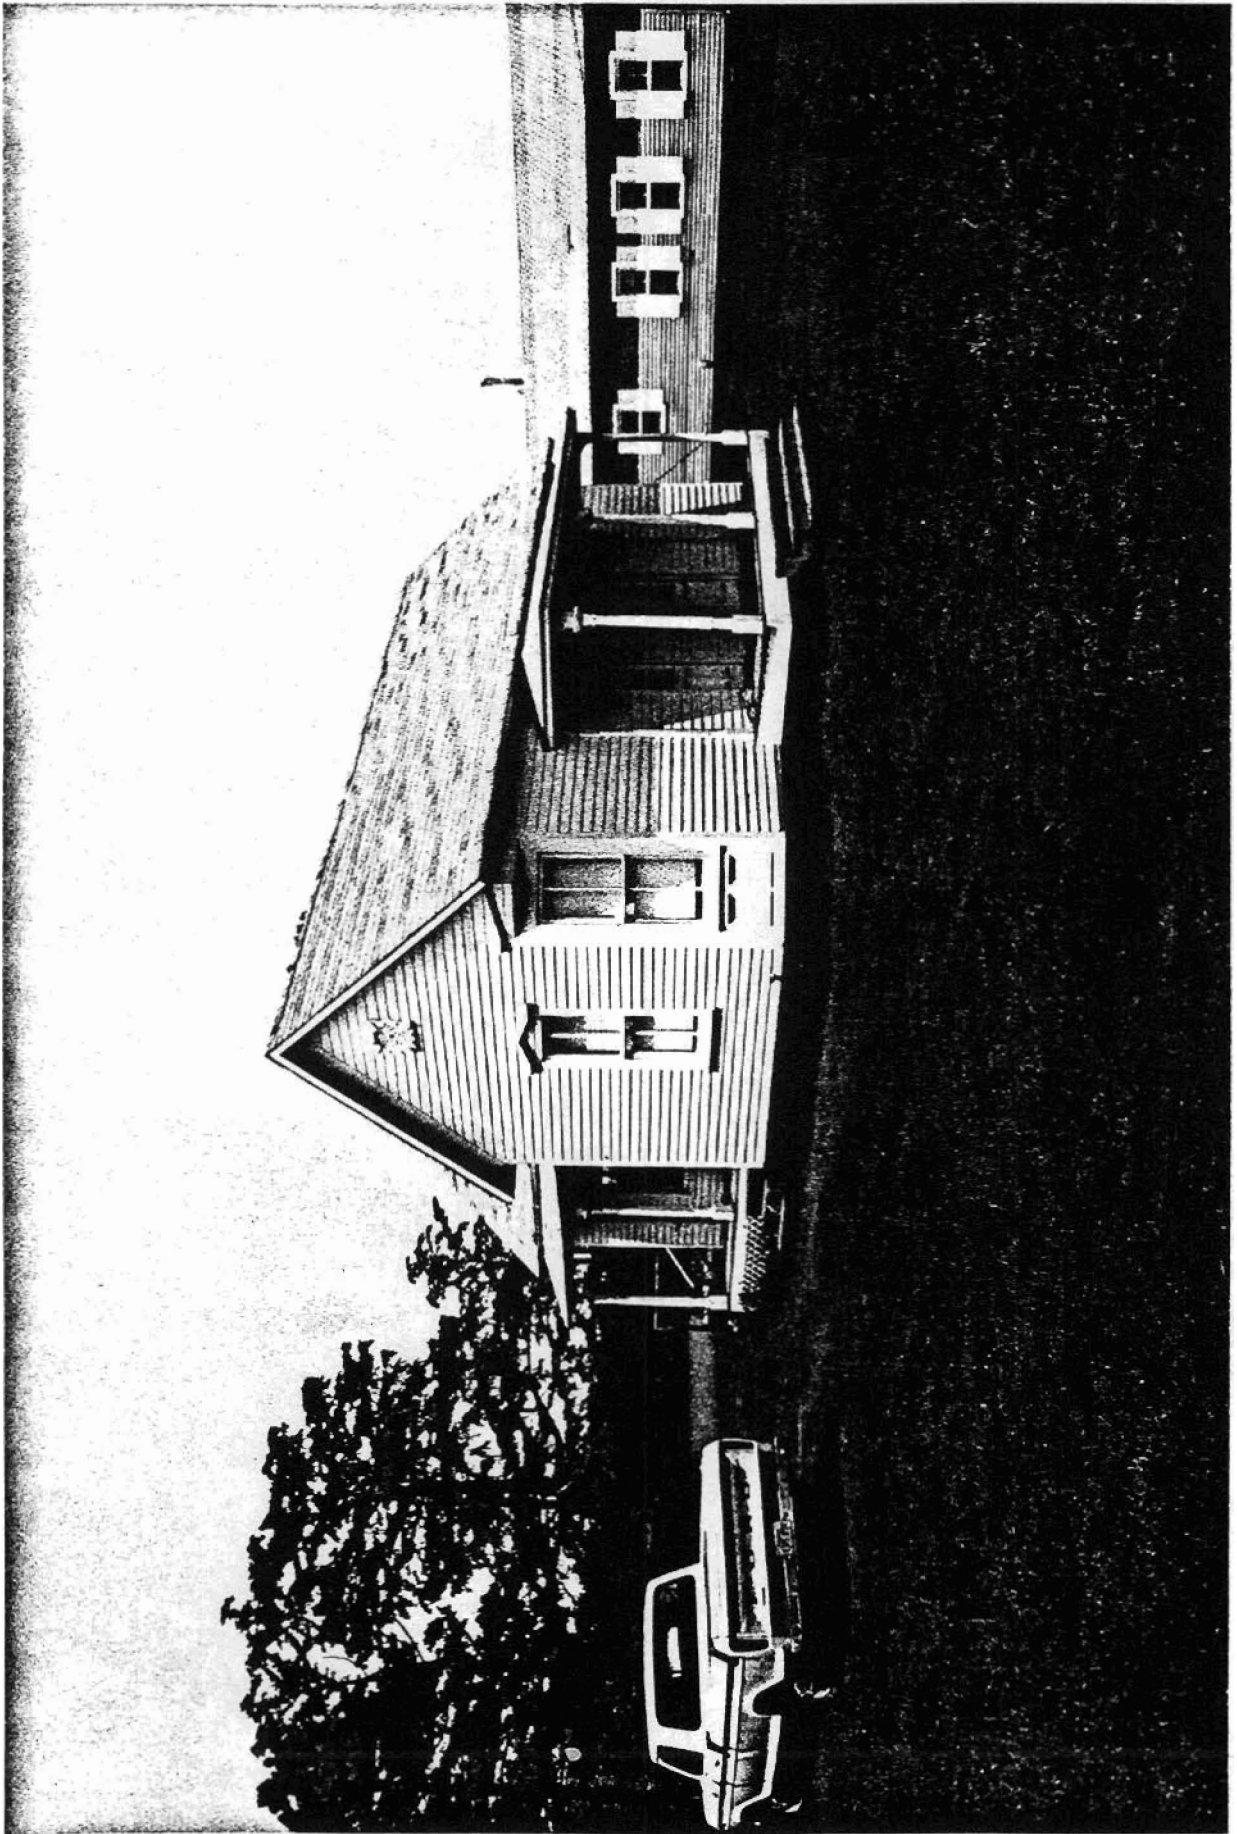
VIEW FROM THE SOUTH EAST

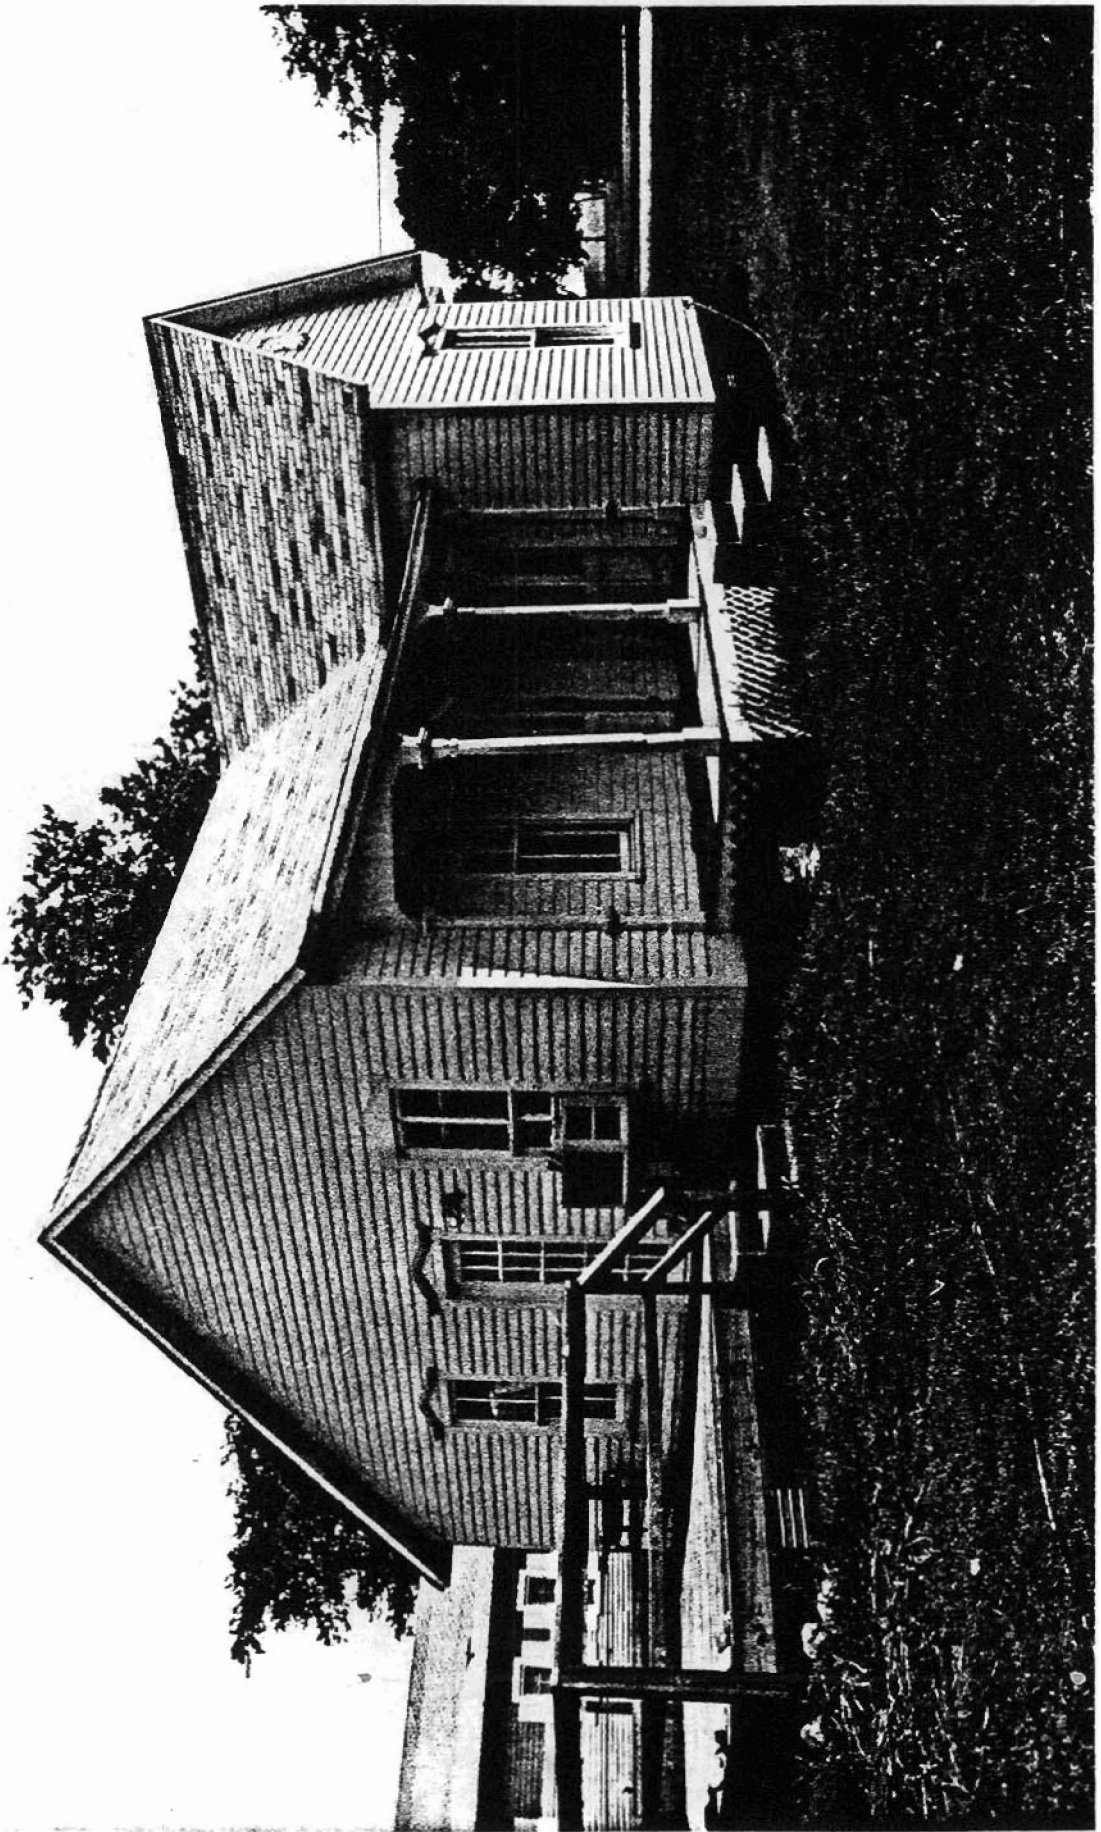
VIEW FROM THE SOUTH WEST

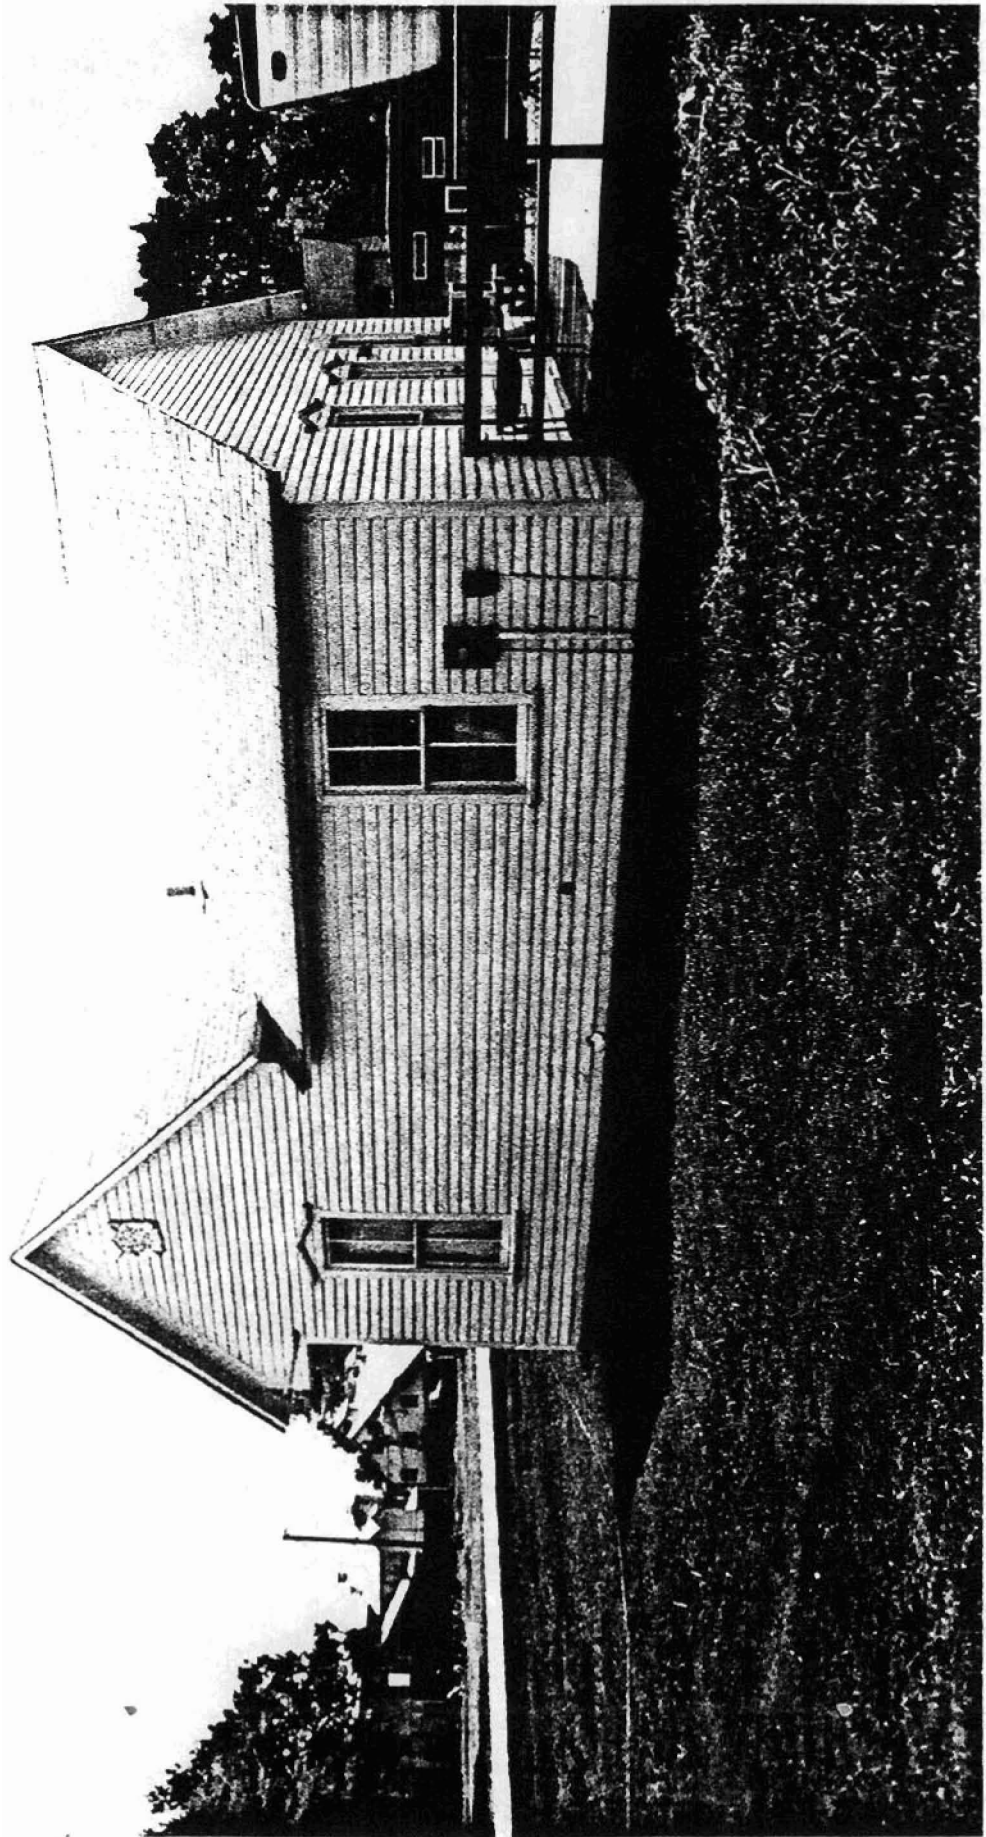
NEGATIVE ON FILE AT AHPD
VIEW FROM THE NORTH

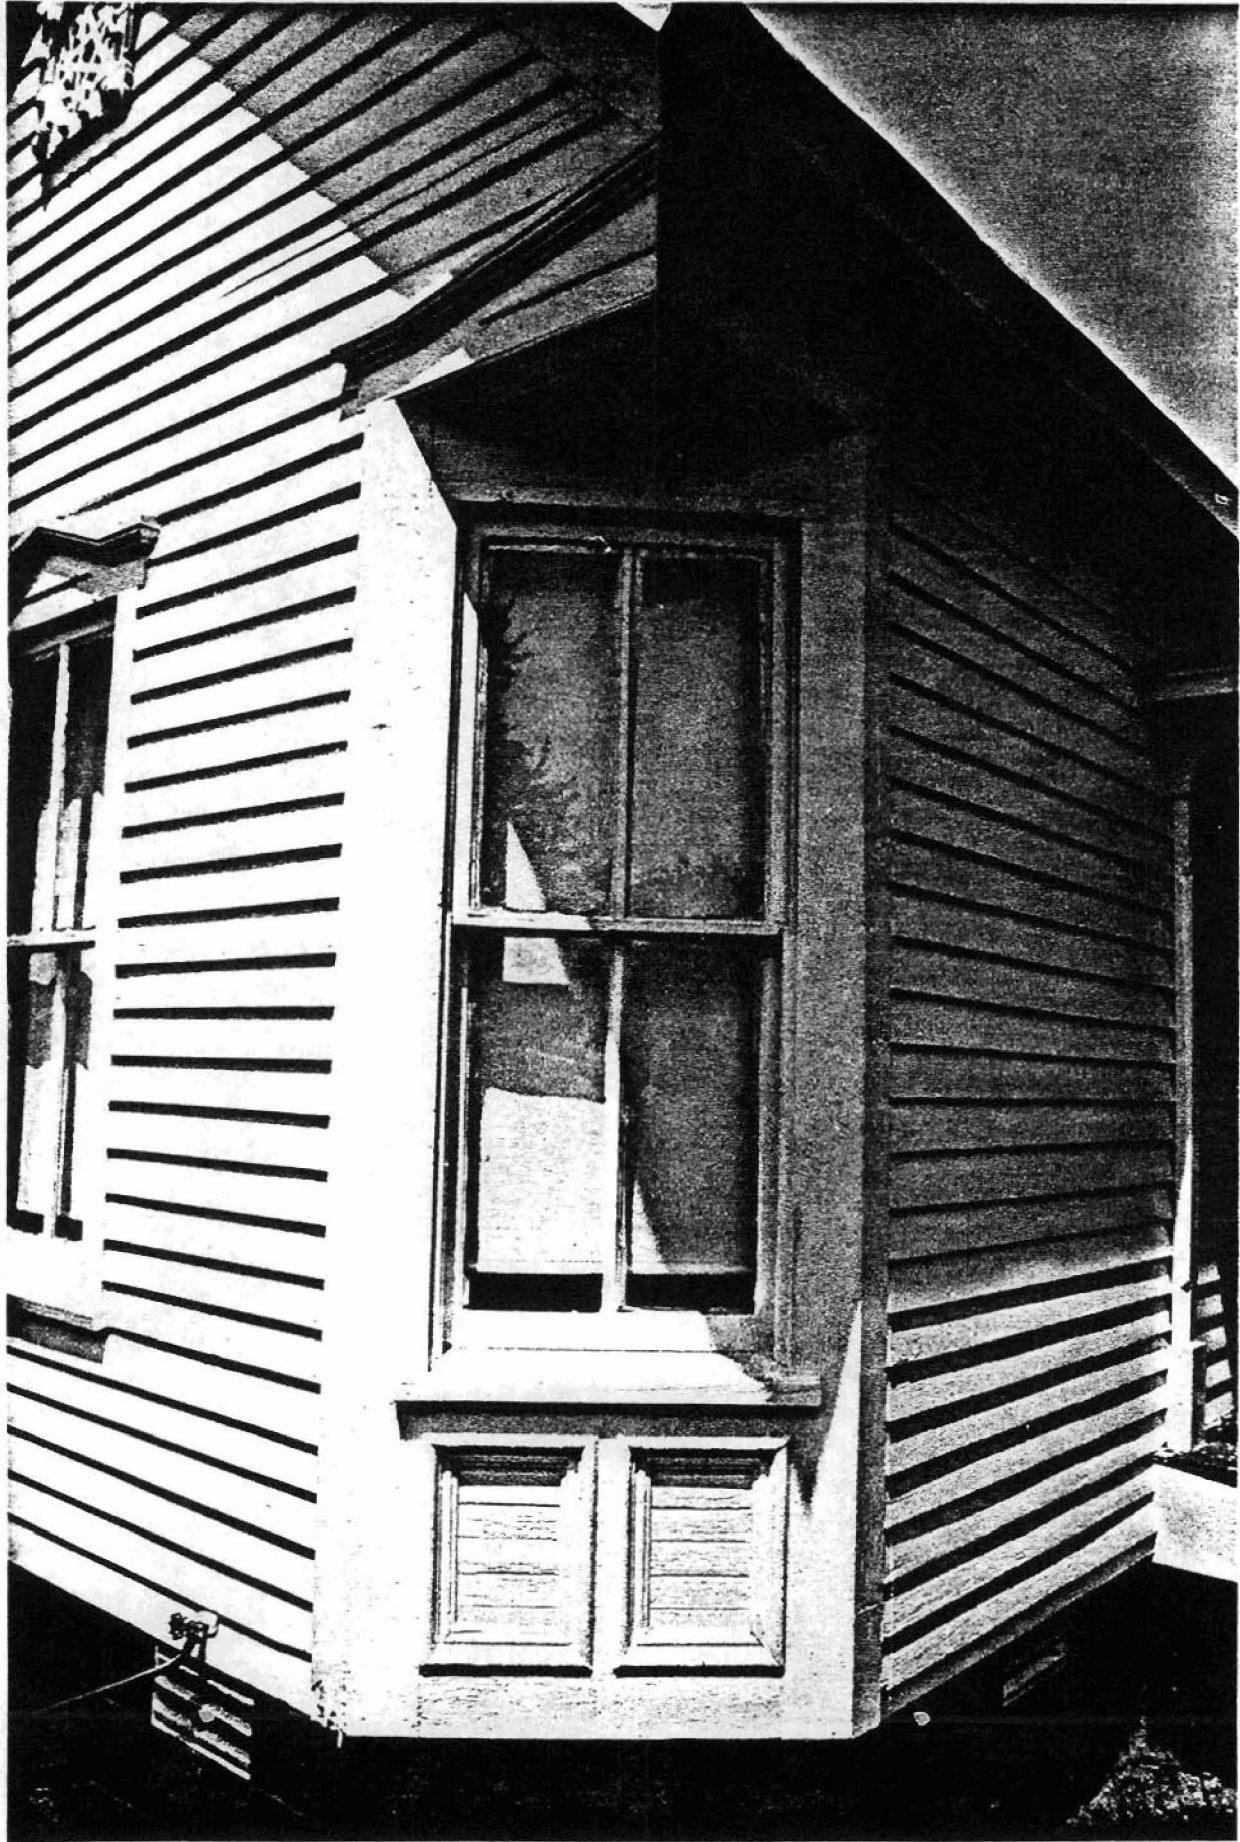
VIEW FROM THE SOUTH EAST

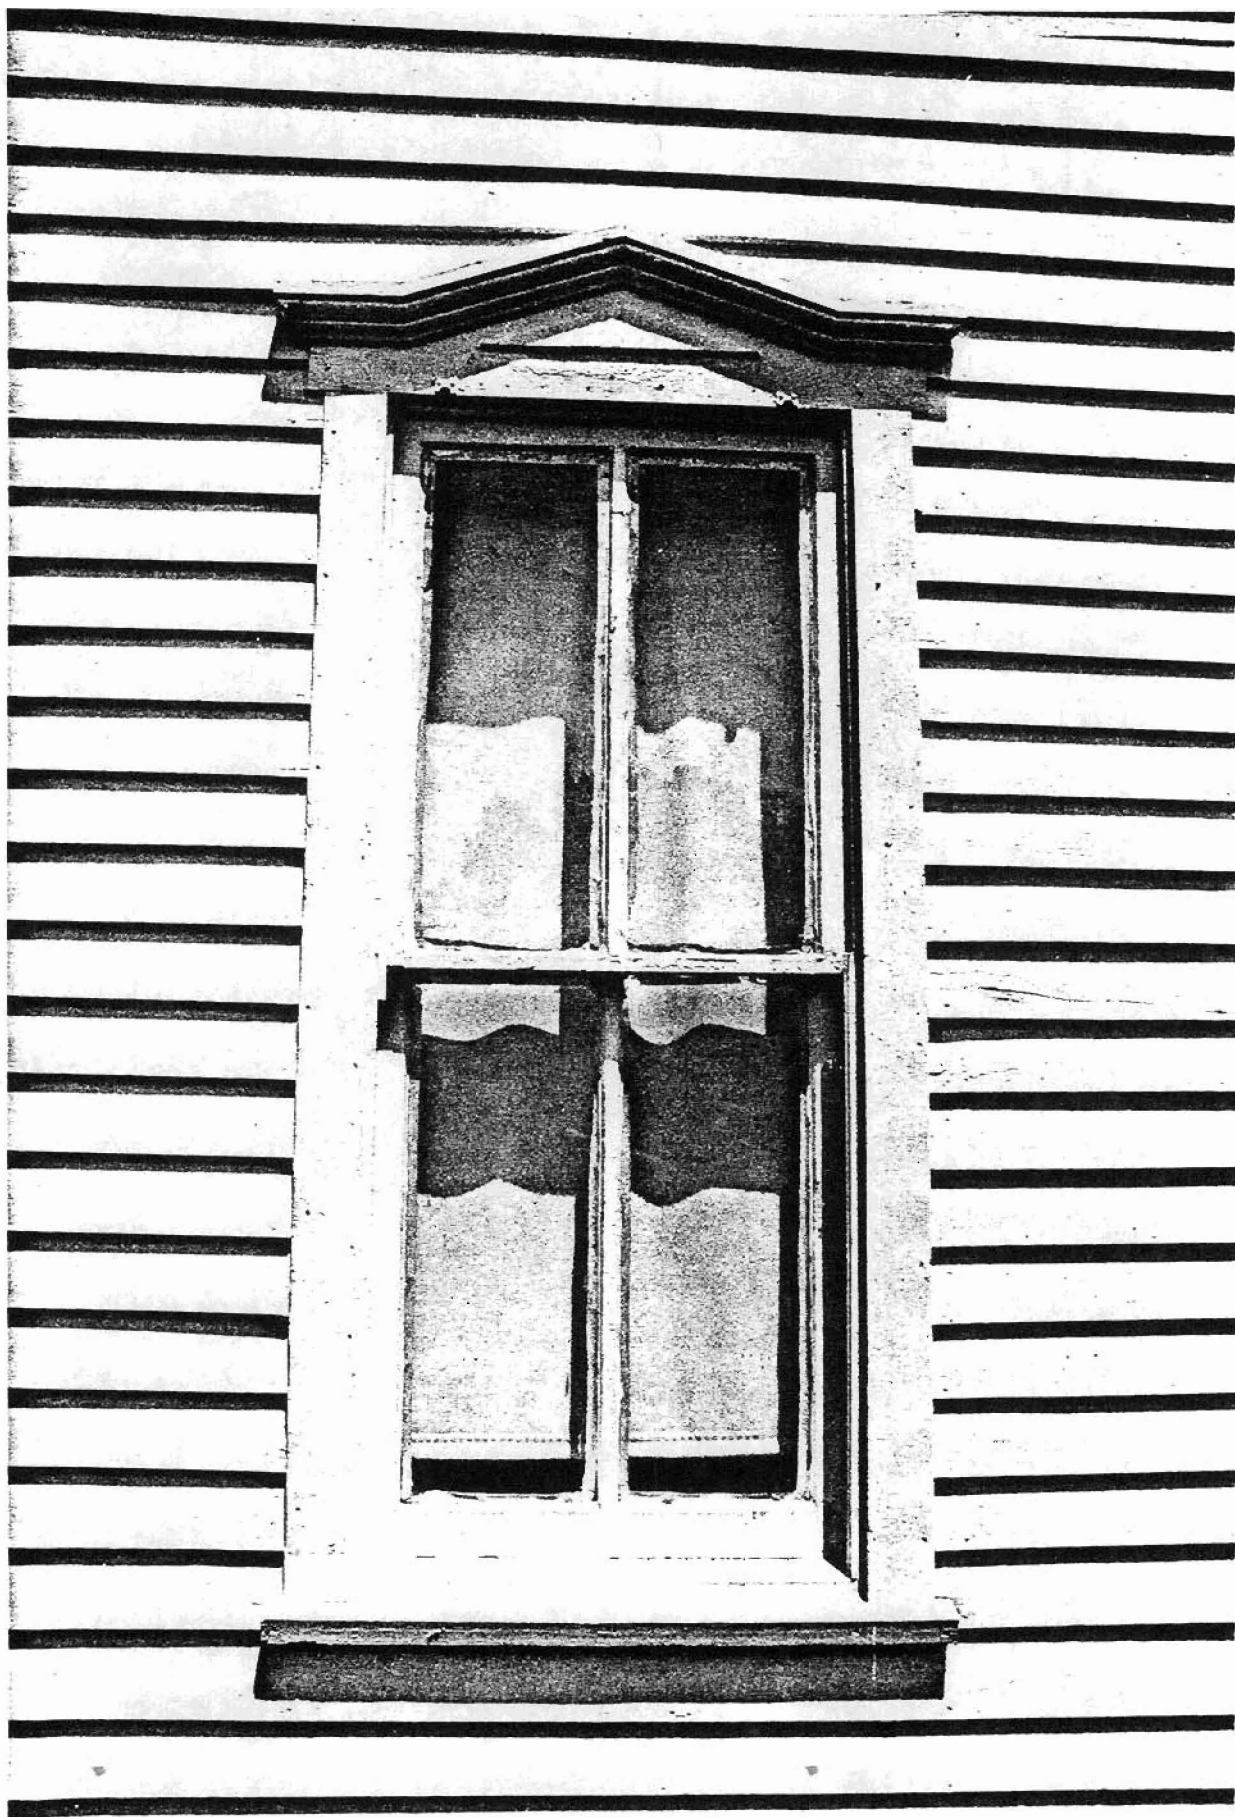
VIEW FROM THE SOUTH

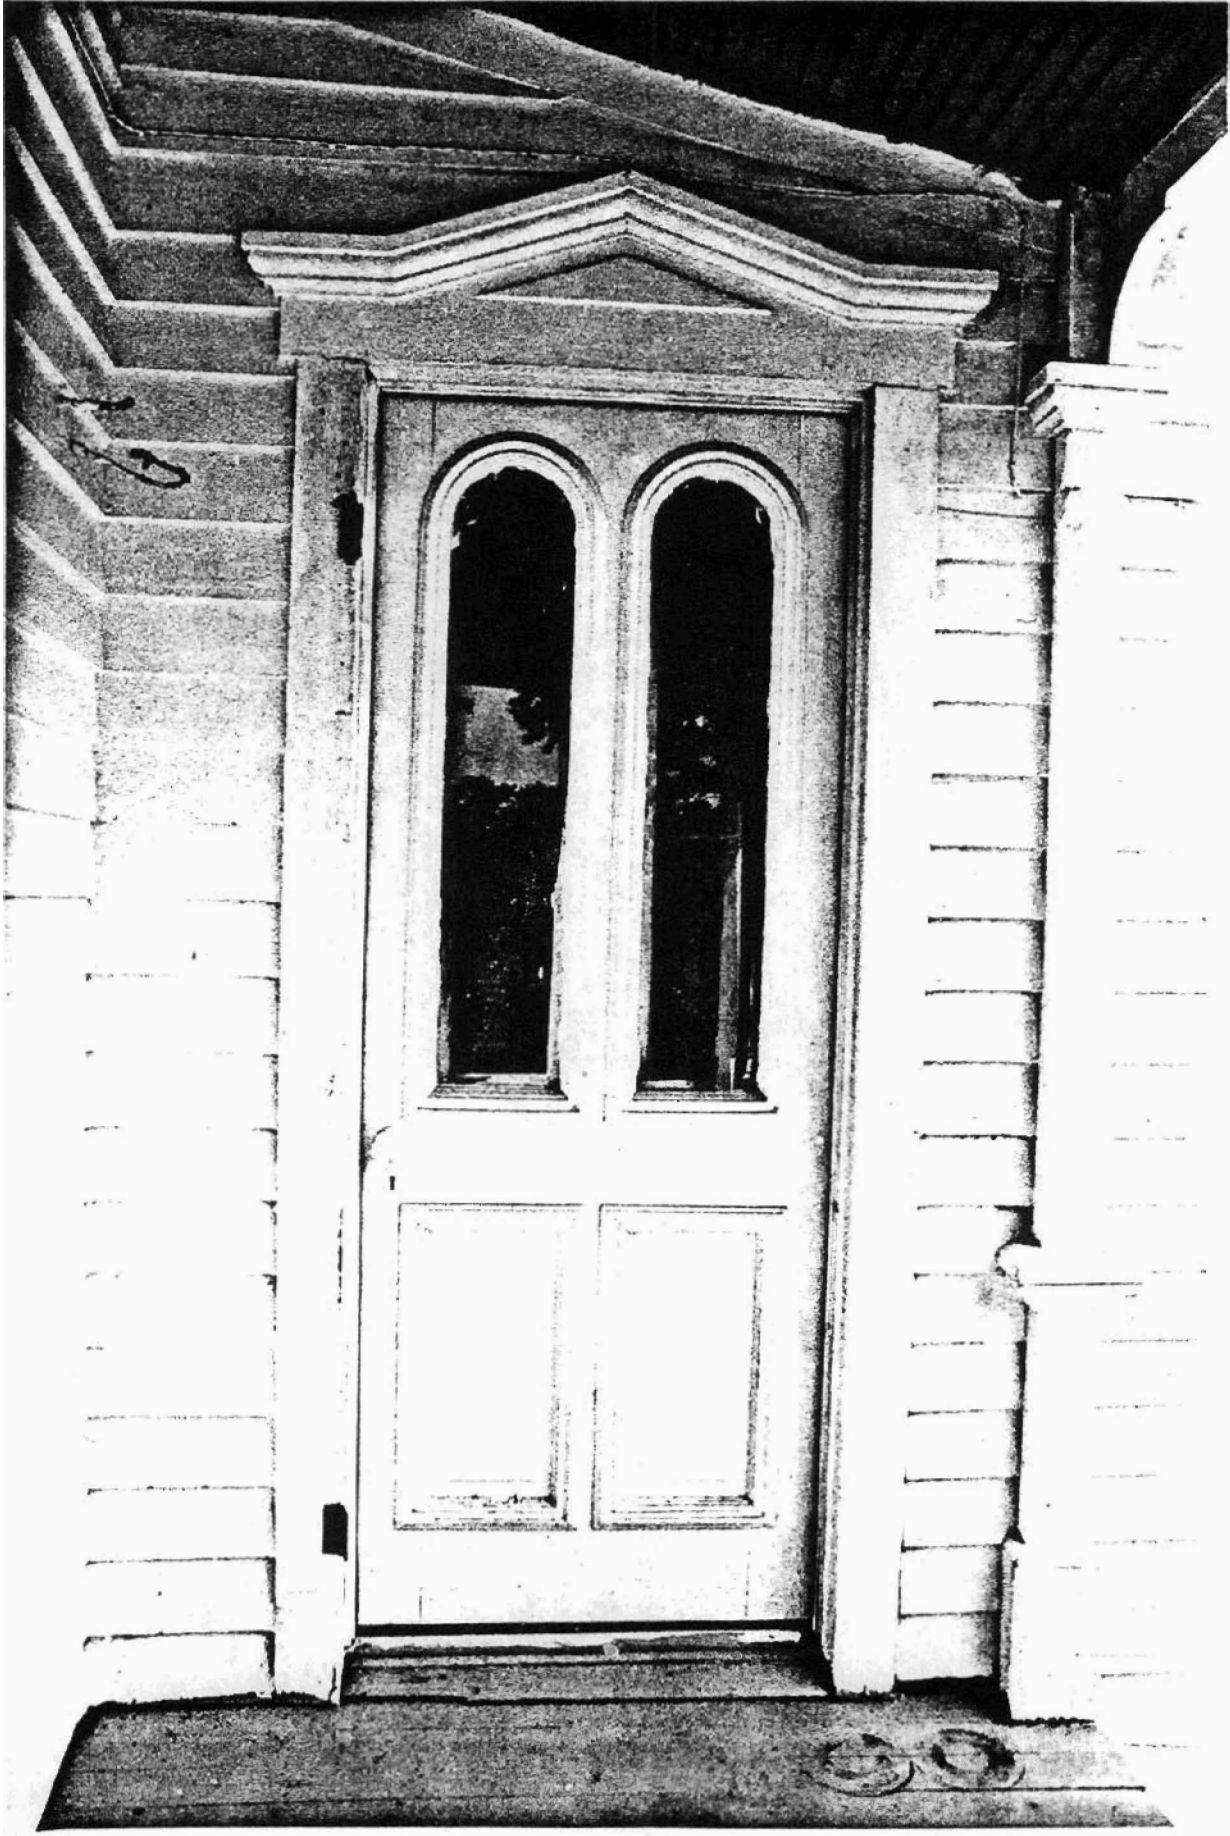
NEGATIVE ON FILE AT AHP
VIEW FROM THE WEST

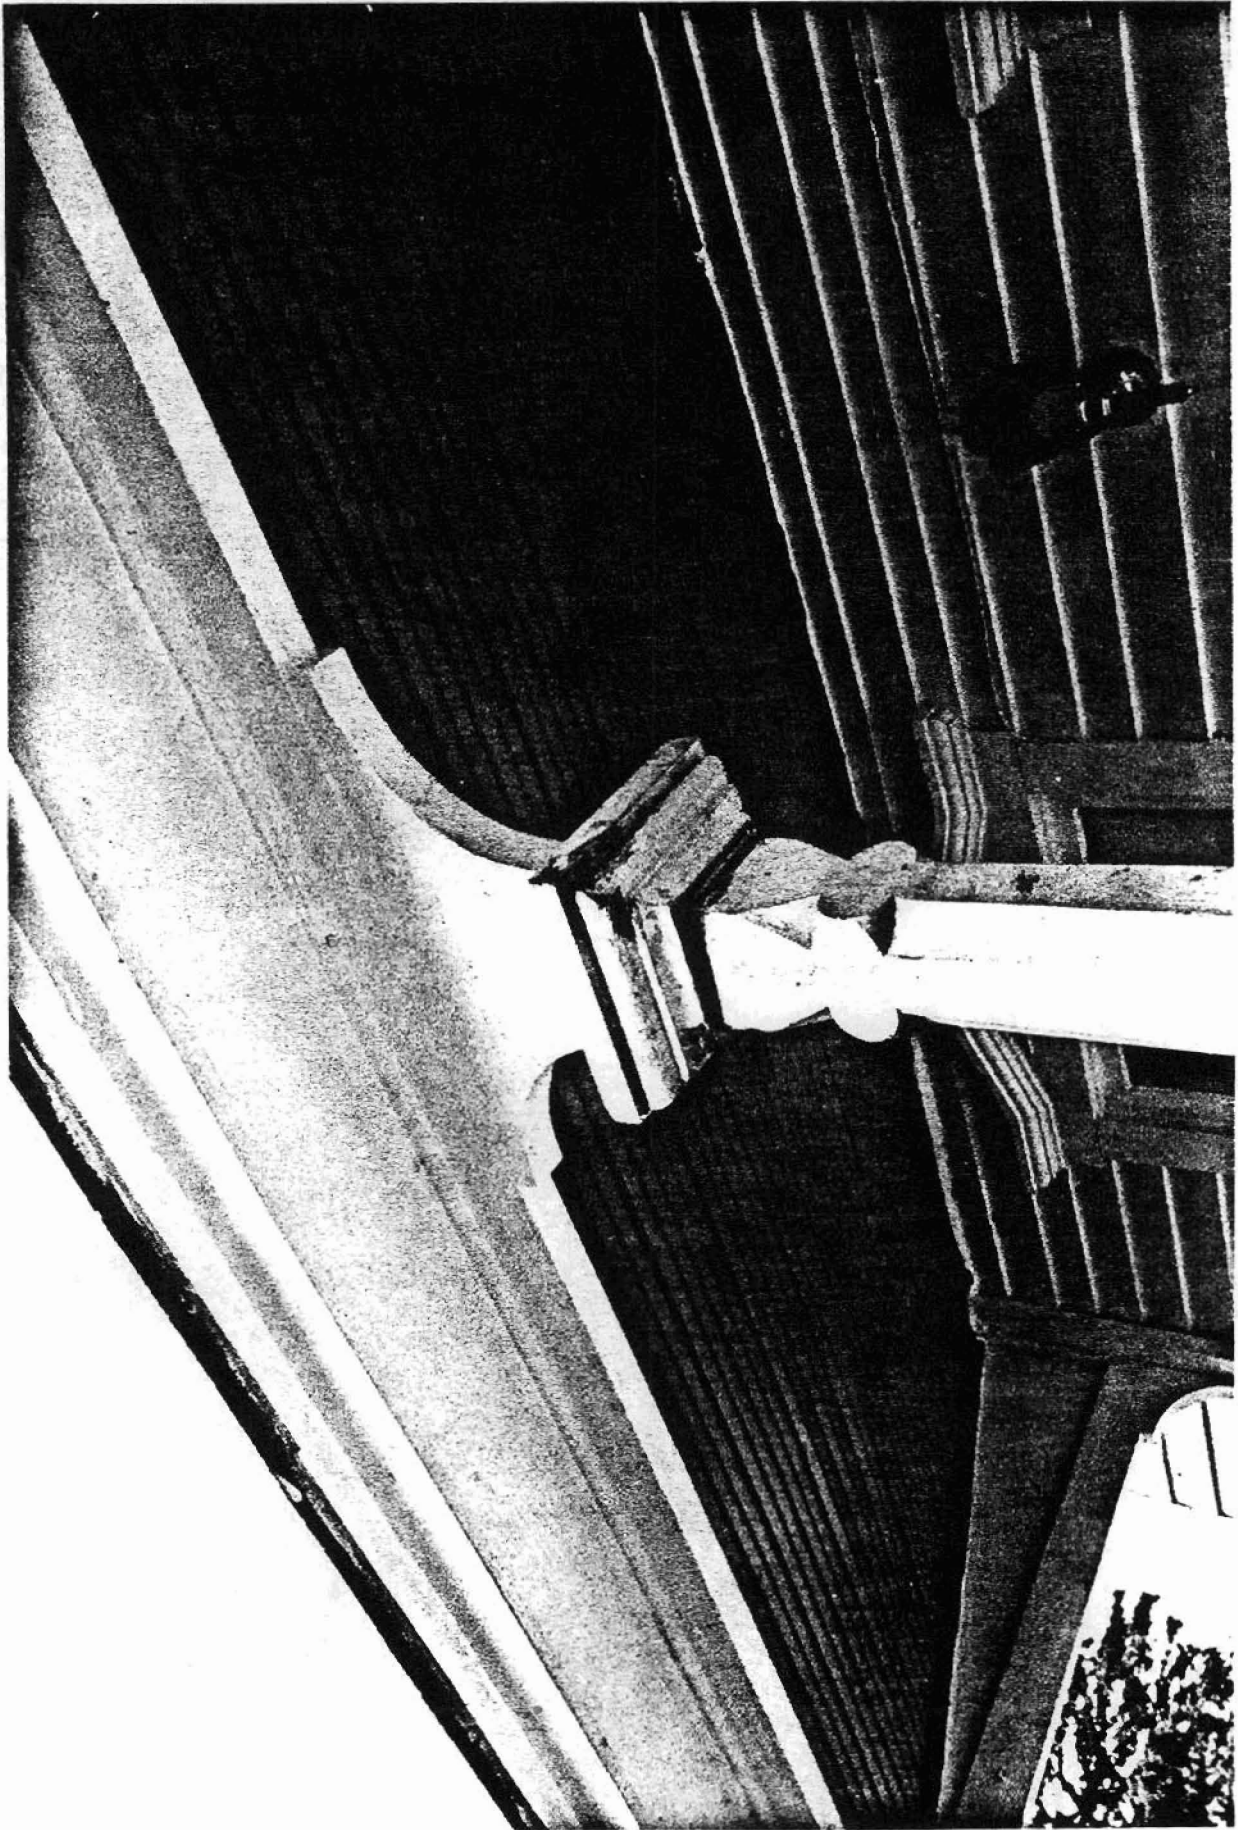
VIEW FROM THE SOUTH

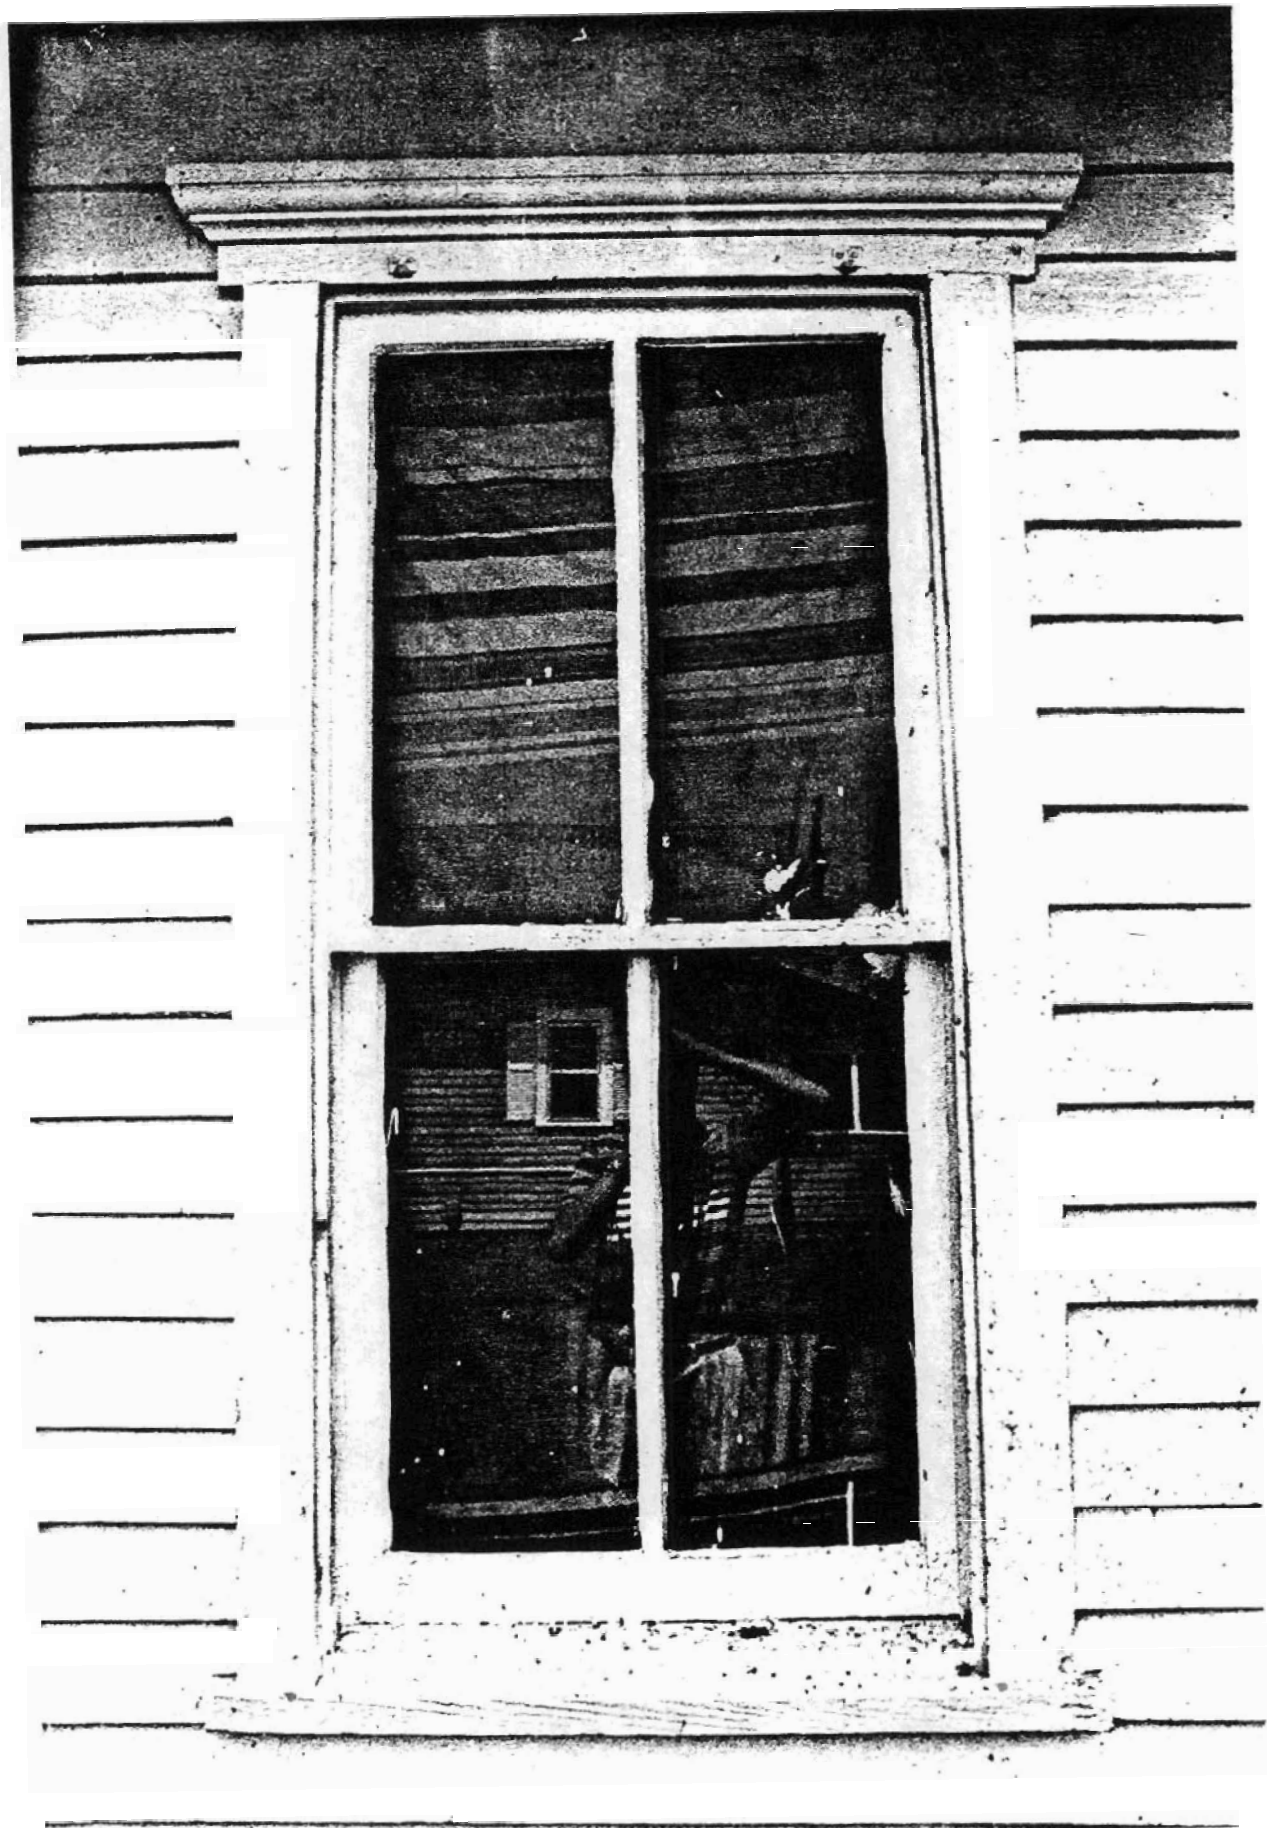
NEGATIVE ON FILE AT AHP
VIEW FROM THE NORTH
