NATIONAL REGISTER OF HISTORIC PLACES
REGISTRATION FORM

historic name: Bank of Marshall Building

street & number: Southeast corner of Main and Center Streets

city/town: Marshall

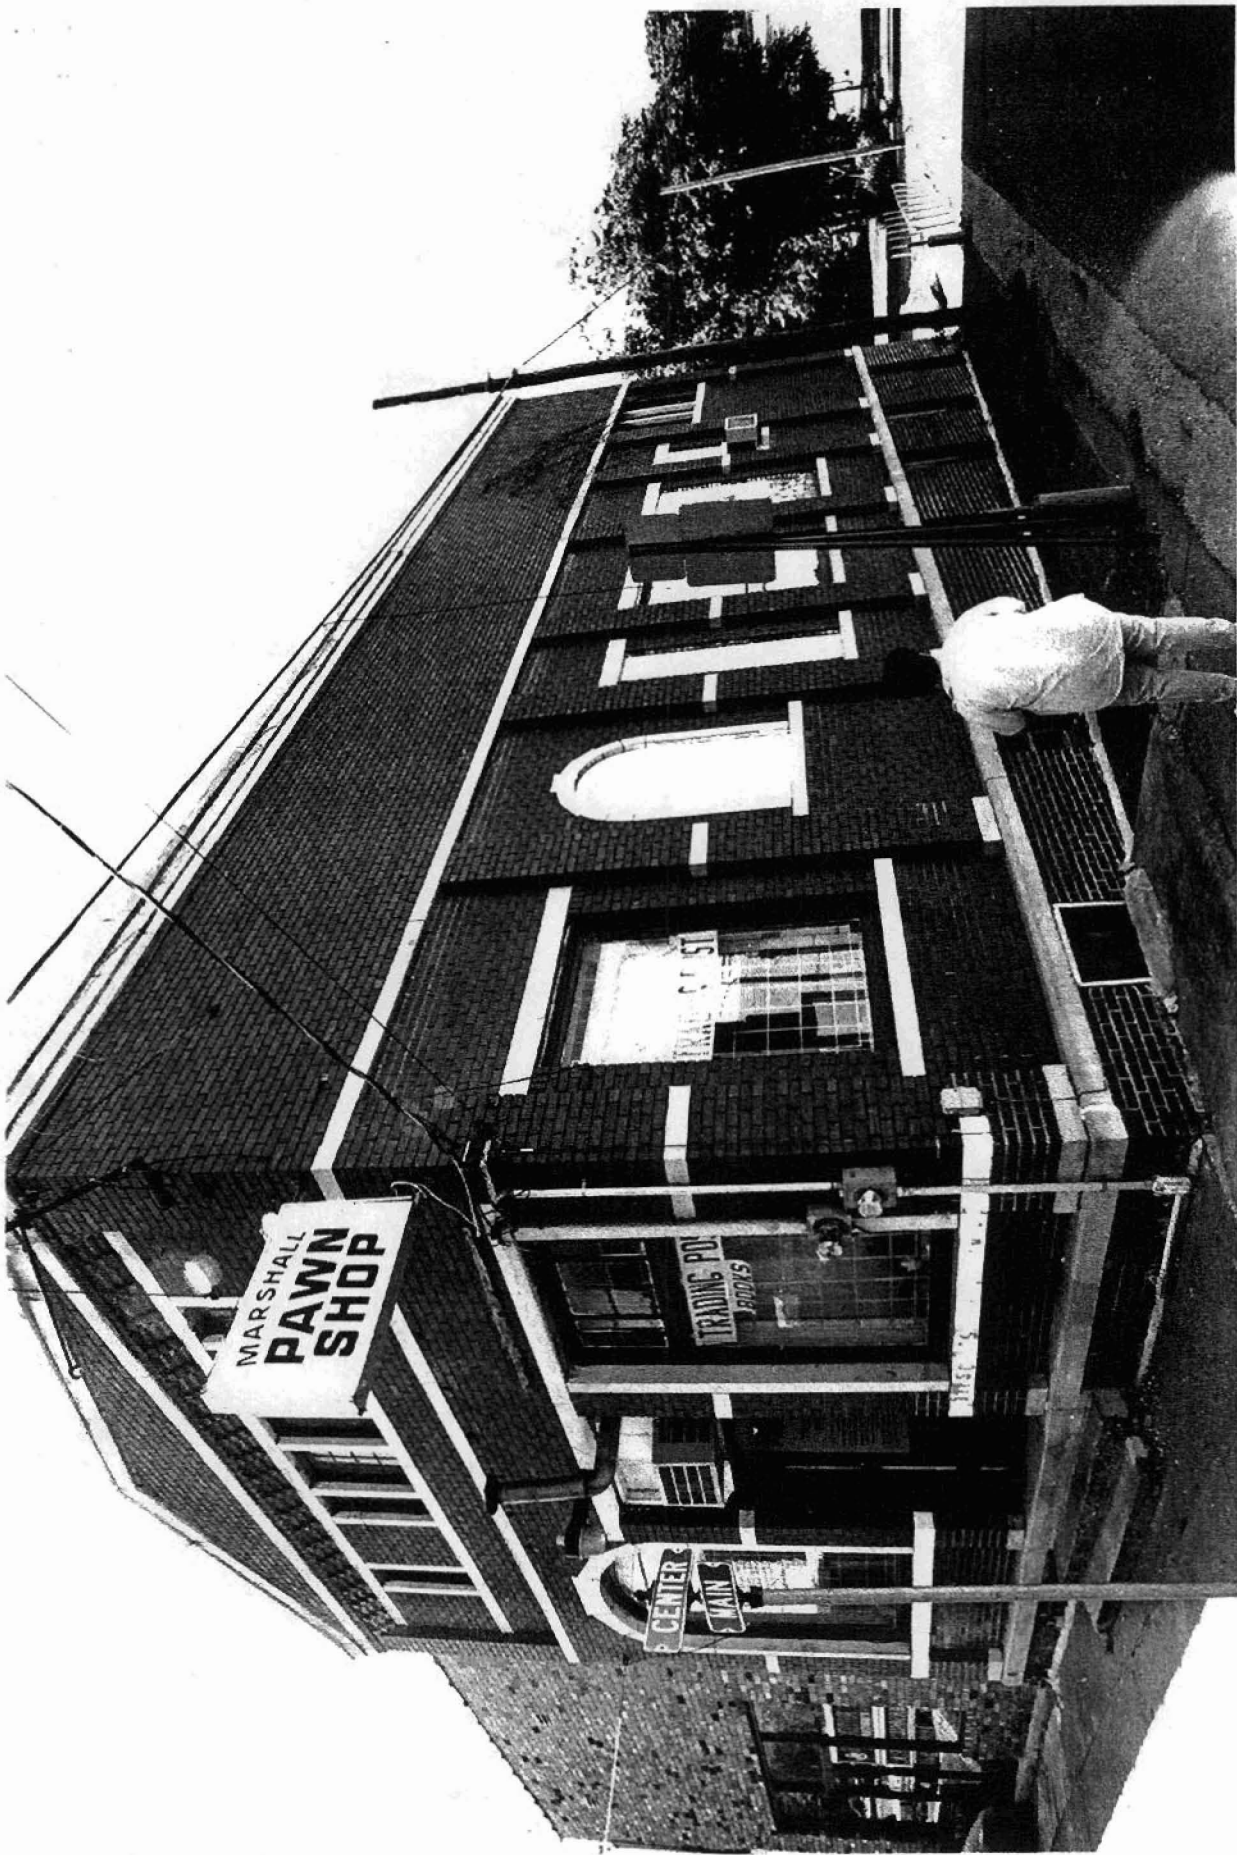
MARSHALL
PAWN
SHOP

The northern or front facade is composed of two large window openings on the first floor -- one rectangular and the other arched -- that is surmounted by a row of five smaller multi-pane windows in the upper half-story, organized into a central group of three flanked by a single window to either side. The two first-story windows are separated by the central, recessed entrance that leads to the single-leaf entrance. The entire facade is capped with a low pediment.
