NATIONAL REGISTER OF HISTORIC PLACES
REGISTRATION FORM

historic name: Lynch, Thomas, House

Located in the Morning Star vicinity, the Lynch House is a c. 1900 one-and-a-half story log dogtrot covered by a gable roof sheathed with corrugated tin. The building is constructed of small oak logs with square notching. Other than the historic addition of a kitchen and a small room on the rear elevation, the house is basically unaltered. There are no extant associated outbuildings.

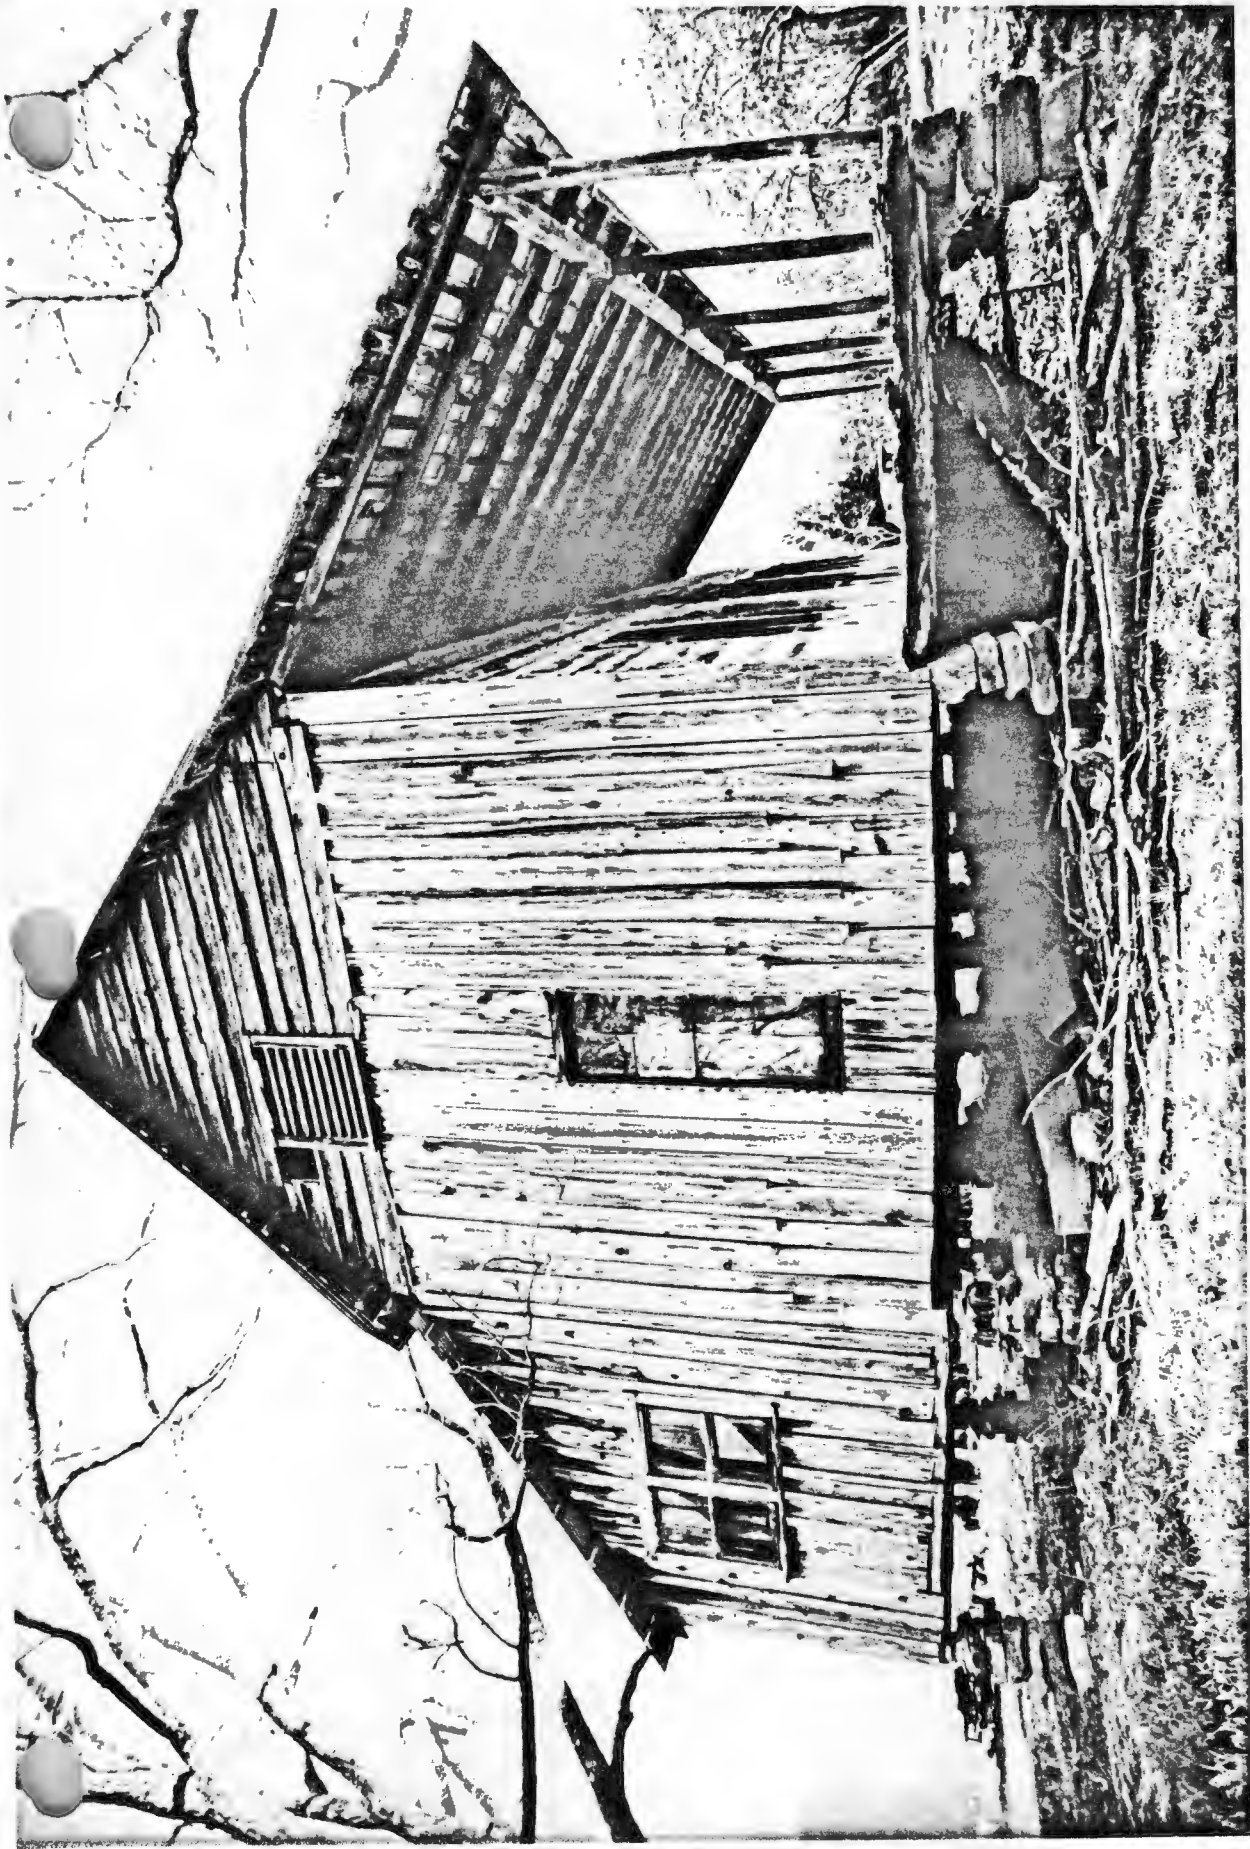
Thomas Lynch Hoose
Searcy Co., Arkansas
Photograph by Todd Ferguson
December 1991
Negative on file at AHPD.
View from the northwest

Board-and-batten siding now covers the northwestern elevation wall, which is fenestrated by a central four-over-four double-hung window. The gable end is sheathed with wide, rough-sawn horizontal weatherboard and has had a wood-louvered vent added at some point.

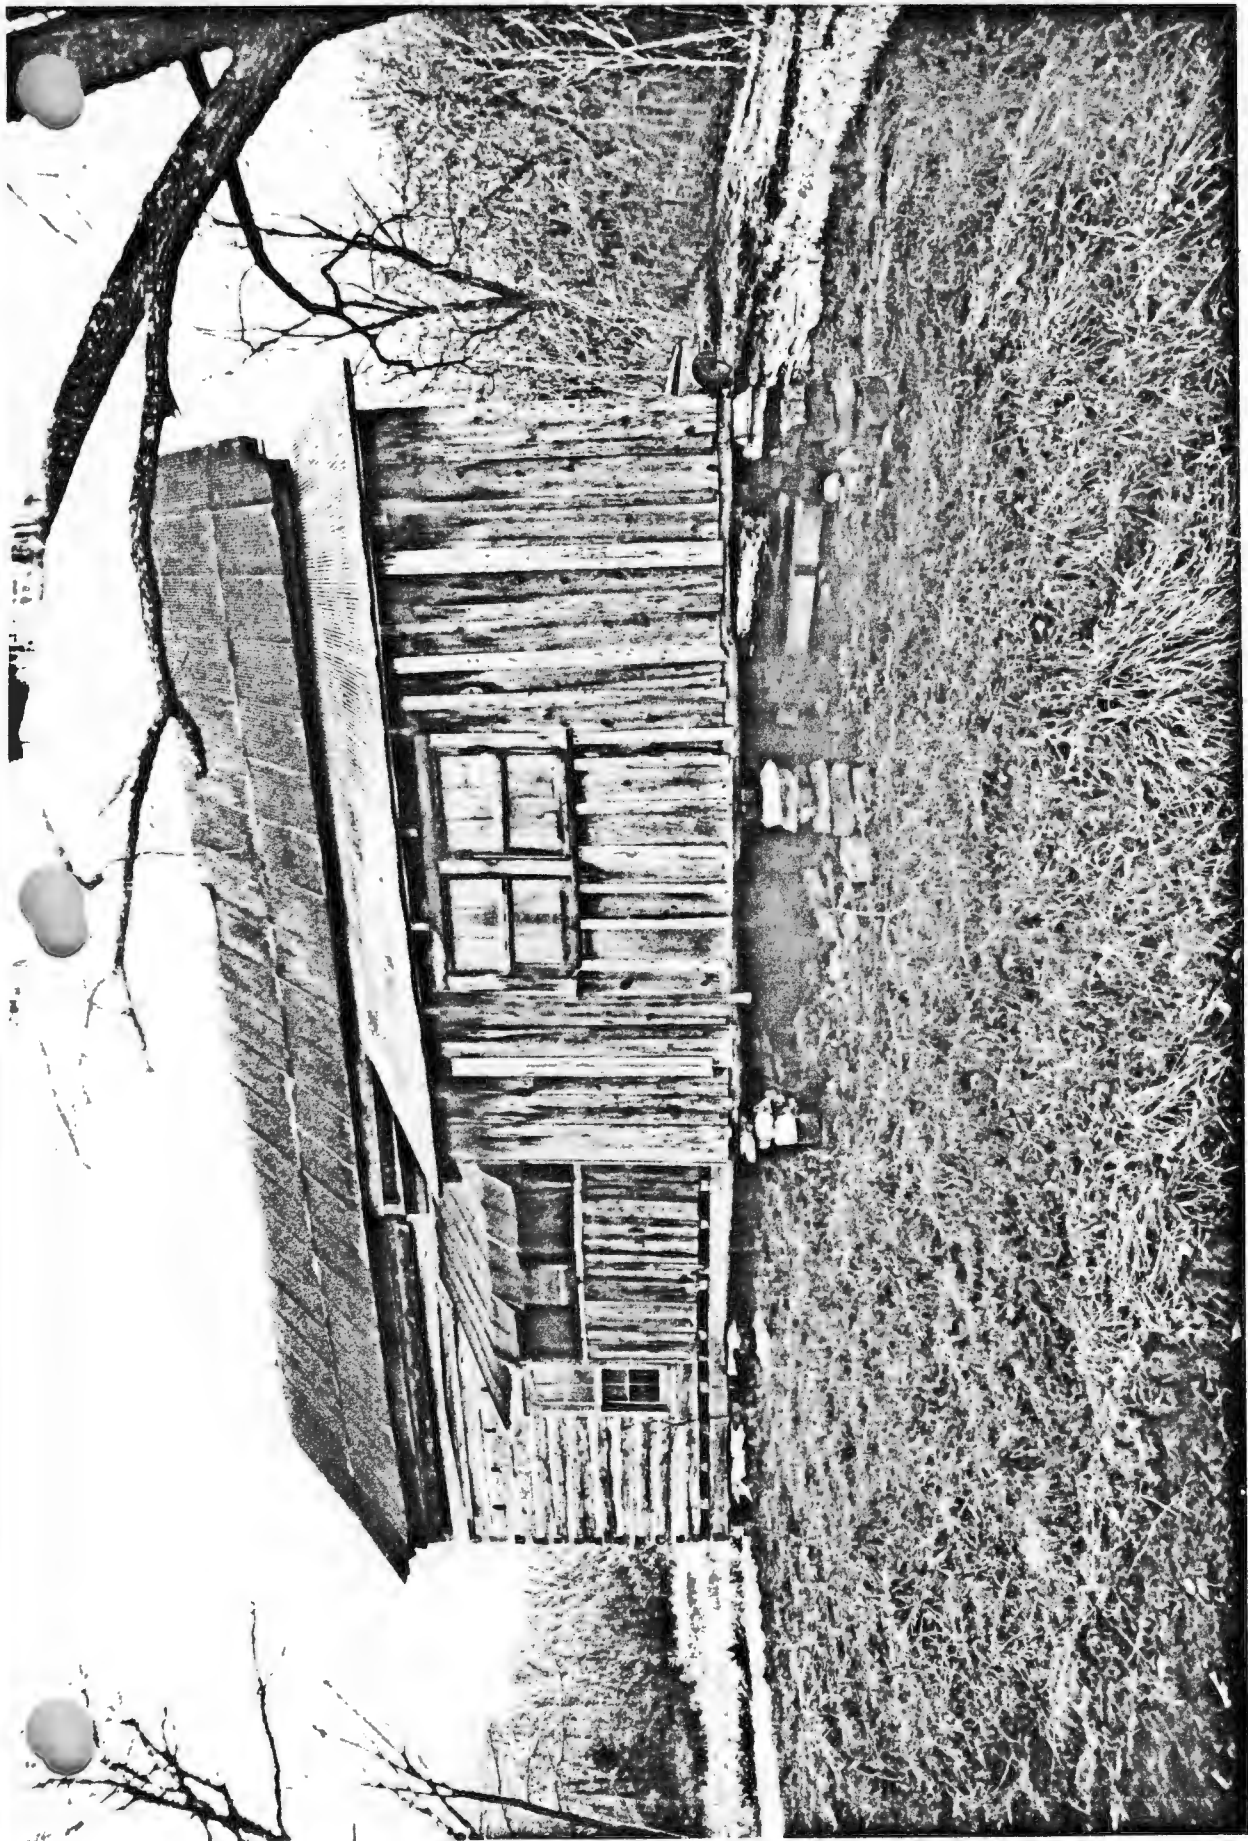
Thomas Lynch House
Searcy Co., Arkansas
Photograph by Todd Ferguson
December 1991
Negative on file at AHPP
View of the northeastern elevation

The rear, or northeastern, elevation contains a c. 1930 shed-roof kitchen addition at the northern end. The board-and-batten covered walls are punctuated by a pair of small three-over-one windows on both the rear and northwestern elevations. Ironically, the addition was constructed by George Jackson, who was considered a champion log hewer at the time. A small and simple shed-roof room was also added to the rear of the breezeway at this time. Built of a partial wall and screen wire, the addition was used as a dining room during the hot summer months. The unaltered southern pen on this elevation is lighted by a central four-over-four window.

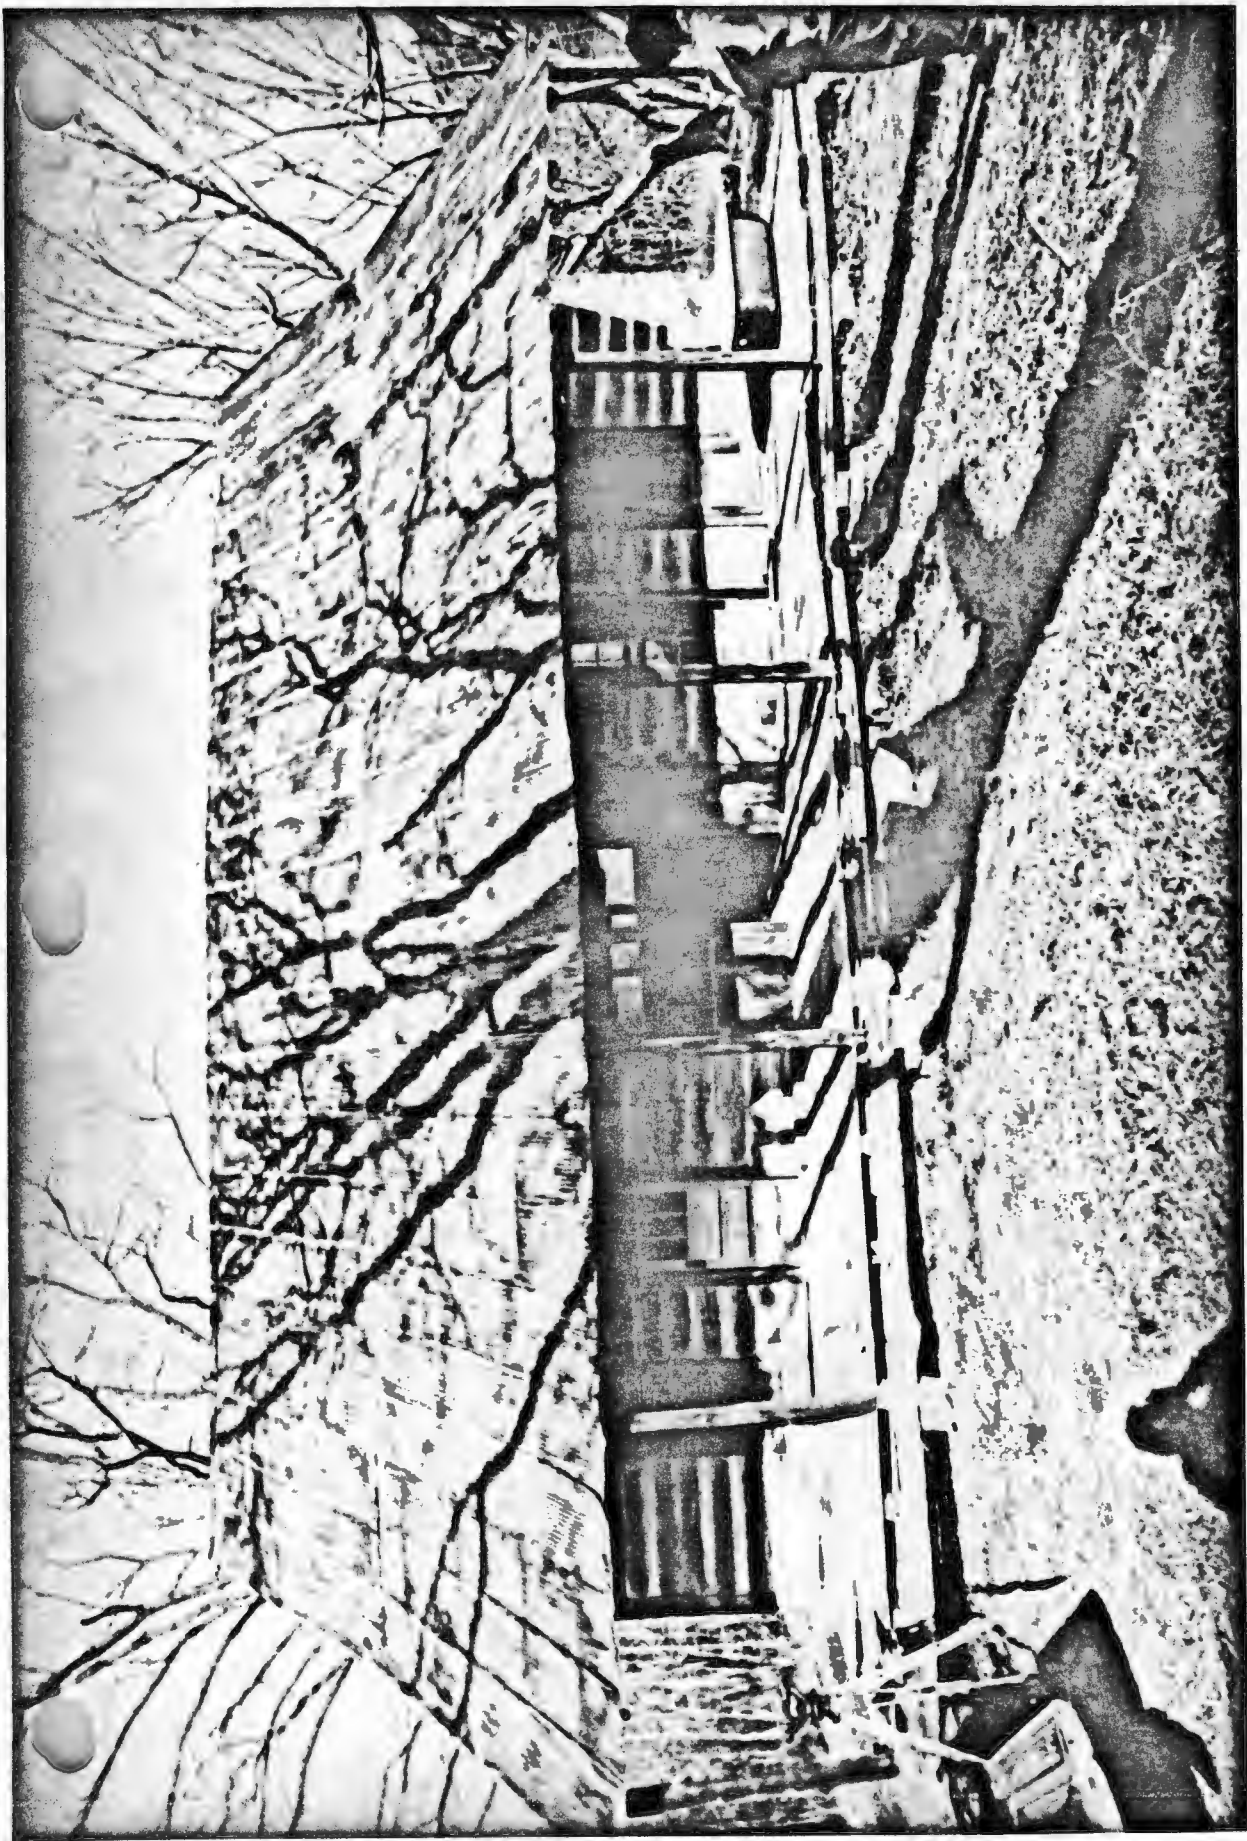
Thomas Lynch House
Searcy Co., Arkansas
Photograph by Todd Ferguson
December 1991
Negative on file at ARPP
View of front, or southwestern, elevation

A full-facade front porch is created by an extension and slight pitch change in the main gable roof on the front or southwestern elevation. The porch roof is sustained by six unfinished wood posts. Underneath, each pen contains a single-leaf wood door and a four-over-four double-hung window. The northern pen has the door placed between the window and the breezeway, while the southern pen has the window positioned between the breezeway and the door. Each pen also has a single-leaf wood door that opens onto the breezeway.
