HISTORIC RESOURCES OF DALLAS COUNTY  
DALLAS COUNTY, ARKANSAS

ARKANSAS HISTORIC PRESERVATION PROGRAM

Survey Number DA-19

Property Name Mt. Zion Methodist Church

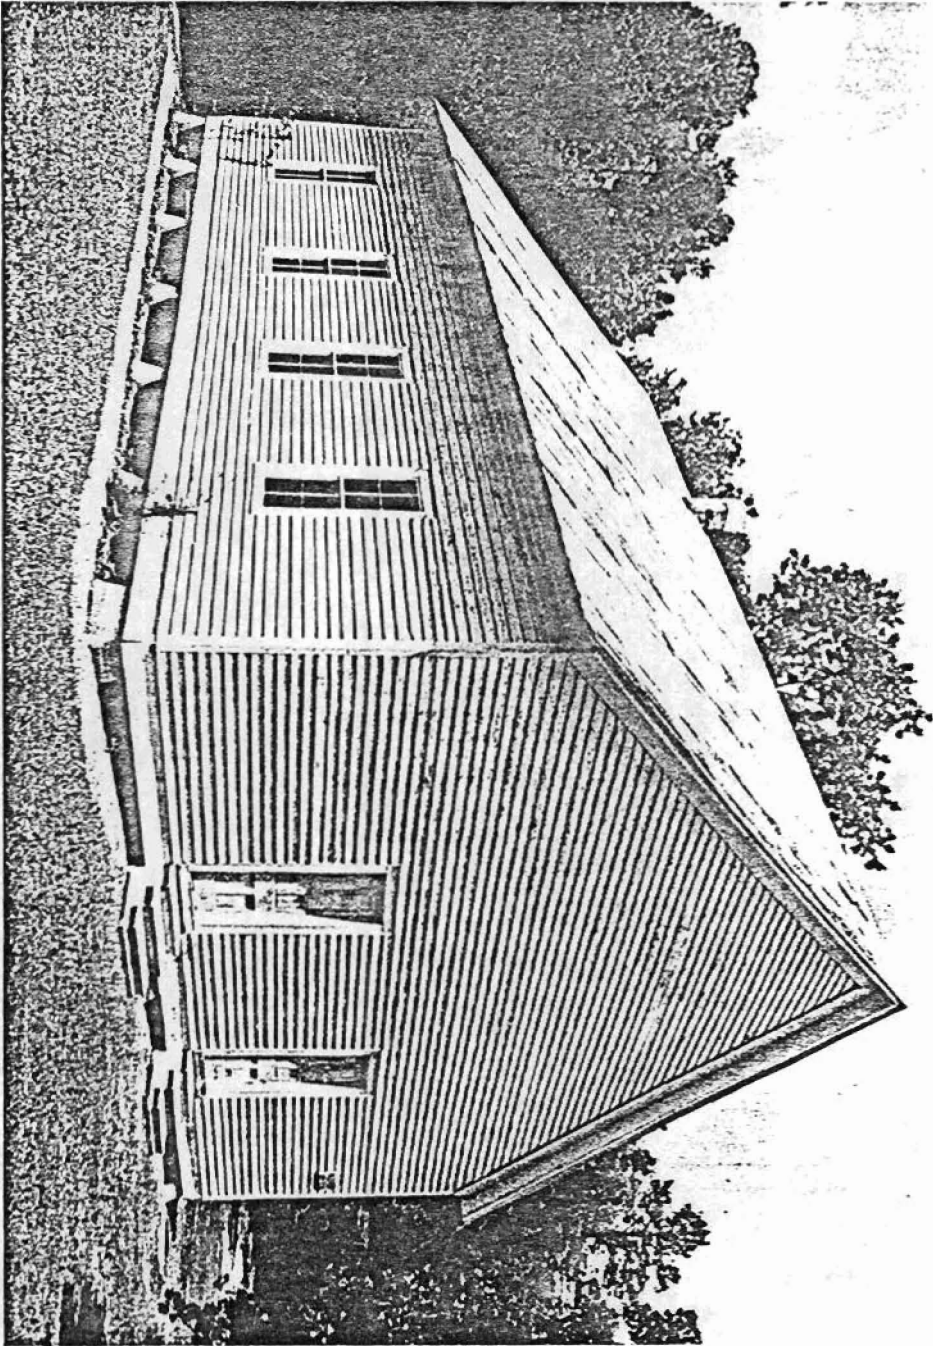
DA-19  
Mount Zion Methodist Church  
Sarah Brown, photographer  
April 28, 1982  
Negative on file at the AHPP  
View from the southeast

Mt. Zion Methodist Church, located approximately 2½ miles northeast of Carthage, sits picturesquely on a tree shaded lot next to a county road. The 30' x 45' dimensions of this rectangular weatherboarded structure give it squarer proportions than what is common for rural churches of this form. The expansive front gable facade which is unadorned and penetrated only by two four-panelled doors accentuate the box-like character of the structure. This solid white mass which offers a pleasant contrast to its natural surroundings is intensified by the white tones of the extensive roof sheathed in corrugated sheet metal. Striking in its austerity, the church's simplistic facades are gracefully framed by frieze, corner and skirt boards. The side (north and south) elevations are penetrated by four four-over-four windows. As is common for rural churches of this type, a second entry exists on the west side of the north elevation. All windows and doors have simple surrounds.
