NATIONAL REGISTER OF HISTORIC PLACES  
REGISTRATION FORM

historic name: Rector Log Barn

street & number: Located on County Road 218, 1.23 miles northwest of State Highway 9

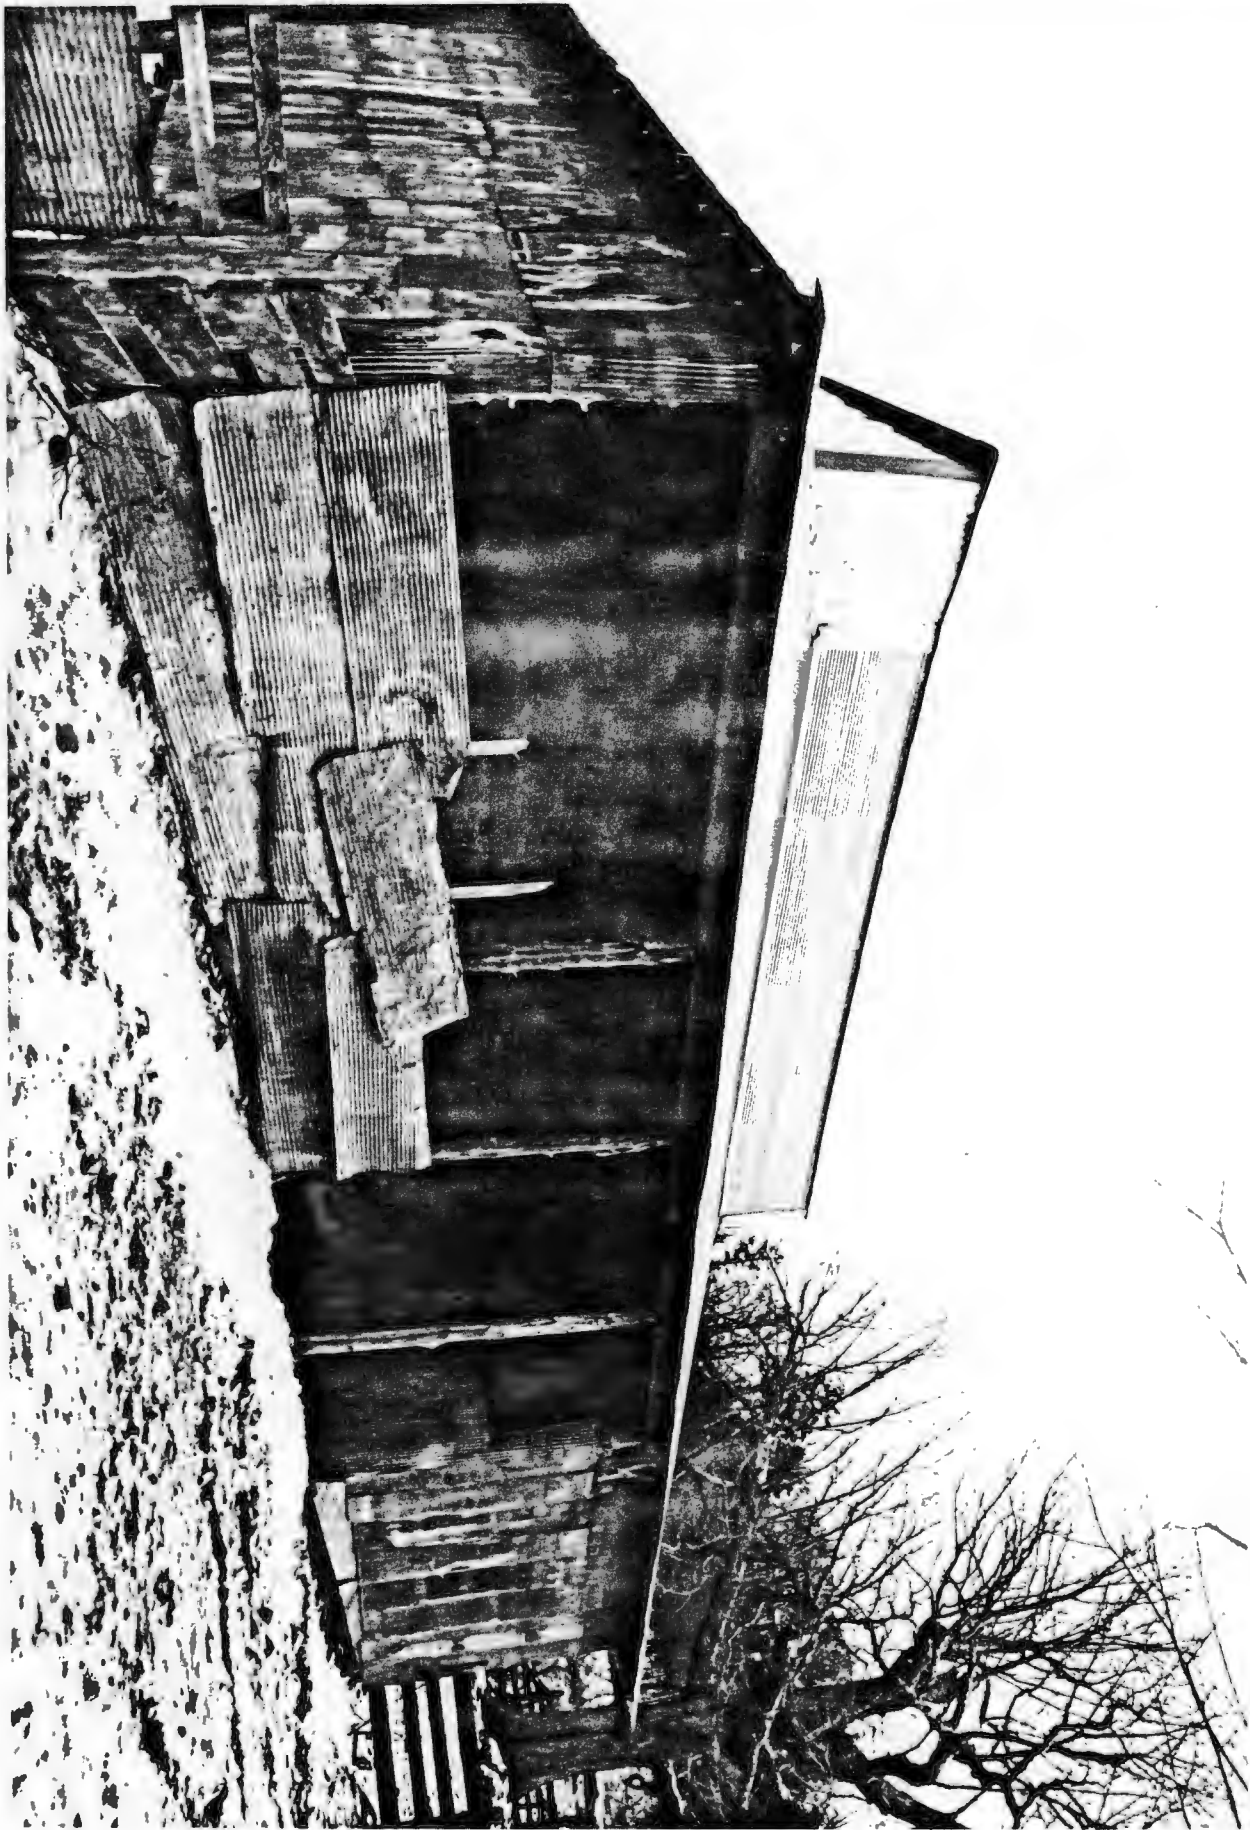
PECTOR & OS BARN  
MELBOURNE VIC, 12ARD CO. ARKENSAS  
PHOTOGRAPHED BY K. STORY  
FEBRUARY, 1993  
NEGATIVE ON FILE AT A&P  
VIEW FROM EAST

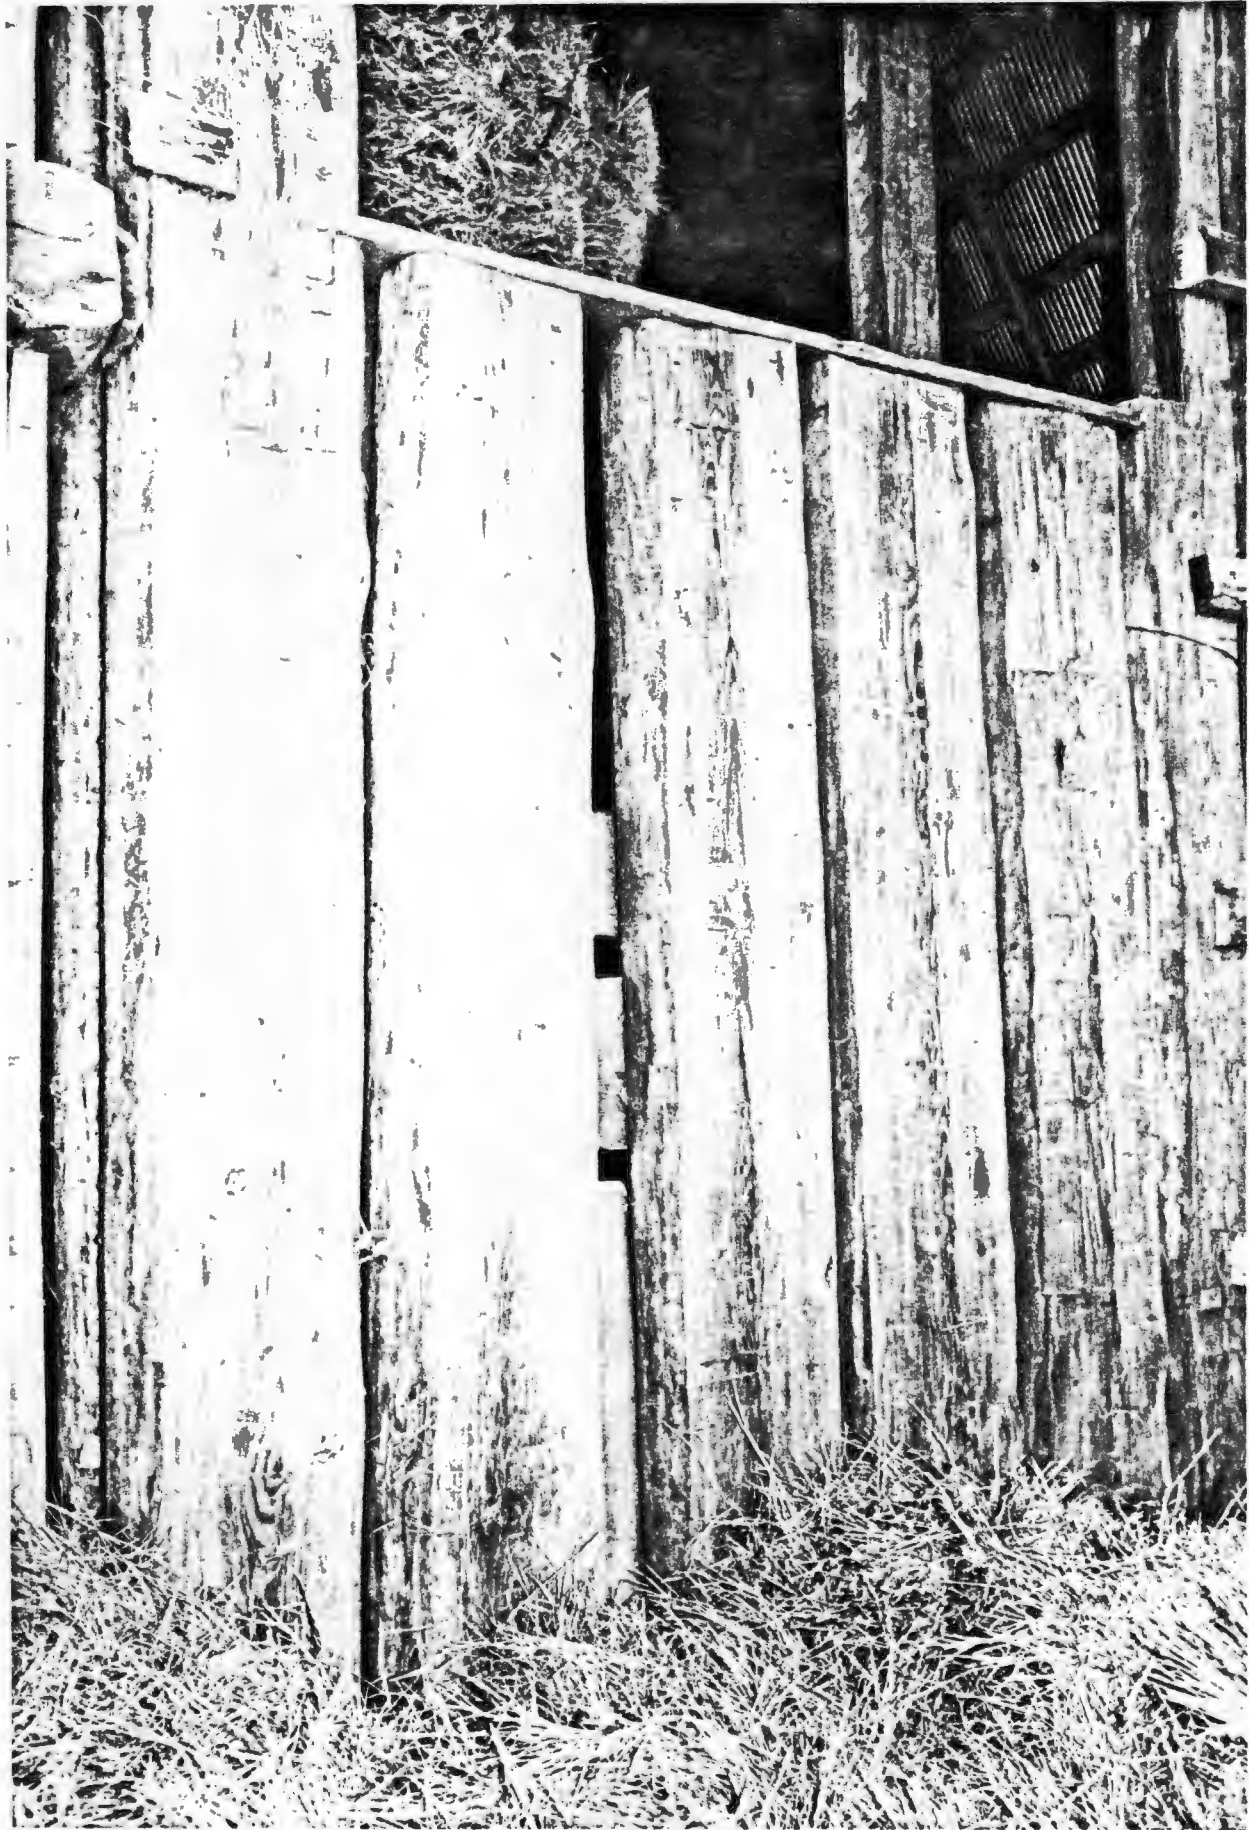
FLECTOR & OR BARN  
MELBOURNE VIC, 12ARD C. INKUSSES  
PHOTOGRAPHED BY A STORY  
FEBRUARY, 1993  
NEGATIVE ON FILE AT AMP  
VIEW OF SOUTHERN WALL

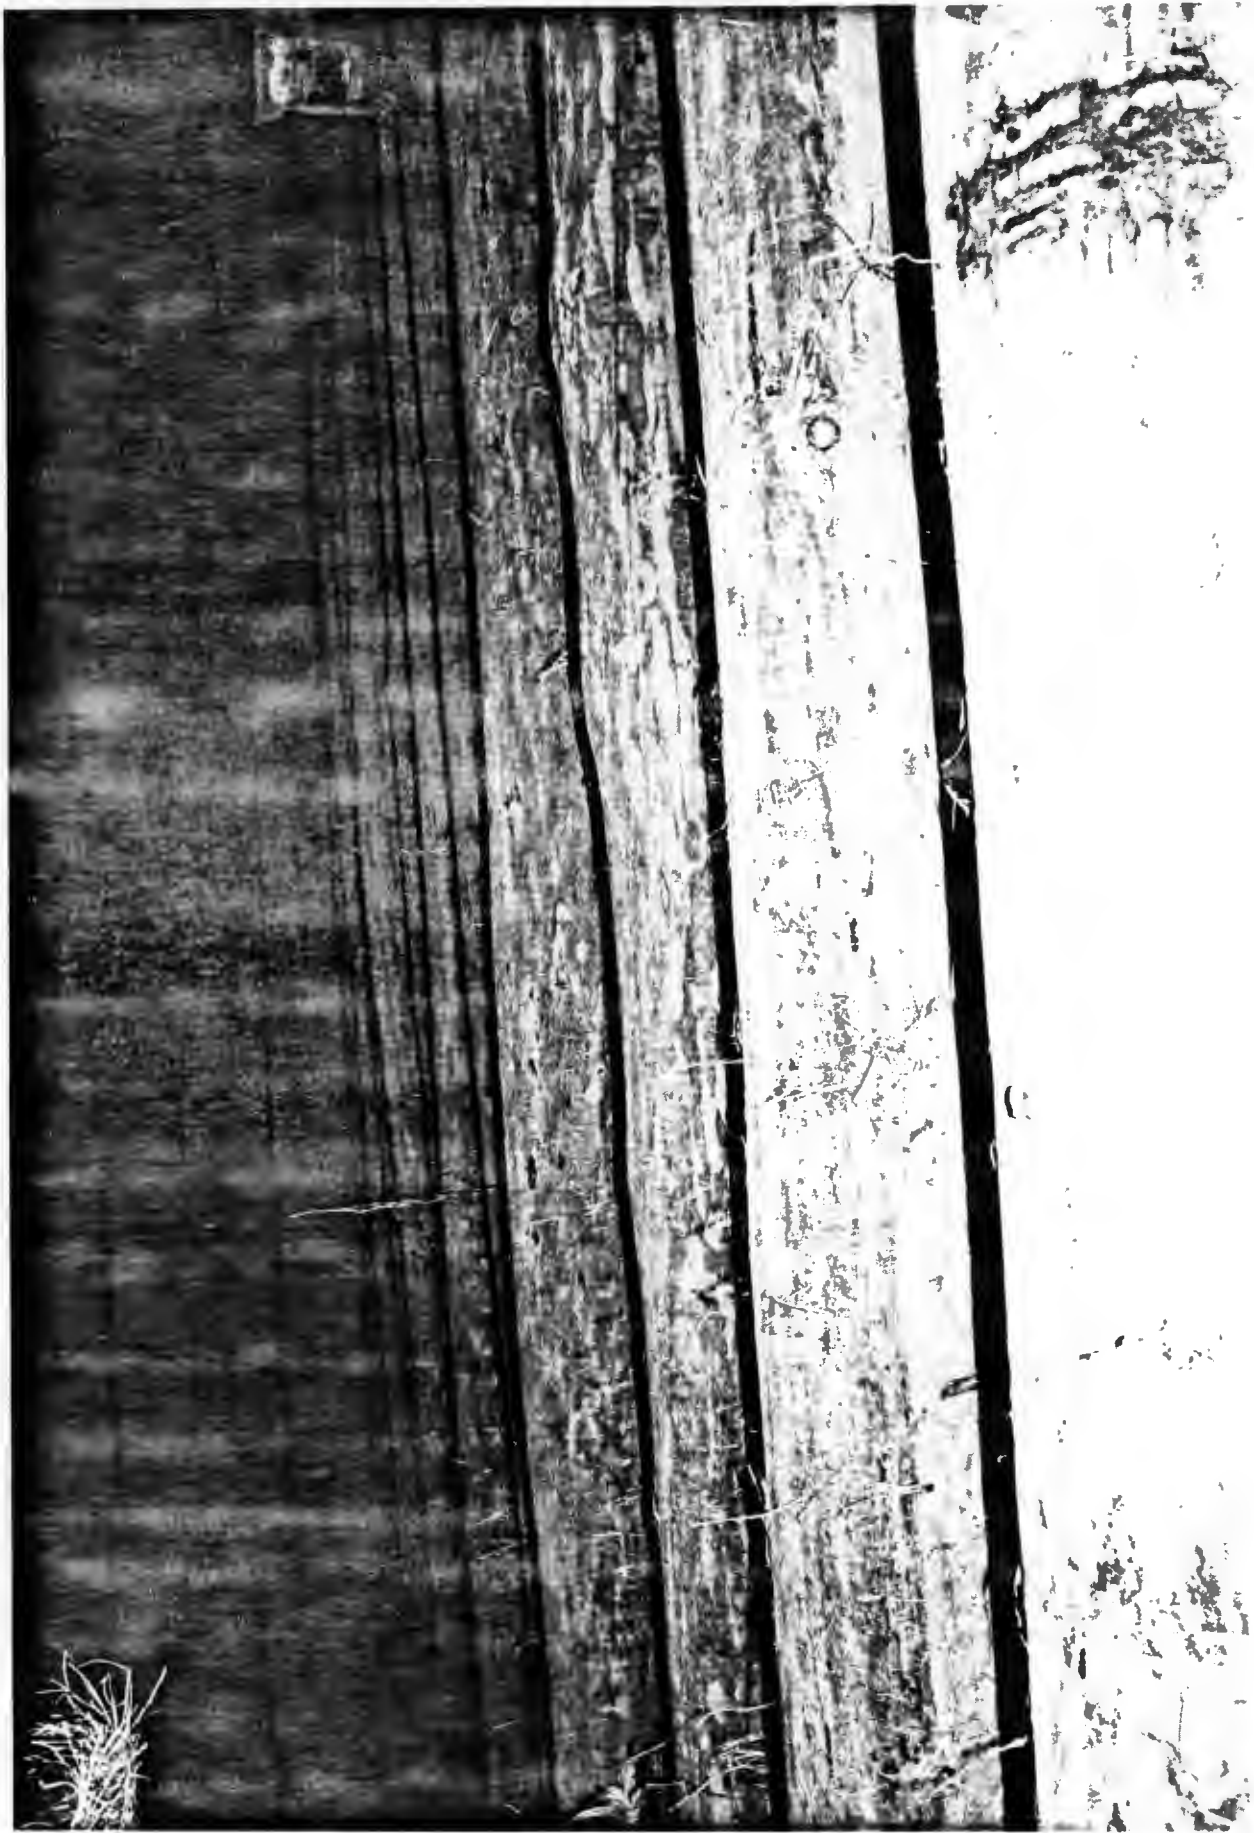
RECTOR LOS BARN  
MELBOURNE, VIC, LAND CO., KIRKENS  
PHOTOGRAPHED BY H. STORY  
FEBRUARY, 1993  
NEGATIVE ON FILE AT AMPP  
DETAIL OF LOS WALK

The wall logs of the Rector Log Barn are half-dovetail notched and hewn evenly on both sides to form log "planks." The first two logs at the bottom of the structure are oak, while all the logs above are pine (the use of pine for log structures was relatively common in IZARD County during the antebellum period, largely due to their availability and the abundance of large, virgin growth timber that could be hewn into usable logs). The wall logs above the second floor appear to be hewn only on the sides, while the logs on the first story (which may well be later replacements) are hewn on four sides, and thus fit together more closely. There is no indication that the logs were ever chinked, which would not be surprising for an agricultural outbuilding that probably served as a shelter for feed storage. Its full two-story log construction remains largely intact, the only alteration having been the removal of the original log ramp that provided access to the second story. As such, the Rector Log Barn is locally eligible under Criterion C as the best known example of a two-story, antebellum log outbuilding that survives in Melbourne and IZARD County.

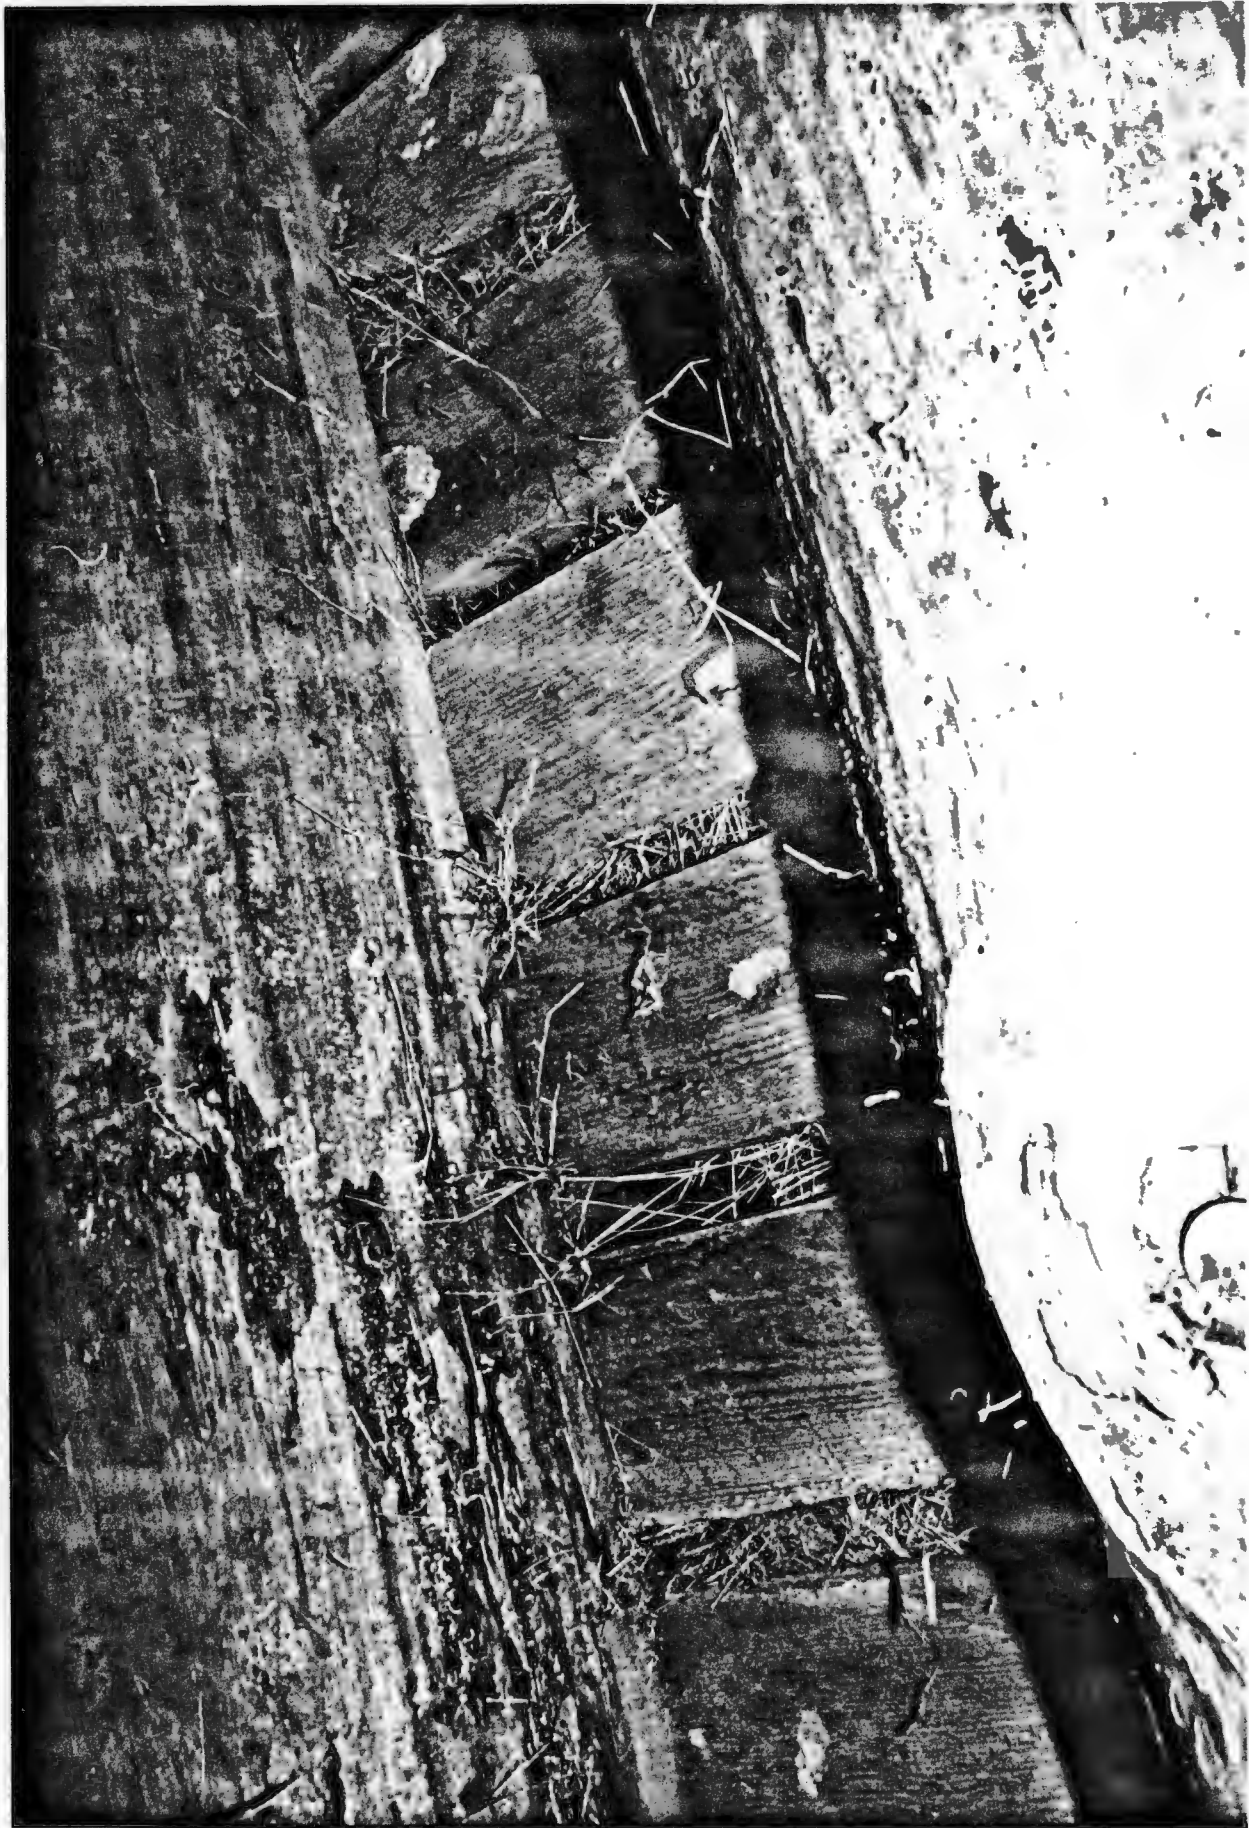
SECTION 406 BARN  
MELBOURNE VIC. 12 AND Co. AIRMAILS  
PHOTOGRAPHED BY S. LLOYD  
FEBRUARY, 1993  
NEGATIVE ON FILE AT MMP  
MURKIN DETAIL

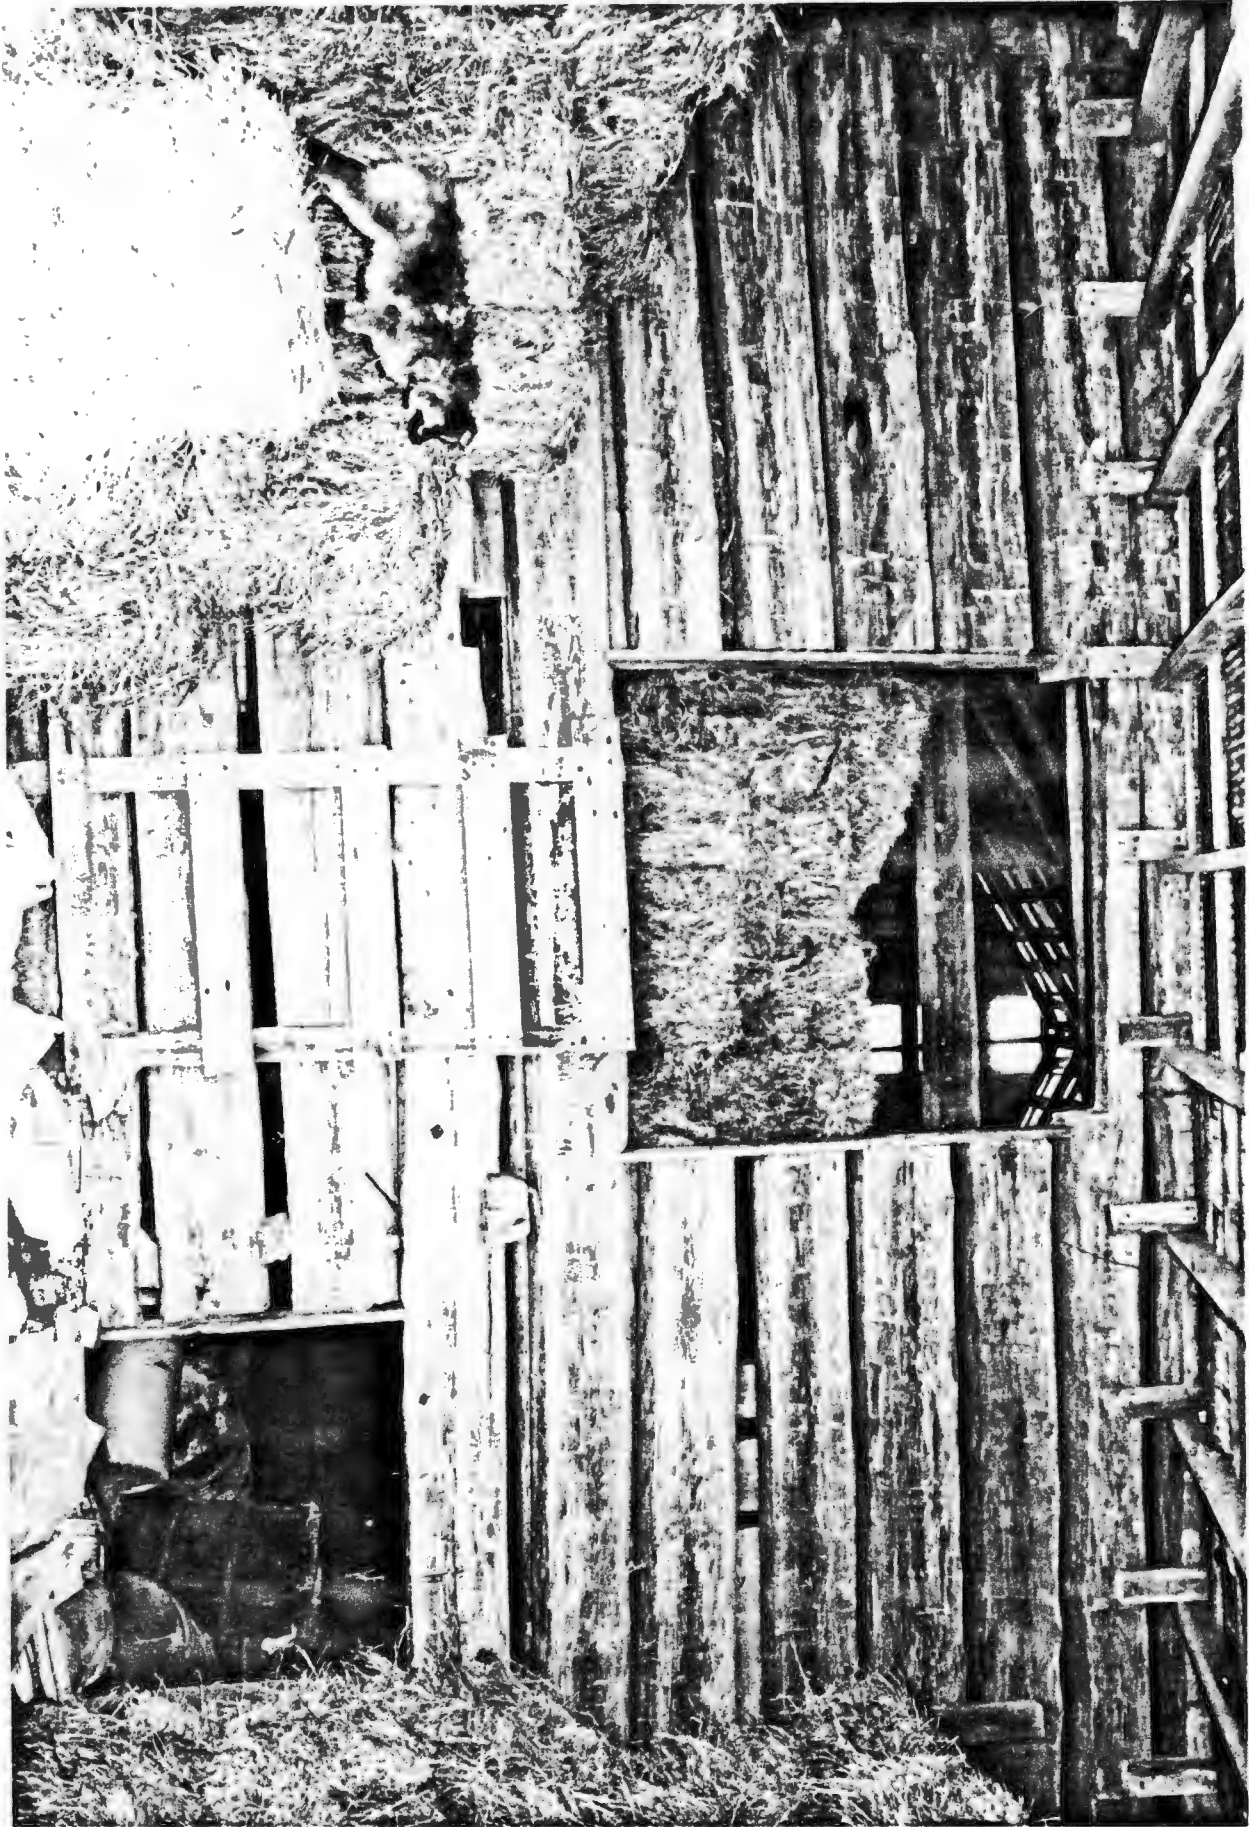
BEETLE LUG NAIL  
WELLSBORNE VIC, IZARD CO, ARKANSAS  
PHOTOGRAPHED BY K. BERRY  
FEBRUARY, 1993  
NEGATIVE ON FILE AT AHPP  
FLOOR DETAIL
