NATIONAL REGISTER OF HISTORIC PLACES
REGISTRATION FORM

historic name: The Farmers Bank Building

other name/site number: Old Leslie Post Office; SE 0234

Name of related multiple property listing: Historic and Architectural Resources of Searcy, Arkansas

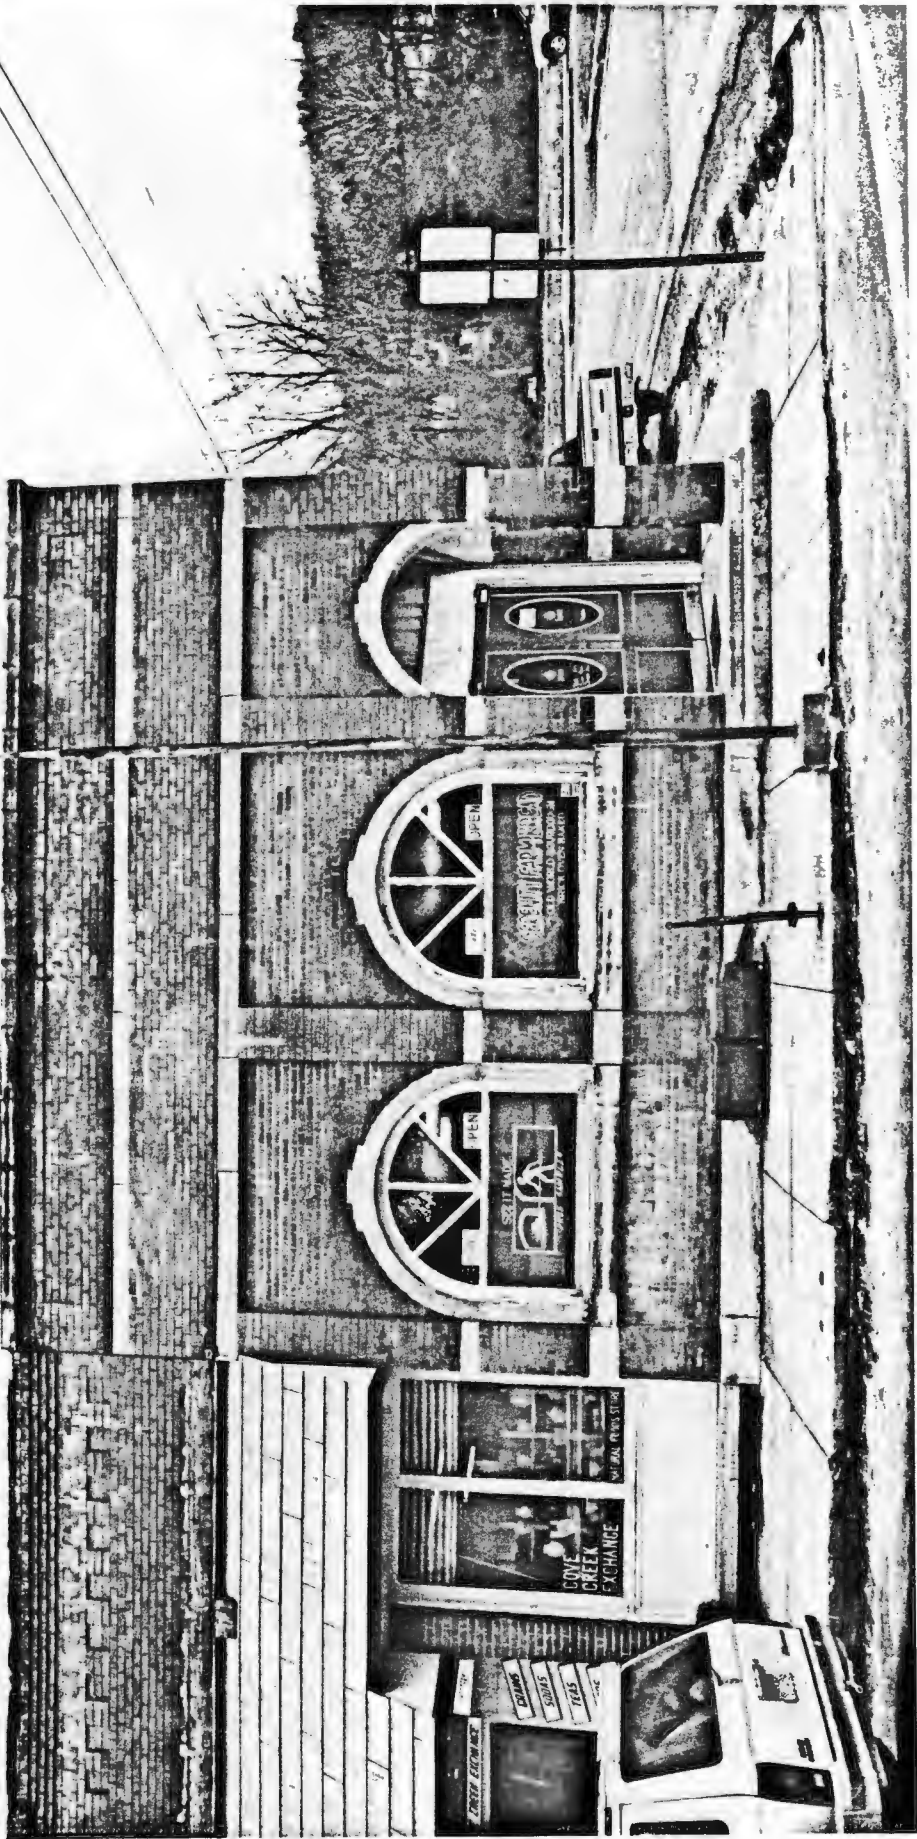
Farmers Bank Bldg.
Searcy Co., Arkansas
Photograph by Patrick Zolner
January 1993
Negative on file at AHPP
View of the southwest elevation

The front, or western, elevation is anchored by the bevelled corner bay at the southern end. New double-leaf doors are located underneath the porch, which is supported by a single square brick column. Semi-circular limestone arches connect the column with the two respective walls. The remainder of the front elevation is dominated by two enormous arched windows. Again, the arches (and sills) are constructed of limestone and feature a three-part keystone. The windows are wood-frame and consist of four triangular panes over one. Three three-quarter-height brick pilasters separate the windows and the bevelled bay. There are also four horizontal limestone belt courses that lend texture to the facade. The first is formed by the window sills; the next highest is found only on the pilasters and porch column at the height of the middle window sash; another course caps the pilasters; and the last course divides the remaining distance to the roof coping, which also appears to be of limestone.

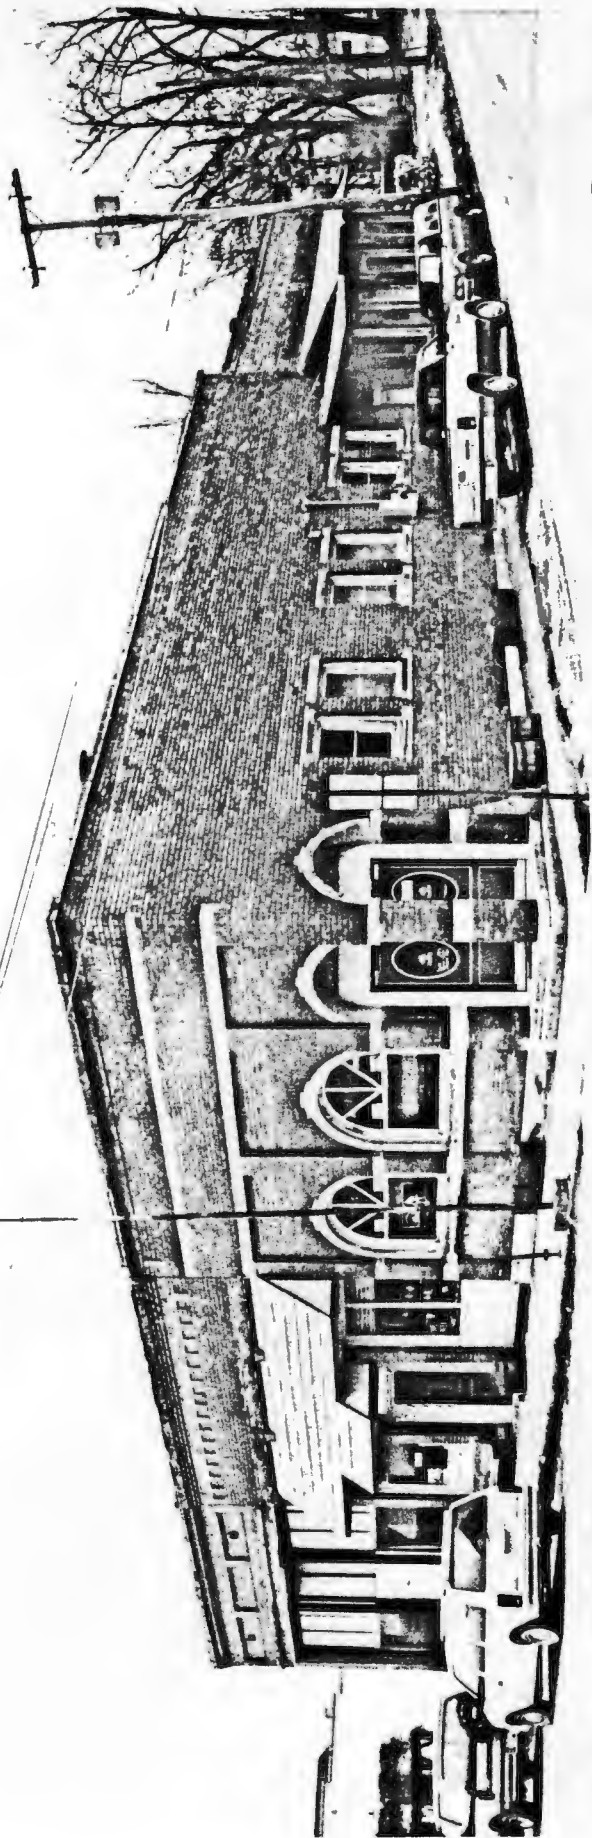
Farmers Bank Bldg.
Searcy Co., Arkansas
Photograph by Patrick Zollner
January 1993
Negative on file at AHPP
View from the south

The longer southern elevation is much more simply arranged and consists of three groups of side-by-side (actually separated slightly) one-over-one wood-frame windows. Although much shorter than conventional one-over-one sashes, these windows still present a dignified appearance through the use of flat limestone crowns and sills. A single-leaf wood door covered by a flat metal roof is located at the eastern end of the elevation.

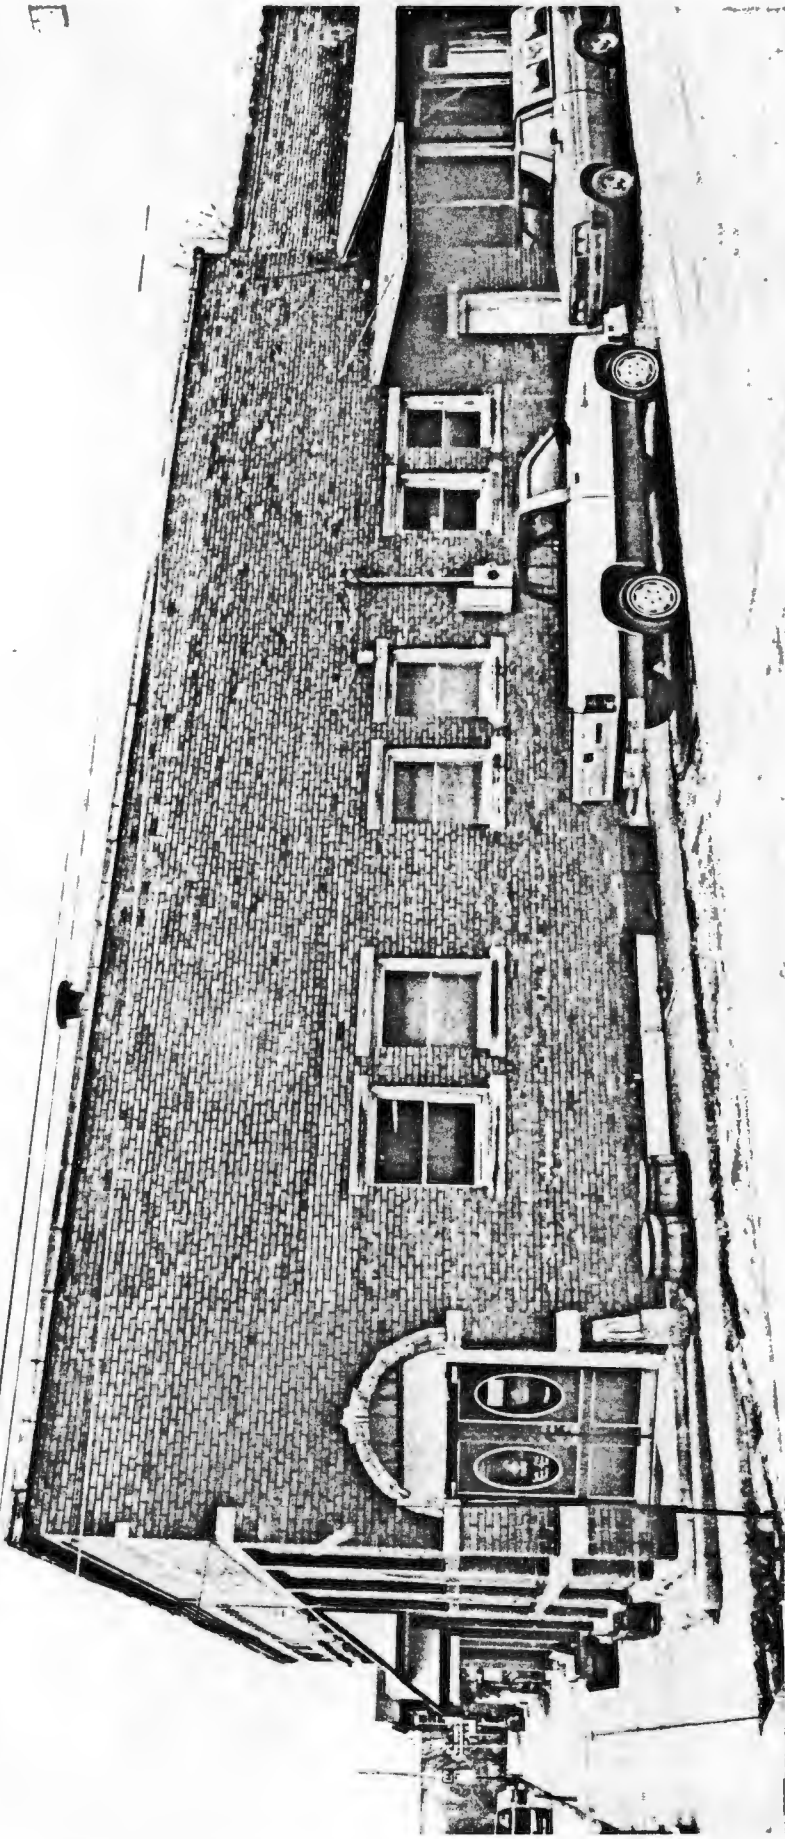
Farmers Bank Bldg.
Searcy Co., Arkansas
Photograph by Patrick Zoller
January 1993
Negative on file at AHPP
View of the southeast elevation
