HISTORIC RESOURCES OF STONE COUNTY
STONE COUNTY, ARKANSAS

Survey Number ST-161

Property Name H. S. Mabry Barn

ARCHITECTURAL DESCRIPTION

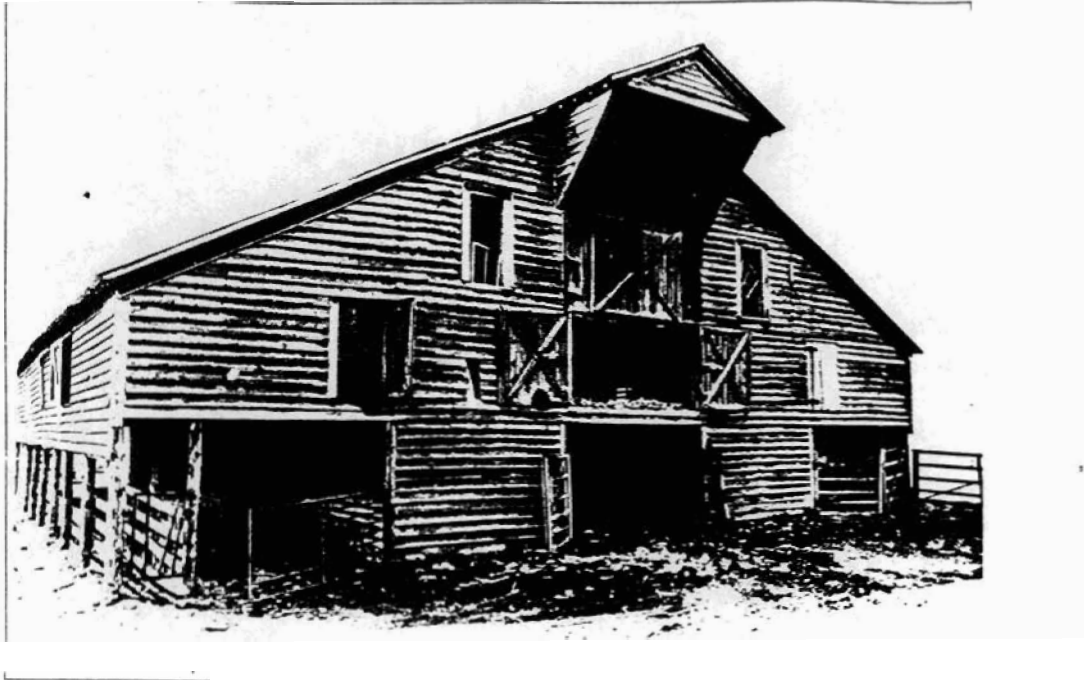
Historic Resources of Stone County
H. S. Mabry Barn, ST-161
East Richwoods
Don Brown, photographer
1983
Negative on file at the AHPP
Viewed from the east

A pedimented gable end extension of the roof's ridge distinguishes the principal (east) elevation of the barn. The overhang provides shelter for the bale carrier and track. Underneath the overhang are two double door rectangular openings. These doors furnish access to the loft area. A four-over-four window is positioned to each side of the top door configuration while two door openings flank the second central opening. Directly below, a large rectangular opening with two wood gates provides entry to the central driveway. Gates to the two side sheds complete the front facade.

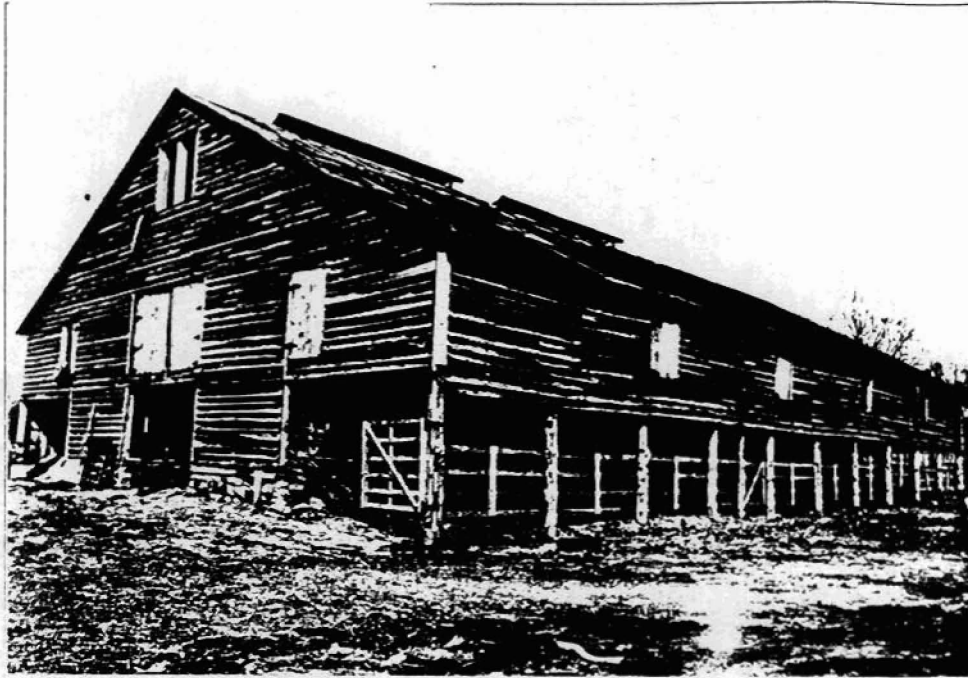
Historic Resources of Stone County
H. S. Mabry Barn, ST-161
East Richwoods
Don Brown, photographer
1983
Negative on file at the AHPP
Viewed from the southwest

An open shed defines the south elevation of the structure. This space is created by the extension of the second story which is supported by ten rustic posts. Four horizontal boards with a cross vertical board are located between each post creating a side barrier. The second story elevation is marked by four doors symmetrically arranged on the elevation. The second shed area on the north elevation is also created by the continuation of the second floor. Supported by posts on a stone foundation the shed is enclosed with vertical board infilling. The small window openings are intermittently spaced in the vertical board side. Two door openings are placed in the east and west ends of the second floor wall.

The rear (west) elevation is similar to the principal facade. The ground is marked by the entrances into the central driveway and the shed wings. Above the central ground opening is a rectangular double door configuration with a single leaf door to each side of it. A paired window opening in the gable completes the elevation.
